**ADA ASSESMENT REPORT**  
**COMCARE – RAINBOWS UNITED**  
**603 S. ERIE, WICHITA, KS**  
**Report Date: July 31, 2008**

The following ADA site assessment was performed on July 16, 2008 upon request of April Powell, Project Manager for Sedgwick County Project Services.

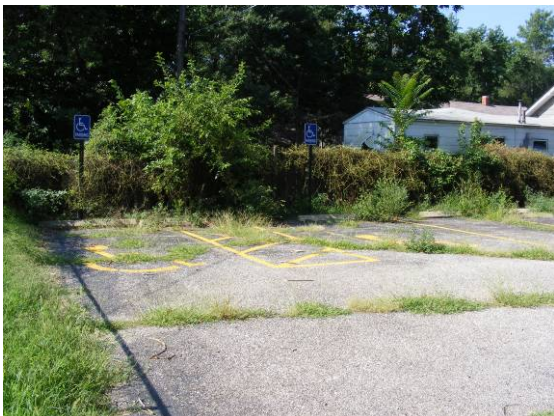
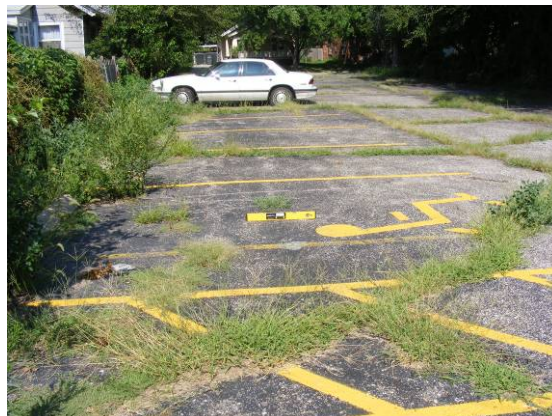
**EXISTING CONDITION:** Parking spaces are not accessible due to grass and weeds growing in cracks in the parking area, access aisle, and along the route to the building. ADAAG requires parking areas and access aisles to be level with surface slopes not exceeding 1:50 (2%) in all directions. The slopes of the paved area are compliant; however the grass growing from cracks creates abrupt changes in level and slopes which exceed 2%. (ADAAG 4.6.3)

Remove grass and weeds, and repair cracks so that abrupt changes in level and slopes exceeding 2% do not occur.

Priority: H

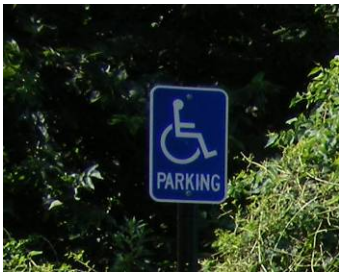
**EXISTING CONDITION:** A designated van accessible parking space exists (one space is 11' wide with a 5' access aisle, which meets universal design requirements and complies with Wichita city code), but van accessible signage does not. If parking spaces are provided for self-parking by employees or visitors, or both, then accessible spaces complying with 4.6 shall be provided in each such parking area in conformance with the table shown in (5)(a).

**RECOMMENDATION:** Provide van accessible signage at, at least, one van accessible parking space. This should be installed at the 11' wide parking space.

(ADAAG 4.6.4)

Priority: M

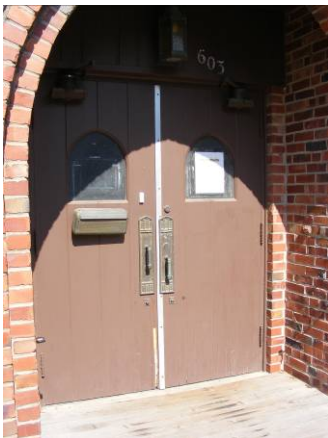
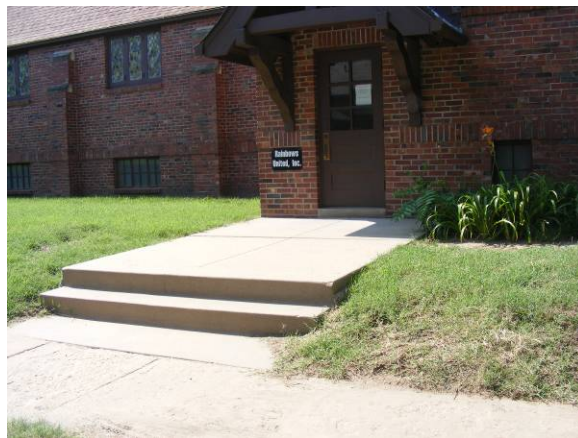
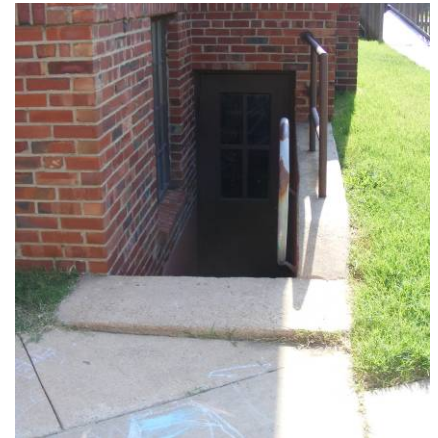
**EXISTING CONDITION:** Not all inaccessible entrances provide directional signage to indicate the nearest accessible entrance, and accessible entrance does not provide the symbol of accessibility. According to ADAAG, the symbol of accessibility must exist at accessible entrances when not all are accessible and inaccessible entrances shall have directional signage to indicate the route to the nearest accessible entrance.

Provide the symbol of accessibility on accessible entrances and provide directional signage at inaccessible (public) entrances.

(ADAAG 4.1.2(7)(c))

Priority: VH

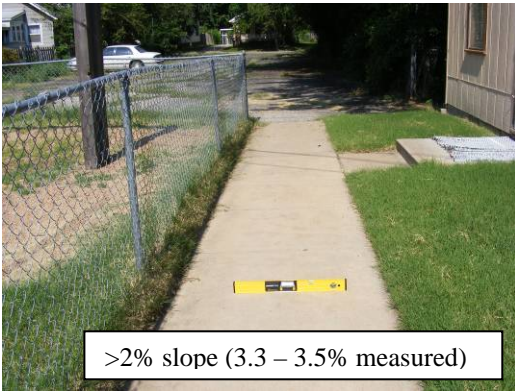
**EXISTING CONDITION:** A portion of the sidewalk along the fence (on route from parking to building) is not accessible due to cross slopes over 2%. According to ADAAG, nowhere shall the cross slope of an accessible route exceed 1:50 (2%).

(ADAAG 4.3.7)

Modify the sidewalk in front of accessible parking so the cross slope complies with ADAAG specifications and does not exceed 2%.

**Priority: L**

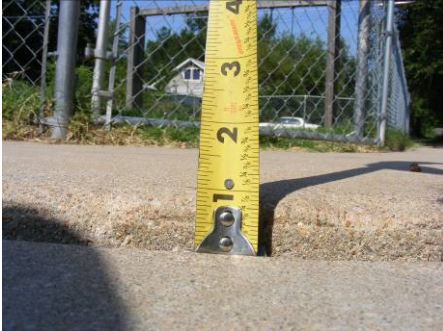
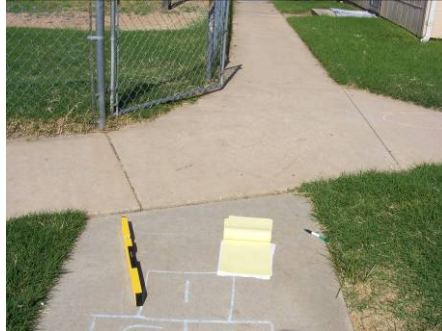
**EXISTING CONDITION:** An abrupt change in level of 3/4" exists on the path of travel (sidewalk) leading from the parking to the building. According to ADAAG, changes in level up to 1/4 in (6 mm) may be vertical and without edge treatment (see Fig. 7(c)). Changes in level between 1/4 in and 1/2 in (6 mm and 13 mm) shall be beveled with a slope no greater than 1:2 (see Fig. 7(d)).

(ADAAG 4.3, 4.3.7, 4.5.2)

Modify sidewalk so that abrupt changes in level do not occur.

**Priority: M**

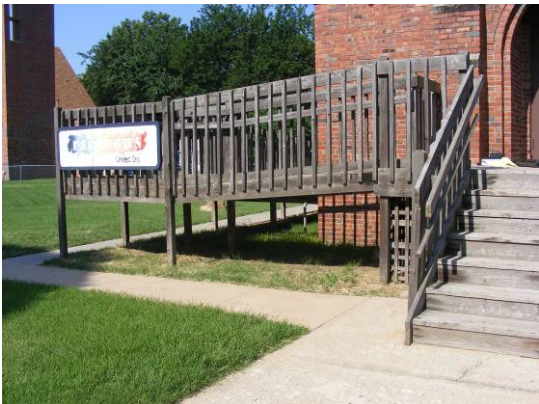
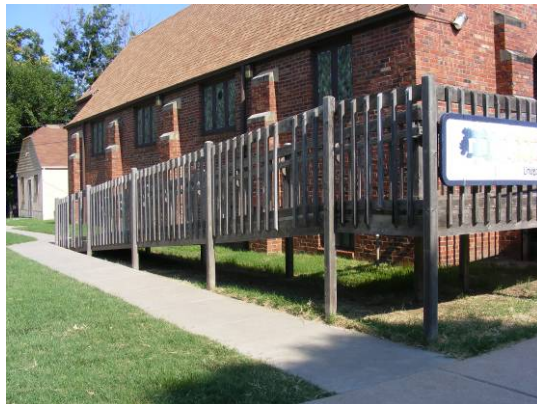
**EXISTING CONDITION:** A ramp exists to provide access to the building; however the ramp lacks full compliance due to the following structural inconsistencies:

- **Slopes exceed 1:12 (8.33%).** Slopes between 8.5% and 10.8% were measured. According to ADAAG, any part of an accessible route with a slope greater than 1:20 shall be considered a ramp and shall comply with

4.8. The least possible slope shall be used for any ramp. The maximum slope of a ramp in new construction shall be 1:12. (ADAAG 4.8.1, 4.8.2)

- **Abrupt changes in level (up to 1") exist on the ramp due to boards with nails that have come loose.** According to ADAAG, changes in level up to 1/4 in (6 mm) may be vertical and without edge treatment (see Fig. 7(c)). Changes in level between 1/4 in and 1/2 in (6 mm and 13 mm) shall be beveled with a slope no greater than 1:2 (see Fig. 7(d)). (ADAAG 4.3, 4.3.7, 4.5.2)

Modify ramp so that it complies with ADAAG specifications. (ADAAG 4.8)

**Priority: M**

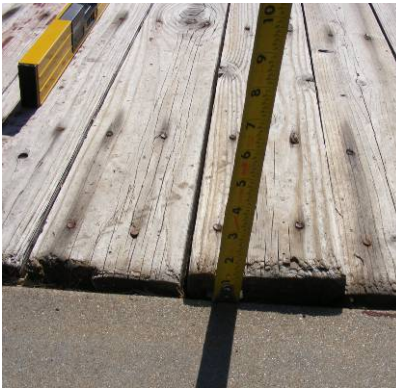
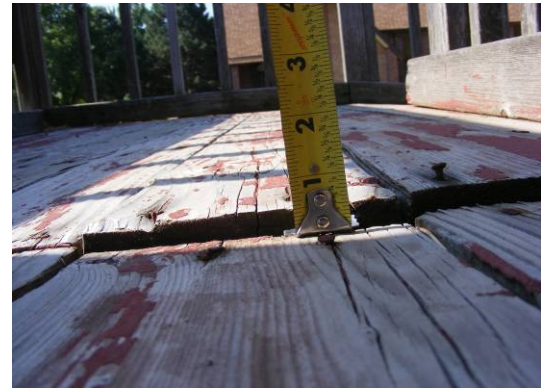
- **Handrails do not meet ADAAG specifications.** According to ADAAG, if a ramp run has a rise greater than 6 in (150 mm) or a horizontal projection greater than 72 in (1830 mm), then it shall have handrails on both sides. Handrails shall comply with 4.26 and 4.8.5. (ADAAG 4.8.5, 4.26)
- **Landing where ramp changes direction does not meet ADAAG requirements.** ADAAG that if ramps change direction at landings, the minimum landing size shall be 60 in by 60 in (1525 mm by 1525 mm). The existing landing is 3'-9" x 6'-7 1/2". (ADAAG 4.8.4)

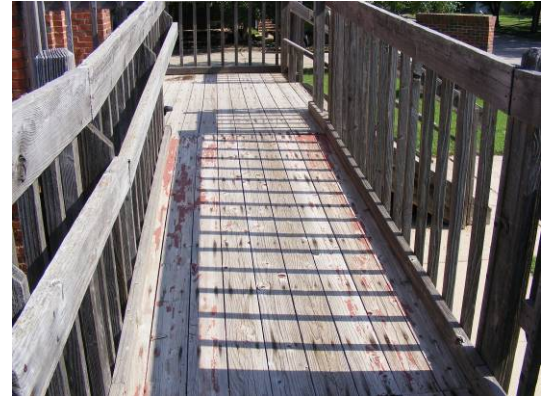
- **The bottom run of the ramp is too long at 34'.** ADAAG specifies that the maximum rise for any run shall be 30 in (760 mm) (see Fig. 16). The existing ramp run exceeds this requirement. (ADAAG 4.8.2)

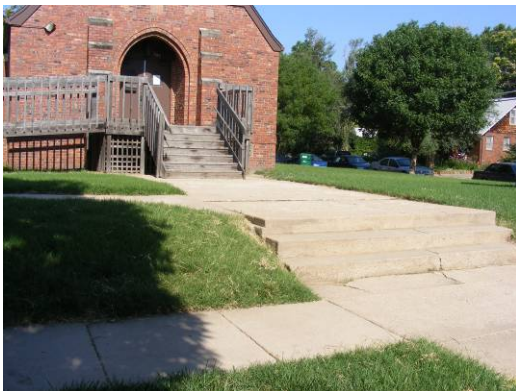
**EXISTING CONDITION:** ADAAG compliant handrails are not provided at stairs. ADAAG requires handrails at both sides of all stairs. Handrails shall comply with 4.26 and 4.9.4.

Since a ramp and directional signage will be provided, stairs are not part of the accessible route. In new construction, stairs are required to comply with ADAAG. However, this is existing construction, and as such stairs are allowed to remain in their current configuration. Although not required, ADAAG compliant handrails should be considered as a safety and accessibility improvement.

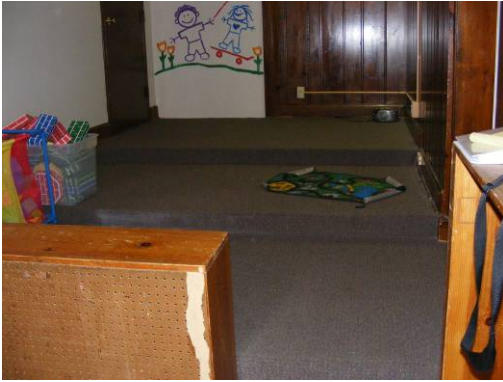
**EXISTING CONDITION:** A series of three raised platforms exist at the back of the building. The two upper platforms are not accessible due to a 5” step at each level. COMCARE staff explained that this area is used for a “quiet time” area where children can read. They explained that the area is not used as a “stage” where children would perform from the highest level. A ramp exists to provide access to the lowest of the three platforms so that a child with a disability would have access to the lower level of this area.

**RECOMMENDATION:** No action required at this time.

Note: COMCARE staff shall ensure that “program access” is always provided, and a child with disabilities could participate in the same programs and activities as other children. A child shall not be denied opportunities (or interaction/integration with other children) due to the lack of access to the upper levels of these platforms.

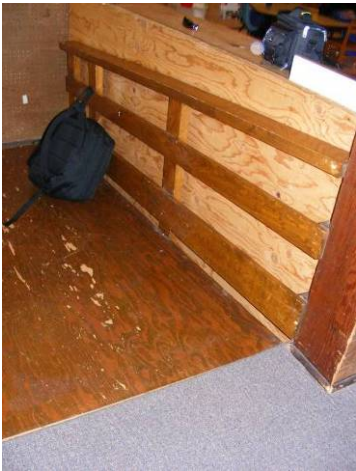
**EXISTING CONDITION:** A ramp exists to provide access to the lowest of the three raised platforms at the back of the facility; however the ramp is not compliant with all ADAAG requirements. The ramp is blocked by furniture (COMCARE staff explained that children were using the ramp to run circles); however, staff explained that the furniture would be moved immediately if a person with a disability entered the facility. The slope of the existing ramp, at 6.9%, is compliant. However the ramp has a number of other structural inconsistencies that require modification.

(ADAAG 4.8)

- **Abrupt changes in level over 1/4” exist at the top and bottom of the ramp.** According to ADAAG, changes in level up to 1/4 in (6 mm) may be vertical and without edge treatment (see Fig. 7(c)). Changes in level between 1/4 in and 1/2 in (6 mm and 13 mm) shall be beveled with a slope no greater than 1:2 (see Fig. 7(d)).  
(ADAAG 4.3.8, 4.5.2)
- **The ramp has a rise of 7” and no handrails are provided.** ADAAG requires that if a ramp run has a rise greater than 6 in (150 mm) or a horizontal projection greater than 72 in (1830 mm), then it shall have handrails on both sides.  
(ADAAG 4.8.5, 4.26)

**RECOMMENDATION:** Modify ramp so that it complies with all ADAAG requirements (ADAAG 4.8).

- Modify thresholds at top and bottom of ramp so that abrupt changes in level do not occur.
- Provide ADAAG compliant handrails. Ensure that the minimum clear width of the ramp is 36” between handrails (ADAAG 4.8.3), and that edge protection is provided at the south side of the ramp (ADAAG 4.8.7).
- Ensure that ADAAG compliant landings exist at the top and bottom of the ramp (ADAAG 4.8.4). ADAAG requires ramps to have clear and level landings at the bottom and top of each ramp. Landings shall have the following features: (1) The landing shall be at least as wide as the ramp run leading to it. (2) The landing length shall be a minimum of 60 in (1525 mm) clear.

Priority: M

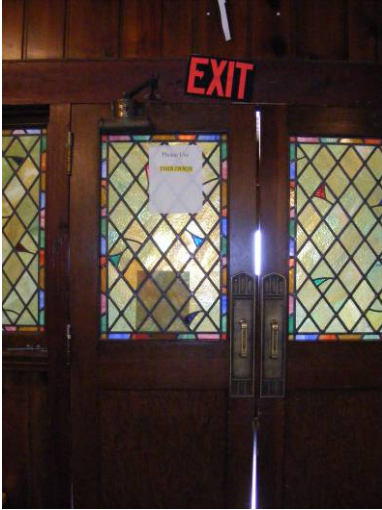
**EXISTING CONDITION:** Exit signs are not also provided in Braille. Signs that identify permanent rooms and spaces (room numbers, exit signs, and restrooms) are required to be provided in Braille, mounted at the latch side of doorway openings. The New ADAAG provides specific guidance on the location of signage. Tactile characters on signs are to be located 48 inches (1220 mm) minimum above the finish floor or ground surface, measured from the baseline of the lowest tactile character and 60 inches (1525 mm) maximum above the finish floor or ground surface, measured from the baseline of the highest tactile character. Where a tactile sign is provided at a door, the sign shall be located alongside the door at the latch side. Where a tactile sign is provided at double doors with one active leaf, the sign shall be located on the inactive leaf. Where a tactile sign is provided at double doors with two active leaves, the sign shall be located to the right of the right hand door. Where there is no wall space at the latch side of a single door or at the right side of double doors, signs shall be located on the nearest adjacent wall. Signs containing tactile characters shall be located so that a clear floor space of 18 inches (455 mm) minimum by 18 inches (455 mm) minimum, centered on the tactile characters, is provided beyond the arc of any door swing between the closed position and 45 degree open position. (ADAAG 4.1.3(16), 4.30 & New ADAAG 703)

Provide Braille signage at all locations where exit signs exist. Mount signage so that it complies with the new ADAAG 703.4.1 and 703.4.2. Use the 60” maximum dimension to establish the mounting height.

**Priority: H**

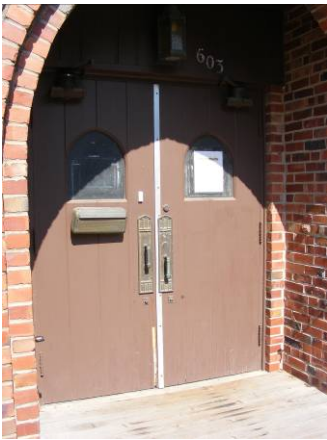
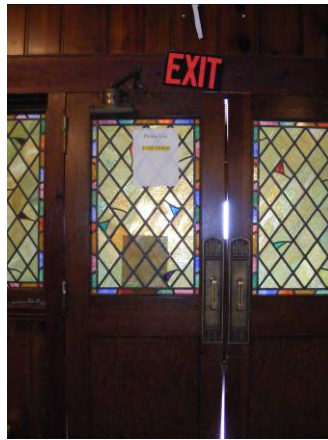
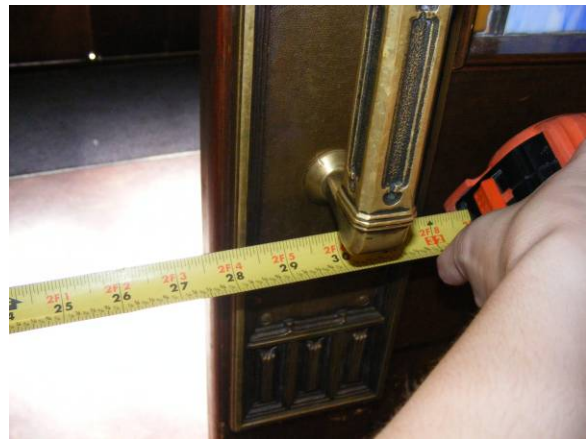
**EXISTING CONDITION:** Main entrance doors (at both the east exterior and interior vestibule) provide less than 32” clear opening (only 27-1/2” – 28-1/2” clearance is provided). ADAAG requires double leaf doorways to have at least one leaf that provides a clear 32” opening. Doors, leading to accessible facilities, are required to have a minimum clear opening of at least 32-inches measured with the door open 90-degrees. (ADAAG 4.13)

Modify doors to ensure that all doors used by the public comply with ADAAG specifications for clear opening width.

- Note: The interior vestibule doors have decorative stained glass that may be of special significance. An alternate solution for these interior doors may be to provide signage which indicates, “These doors to remain open during business hours to ensure accessibility,” and keep the doors held open during business hours.

**Priority: VH**

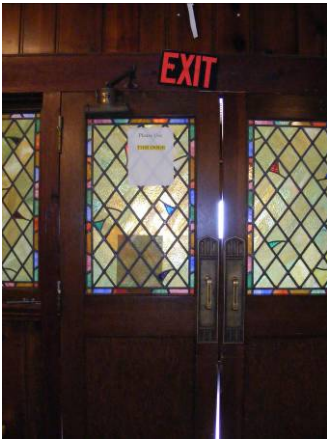
**EXISTING CONDITION:** The push/pull weight of the interior entrance vestibule doors is too heavy. ADAAG requires that the maximum pressure required to push or pull open a door be 5-pounds or less. (ADAAG 4.13.11)

**RECOMMENDATION:**  
Modify the door closers to comply with ADAAG specifications.

**Priority: VH**

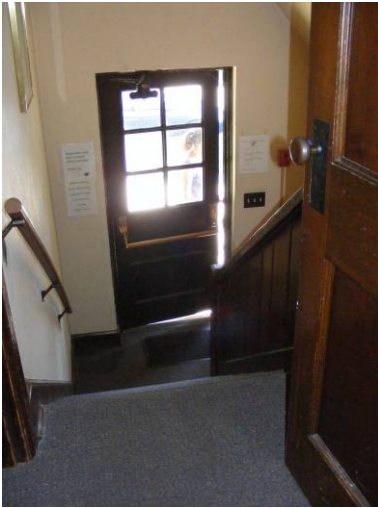
**EXISTING CONDITION:** Stairway and basement are inaccessible due to numerous inconsistencies. Inconsistencies include, but are not limited to: Round door hardware, clear width of door is only 27-1/2", non-compliant handrails, and basement inaccessible due to steps.

**RECOMMENDATION:**  
It was understood that this entrance and the basement are used by employees only (not open to the public). As such, modifications are not required unless necessary to accommodate an employee with a disability.

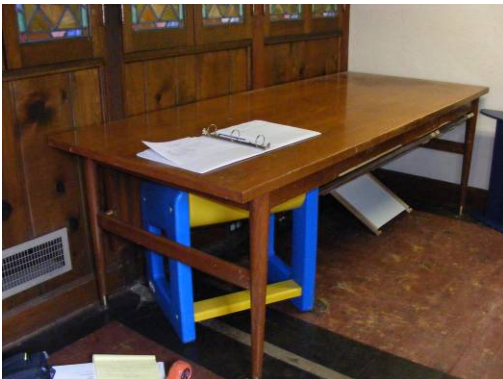
**EXISTING CONDITION:** The sign in table does not provide appropriate knee clearance; however, no chairs are provided and the intent does not appear to provide seating at the table. According to ADAAG, if seating for

people in wheelchairs is provided at tables or counters, knee spaces at least 27 in (685 mm) high, 30 in (760 mm) wide, and 19 in (485 mm) deep shall be provided (see Fig. 45). The existing table only provides 25-inches of height. (ADAAG 4.32, 7.2)

Since seating does not appear to be provided at this table, this table should comply with provisions for providing goods or services (ADAAG 7.2). ADAAG requires a minimum 36-inch long portion of sales or service counters (or tables) to be a maximum height of 36-inches. Since the tabletop is 29" high, it does meet this requirement and modification is not necessary at this time.

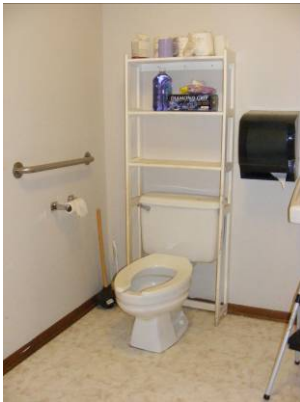
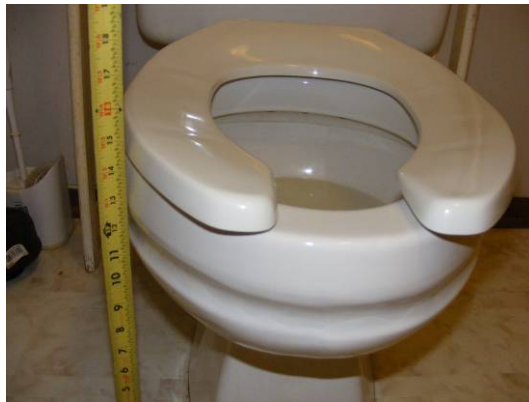
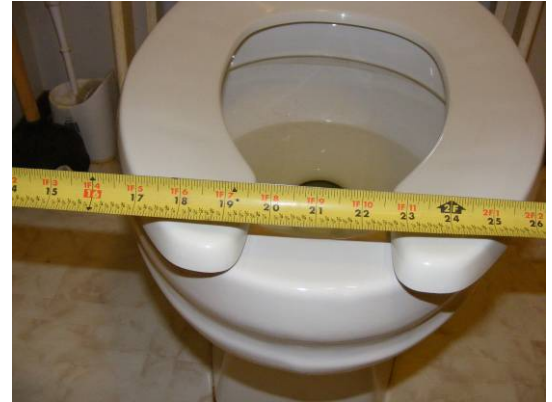
**EXISTING CONDITION:** The flush control for the water closet is located on the wall side. ADAAG requires that controls for flush valves be mounted on the wide side of toilet areas no more than 44 in above the floor.

(ADAAG 4.16.5)

**EXISTING CONDITION:** Height of water closet is too low at 15-1/2".

Per ADAAG, the height of water closets shall be 17 in to 19 in (430 mm to 485 mm), measured to the top of the toilet seat.

Toilet is centered 21 inches from the wall. According to ADAAG, accessible water closets must be centered at 18-inches from the sidewall per Figure 28.

Modify the water closet so that the flush valve is on the wide side of the toilet area (not on the wall side).

**Priority: M**

Modify the water closet so that the seat height complies with ADAAG requirements.

**Priority: H**

Modify water closet to comply with ADAAG specifications.

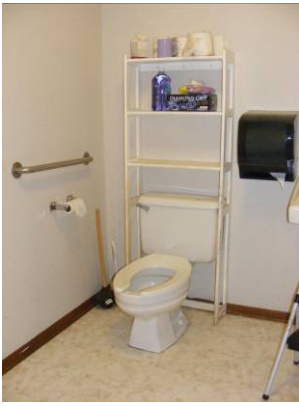
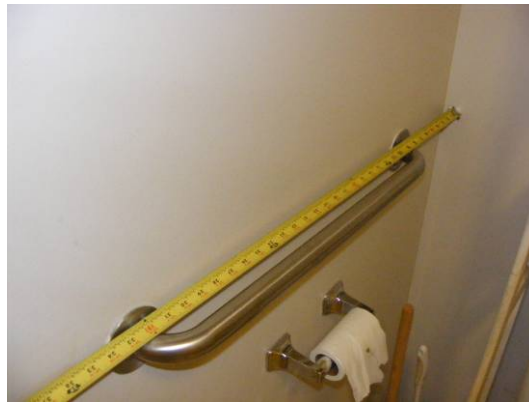
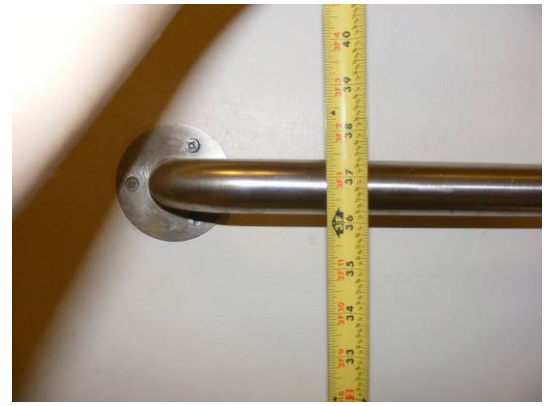
**EXISTING CONDITION:** The side grab bar is too short at 24". There is no back grab bar. Additionally, the grab bar is mounted too high (at 37-3/8" A.F.F.) and is located incorrectly.

ADAAG requires that grab bars are mounted at a height between 33 and 36 inches measured to the top of the grab bar. According to ADAAG, grab bars for water closets not located in stalls shall comply with 4.26 and Fig. 29. The grab bar behind the water closet shall be 36 in (915 mm) minimum.

(ADAAG 4.16.4, 4.26)

Provide a grab bars at the water closet, which comply with ADAAG specifications.

**Priority: H**

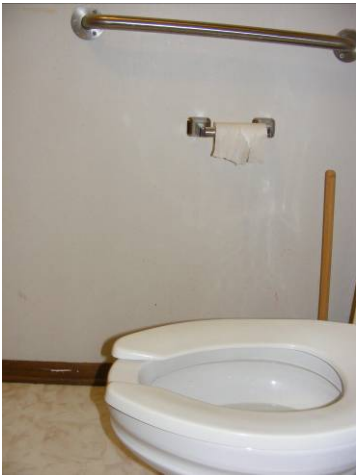
**EXISTING CONDITION:** The toilet paper dispenser is inappropriately located. The current ADAAG does not specify a horizontal distance from the toilet. The new ADAAG (604.7) will require the relocation of the dispenser horizontally to a location 7 to 9 inches forward of the toilet.

(New ADAAG 604.7)

Relocate toilet paper dispenser to comply with the new ADAAG requirements.

**Priority: H**

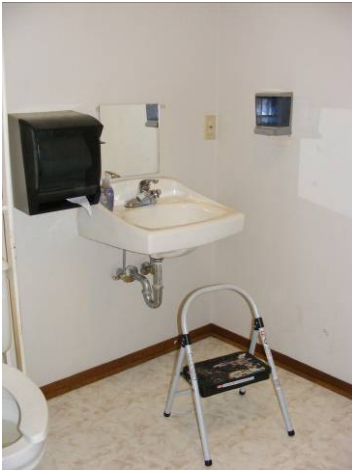
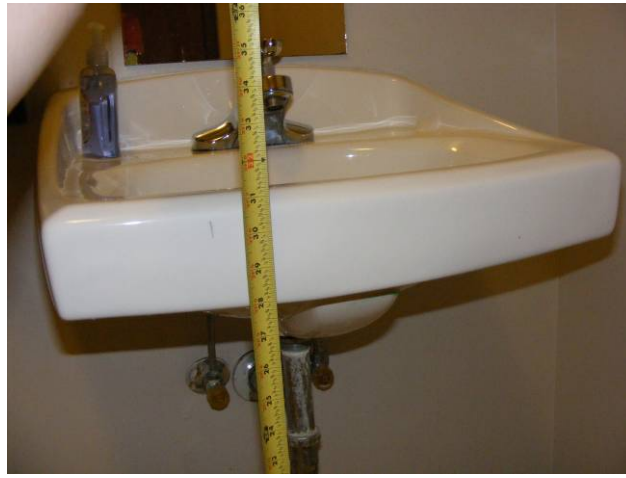
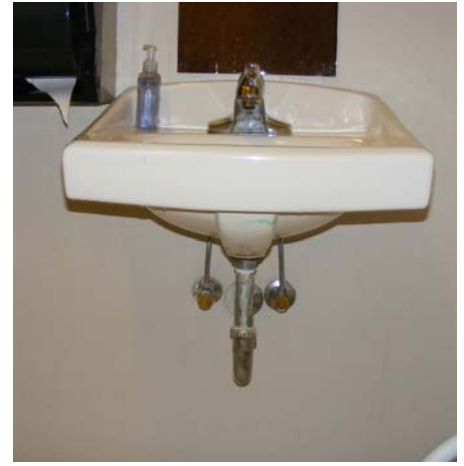
**EXISTING CONDITION:** Insufficient knee clearance (for adults) is provided at the lavatory. Knee clearance of 27-7/8” is provided. ADAAG requires lavatories to be mounted with the rim or counter surface no higher than 34 in (865 mm) above the finish floor and provide a clearance of at least 29 in (735 mm) above the finish floor to the bottom of the apron. Knee and toe clearance shall comply with Fig. 31.

(ADAAG 4.19)

**EXISTING CONDITION:** Pipes under the lavatory are not insulated. Pipes under lavatories are required to be insulated or otherwise configured to avoid contact.

Modify lavatory to comply with ADAAG specifications.

Priority: H

Provide pipe protection or insulation to insure at least one lavatory complies with ADAAG specifications.

Priority: VH

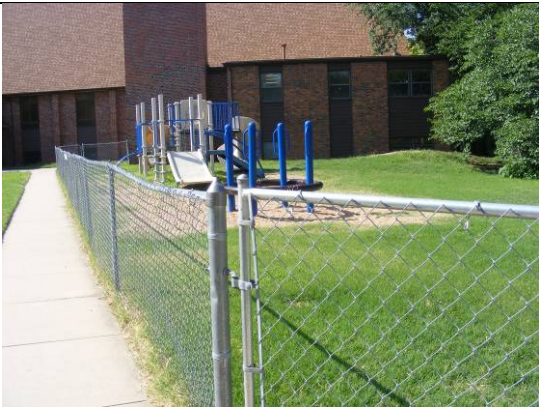
**EXISTING CONDITION:** A stable, firm and slip resistant surface does not exist leading to the individual play components and play structure exit points; and does not exist in the use zone around the play facilities. It was unclear if the play area is used by the COMCARE program, or if it belongs to the adjacent church. During the site visit, children playing outdoors did not enter the play area.

not enforceable guidance. Two such documents exist; the Play Areas, Final Rule, October, 18th, 2000 (Play Areas Final Rule); and the New ADAAG, November 24th, 2004, Chapter 2, 240 Play Areas and Chapter 10, 1008 Play areas (New ADAAG). In essence, both of the Play Areas Final Rule and New ADAAG are identical and both were created by the U.S. Access Board. Accessible routes do not lead to the play equipment, due to surface cross slopes greater than 1:50, running slopes greater than 1:12, and abrupt changes in level greater than ½-inch. In other words, the existing ground surface (sand and grass) is not considered an accessible surface.

To ensure an accessible route surface, not requiring regular maintenance, which is also impact attenuating, it is recommended that one accessible path of travel, be installed which consists of either rubber tiles or poured rubber, leading to each single play component and exit points of the play structures. It is also recommended that a rubber surface be provide in the use zones of each single play component and the composite play structure. However, such rubber surface is not technically required by the available accessibility guidance, but may be required by the general program access provisions of Title II. (Note: A well maintained wood fiber surface, as defined in (Building Block 16), is also considered accessible under the conditions that such surface is maintained regularly.

- Note: The alternative is to lock the gate or otherwise ensure that play equipment is not used by the COMCARE program.

**Priority: M**
