ADA ASSESMENT REPORT
COMCARE – NORTHRIDGE FRIENDS CHURCH
2655 N. BULLINGER, WICHITA, KS
Report Date: August 5, 2008

The following ADA site assessment was performed on July 16, 2008 upon request of April Powell, Project Manager for Sedgwick County Project Services.

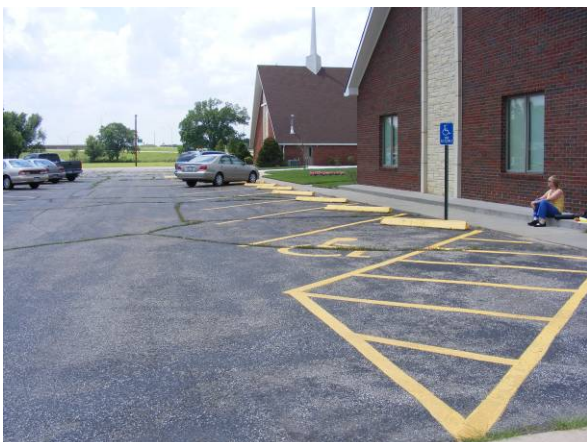
EXISTING CONDITION: One van accessible parking space exists to serve the COMCARE program (located near the COMCARE entrance). The slopes, dimensions, and signage comply with ADAAG

specifications. However, the parking space dimensions do not comply with new Wichita city code. Wichita city code requires all accessible parking spaces to be 11' wide with a 5' aisle for a total of 16'. ADAAG recognizes these dimensions as universal design.

RECOMMENDATION: No action necessary at this time; however, when the parking lot is altered or restriped, striping should be revised to meet Wichita city code.

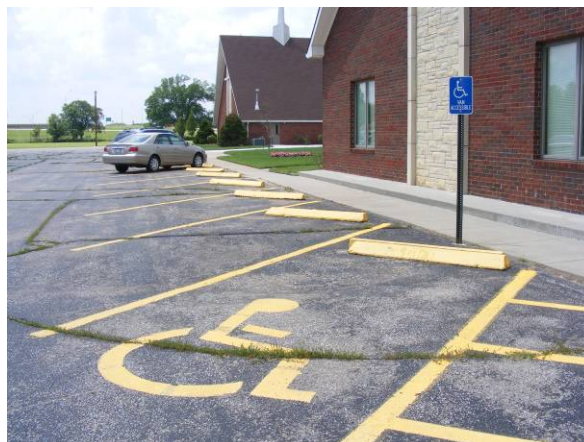
EXISTING CONDITION: Parking space may not be accessible due to grass growing in a crack in the parking area and access aisle. ADAAG requires parking areas and access aisles to be level with surface slopes not exceeding 1:50 (2%) in all directions. The slopes of the paved area are compliant; however the grass growing from the crack may create abrupt changes in level.

(ADAAG 4.6.3)

Remove grass, and repair crack so that abrupt changes in level do not occur.

Priority: H

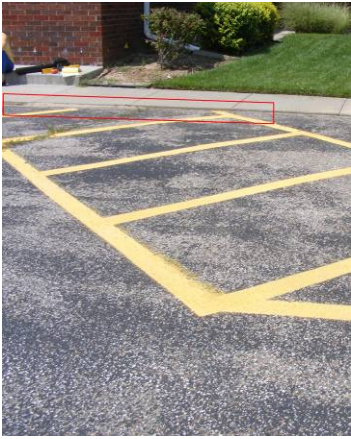
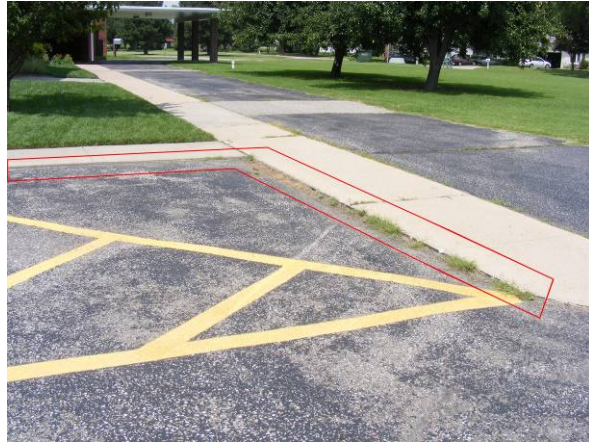
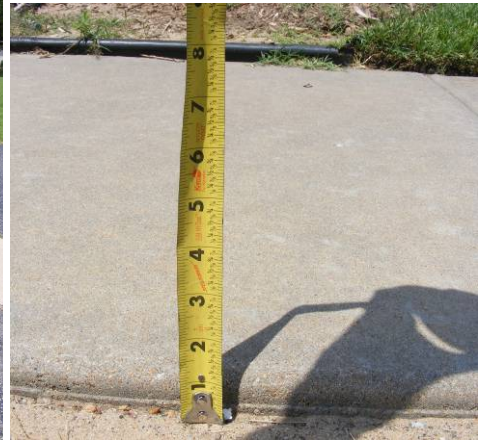
EXISTING CONDITION: An abrupt change in level of 1/2" - 3/4" exists on the path of travel from the access aisle to the sidewalk. This occurs where the sidewalk meets the asphalt paving. According to ADAAG, changes in level up to 1/4 in (6 mm) may be vertical and without edge treatment (see Fig. 7(c)). Changes in level between 1/4 in and 1/2 in (6 mm and 13 mm) shall be beveled with a slope no greater than 1:2 (see Fig. 7(d)).

(ADAAG 4.3, 4.3.7, 4.5.2)

Modify transition so that an accessible route (at least 3'-0" wide) exists, and no abrupt changes in level occur. If the entire area is not made accessible, be sure to clearly mark the accessible route.

Priority: M

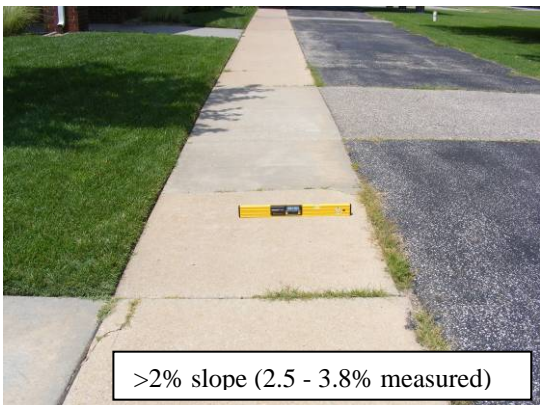
EXISTING CONDITION: A small portion of the sidewalk (on route from parking to building) is not accessible due to cross slopes over 2%. According to ADAAG, nowhere shall the cross slope of an accessible route exceed 1:50 (2%).

(ADAAG 4.3.7)

Modify the sidewalk in front of accessible parking so the cross slope complies with ADAAG specifications and does not exceed 2%.

Priority: L

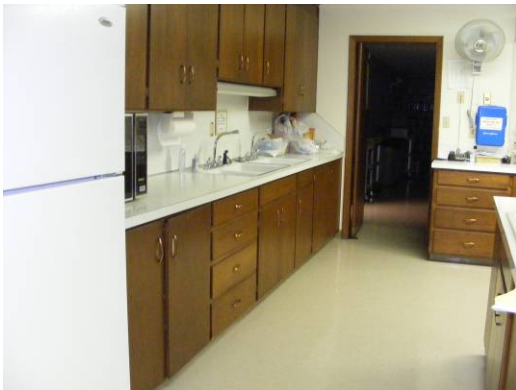
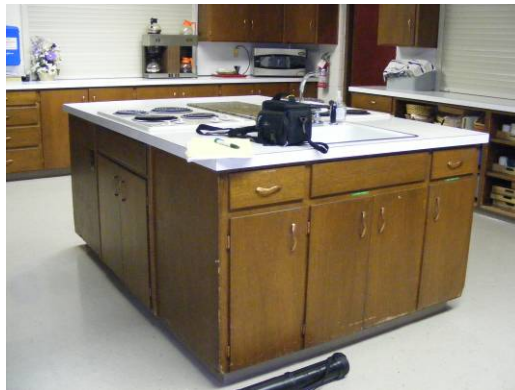
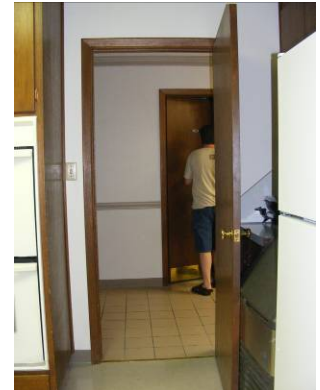
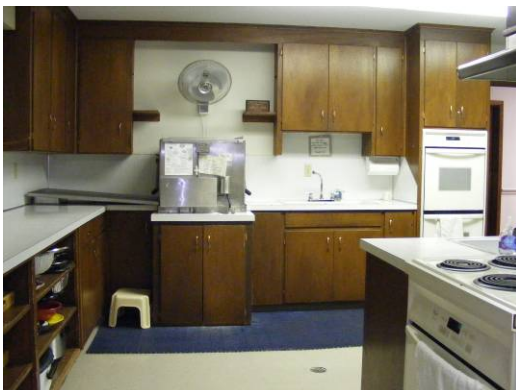
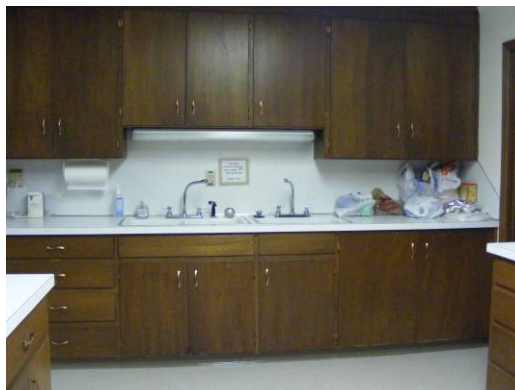
EXISTING CONDITION: Kitchen is inaccessible to people with disabilities due to the following structural inconsistencies:

- **The existing sinks (4 sinks) are too high at 36” and do not provide appropriate knee and toe clearance.** According to ADAAG, knee clearance that is at least 27 in (685 mm) high, 30 in (760 mm) wide, and 19 in (485 mm) deep shall be provided underneath sinks. In addition, each sink shall be a maximum of 6-1/2 in (165 mm) deep. Sinks shall be mounted with the counter or rim no higher than 34 in (865 mm) above the finish floor.
RECOMMENDATION: Ensure at least one sink is fully accessible. (ADAAG 4.24)
Priority: M

- **The top surface of the kitchen counter is 36 inches from the floor.**
RECOMMENDATION: Provide a portion of the countertop that is accessible with a surface that is between 28 and 34 inches from the floor or provide an accessible table in the kitchen for this purpose. (ADAAG 4.1.3(18), 4.32.4)
Priority: M

- **Some operating mechanisms, controls, and accessories may be located too high.** ADAAG requires the highest operable part of controls, dispensers, receptacles, and other operable equipment to be placed within at least one of the reach ranges specified in 4.2.5 and 4.2.6. The new ADAAG further restrict this to a maximum height of 48” A.F.F., and reach ranges are further limited when one must reach over an obstruction (ex. – countertop).
RECOMMENDATION: Ensure that all parts of equipment and accessories that are used by the public are located within an accessible reach range. (ADAAG 4.27.3 & New ADAAG 308)
Priority: M

- **The three doors to the kitchen are 2’-8” wide.** Doors, leading to accessible facilities, are required to have a minimum clear opening of at least 32-inches measured with the door open 90-degrees.
RECOMMENDATION: Provide at least one door with a clear opening of 32 inches with the door open 90 degrees, measured between the face of the door and the opposite stop. (ADAAG 4.13.5, Fig. 24)
Priority: H

- **Round door hardware exists on the main door to the kitchen (from the hall).** Accessible doors are required to have opening hardware, which does not require tight grasping or twisting of the wrist to operate.
RECOMMENDATION: Provide a door with hardware that is easy to grasp with one hand and that does not require tight grasping, pinching, or twisting of the wrist to operate. Lever-operated mechanisms, push-type mechanisms, and U-shaped handles are acceptable designs. (ADAAG 4.13.9)
Priority: H

- **The main door to the kitchen (from the hall), which is accessed through a front approach, lacks sufficient maneuvering clearance on the latch/pull side.**
RECOMMENDATION: On the pull side of the door, provide maneuvering clearance at least 60 inches deep and provide a minimum of 18 inches (24 inches is preferred) of maneuvering clearance on the latch side of the door. An alternate solution may be to provide an automatic opening mechanism or to provide signage which indicates, “This door to remain open during business hours to ensure accessibility,” and keep the door held open at all times during business hours. (ADAAG 4.13.6, Fig. 25)
Priority: M

RECOMMENDATION: Make modifications as necessary to provide program access to all part of the kitchen and equipment that is used by program participants. Note: Modifications are not required to those items or areas that are used by employees only.

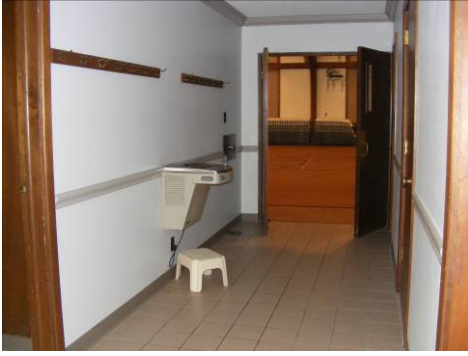
EXISTING CONDITION: Drinking fountain in hallway by kitchen is a protruding object that is not detectable by cane. Objects that project more than 4" from the wall, 27" above the floor and less than 80" above the floor are not cane detectable.

(ADAAG 4.4, 4.15)

RECOMMENDATION: Place a cane detectable object on each side of the drinking fountains. This may be achieved by wing walls or other methods such as those shown below.

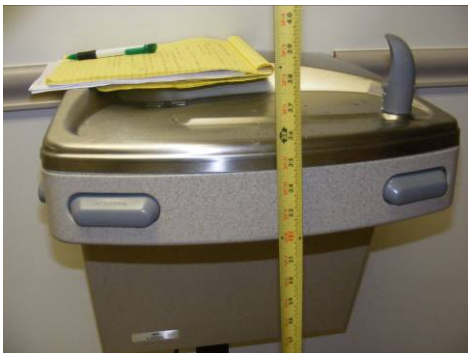
EXISTING CONDITION: Common use drinking fountain is inaccessible.

According to ADAAG if only one drinking fountain is provided on a floor there shall be a drinking fountain which is accessible to individuals who use wheelchairs and one accessible to those who have difficulty bending or stooping. Additionally, the spout of wheelchair accessible fountains shall be no higher than 36 in (915 mm), measured from the floor or ground surfaces to the spout outlet (see Fig. 27(a)). The existing spout is at 37" A.F.F. (ADAAG 4.15)

It is recommended that at least one set of hi-lo drinking fountains exist on this floor, in the proximity of the COMCARE program. Note: Under certain conditions in existing buildings (areas built before 1/26/1992), cups at inaccessible drinking fountains are considered equivalent facilitation. Provide a cup holder at this fountain if a set of hi-lo drinking fountains cannot be provided. However, the hi-lo fountain is preferred. When not all drinking fountains are accessible, directional signage should be provided directing occupants to the nearest accessible location.

Priority: VH

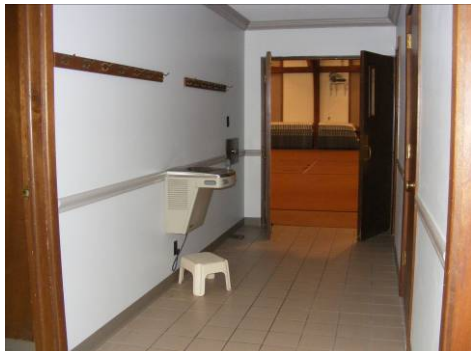
EXISTING CONDITION: Coat racks at hallway by kitchen are located too high at 64”.

Where coat racks or hooks are provided, at least one must comply with reach ranges defined by ADAAG 4.2.5 or 4.2.6. The New ADAAG further limits this to a 48” maximum height.

(ADAAG 4.25.3, 4.2.5, 4.2.6, & New ADAAG 308)

Install at least one lowered coat hook (48” A.F.F. maximum) at an accessible location near the existing coat hooks, making sure not to make the hook a protruding object.

Priority: H

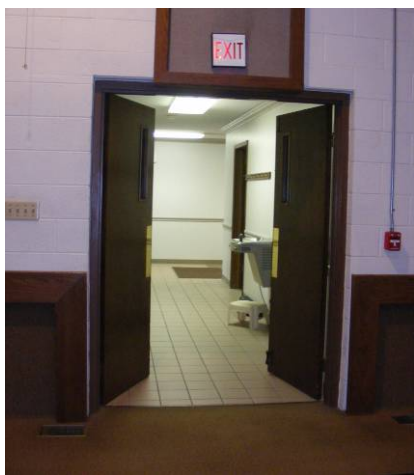
EXISTING CONDITION: Entrance doors (to multi-purpose room) provide less than 32” clear opening (each door is 2’-6”). ADAAG requires double leaf doorways to have at least one leaf that provides a clear 32” opening. Doors, leading to accessible facilities, are required to have a minimum clear opening of at least 32-inches measured with the door open 90-degrees.

(ADAAG 4.13)

Modify doors to ensure that all doors used by the public comply with ADAAG specifications for clear opening width.

- Note: An alternate solution for these interior doors may be to provide signage which indicates, “These doors to remain open during business hours to ensure accessibility,” and keep the doors held open at all times during business hours.

Priority: H

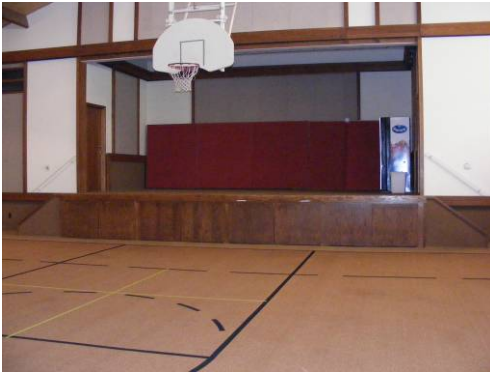
EXISTING CONDITION: A stage exists in the multi-purpose room. According to ADAAG, an accessible route shall connect stages, arena floors, dressing rooms, locker rooms, and other spaces used by performers. An accessible route cannot include steps.

(ADAAG 4.33.5)

COMCARE staff and church staff stated that program participants were not allowed access to the stage, and that the stage was not part of their program. As such, no modifications are necessary at this time.

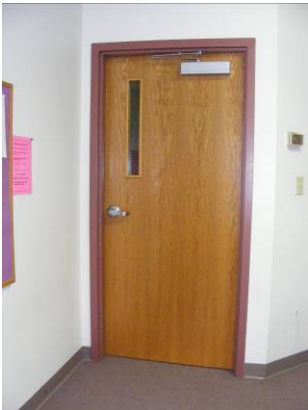
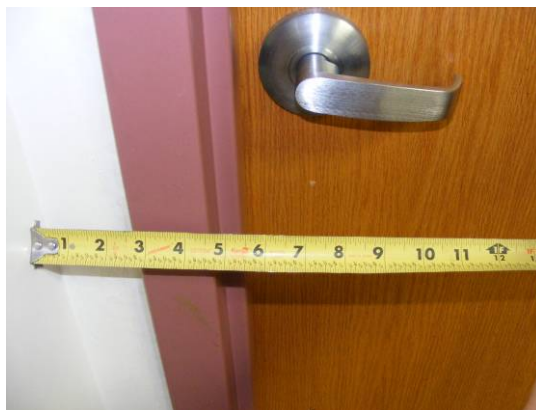
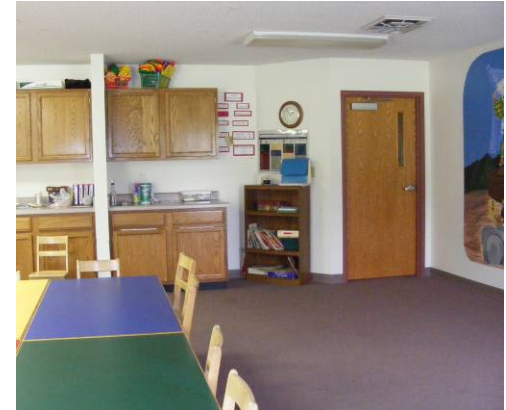
EXISTING CONDITION: Doorways to classrooms do not provide appropriate maneuvering space at door. ADAAG requires at least 12-inches to the latch push side of doors when doors have both a closer and a latch per ADAAG Figure 25.

(ADAAG 4.13.6)

Modify interior doors to comply with ADAAG specifications or install an automatic opening mechanism. According to ADAAG, accessible entrances/exits must be provided, at a minimum, in the same number that local fire code requires entrances to exist. In other words, if local fire code requires two entrances at a facility, then both entrances are required to be accessible.

- Note: An alternate approach, if allowable by building and fire code, may be to either remove the closers, or add signage indicating, “These doors to remain open during business hours to ensure accessibility,” and keep the doors held open at all times during business hours. Note that this would not be acceptable if doors are required to be fire-rated.

Priority: M

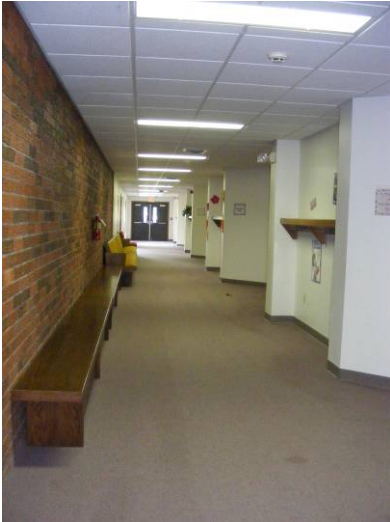
EXISTING CONDITION: Coat racks at hallway by classrooms are located at 48-1/2” to the lowest hook. This complies with current ADAAG, but may be too high at 53” once the New ADAAG is adopted.

Where coat racks or hooks are provided, at least one must comply with reach ranges defined by ADAAG 4.2.5 or 4.2.6. The New ADAAG further limits this to a 48” maximum height. (ADAAG 4.25.3, 4.2.5, 4.2.6, & New ADAAG 308)

Install hook at this time (48” A.F.F. maximum), or immediately upon adoption of the new ADAAG (Department of Justice is in its final review period, and imminent adoption is expected).

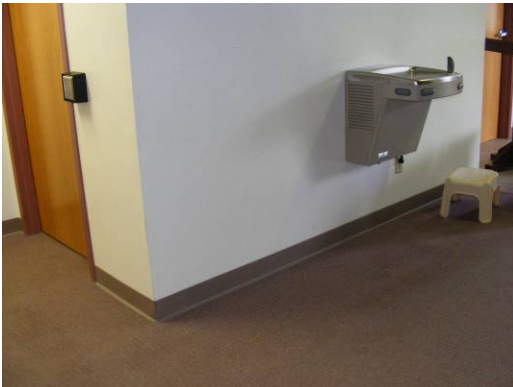
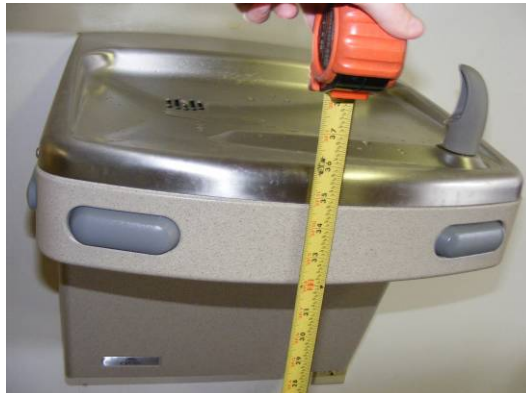
EXISTING CONDITION: Common use drinking fountain is inaccessible and is a protruding object.

See comments about drinking fountain in hallway by kitchen. The same problems exist and require correction at this location.

Priority: VH

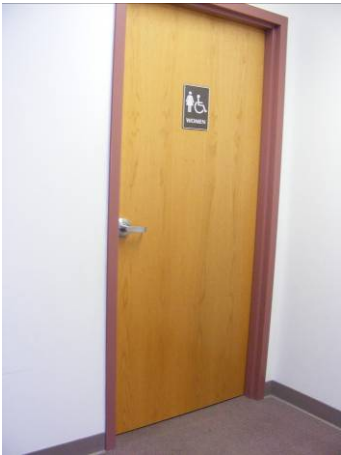
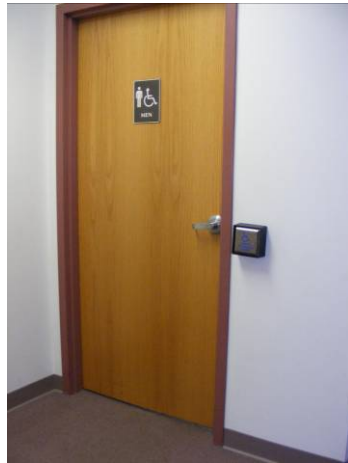
EXISTING CONDITION: Restroom signage is inappropriately located at both the Men's and Women's Restrooms. Signs that identify permanent rooms and spaces (room numbers, exit signs, and restrooms) are required to be provided in Braille, mounted at the latch side of doorway openings. The New ADAAG provides specific guidance on the location of signage. Tactile characters on signs are to be located 48 inches (1220 mm) minimum above the finish floor or ground surface, measured from the baseline of the lowest tactile character and 60 inches (1525 mm) maximum above the finish floor or ground surface, measured from the baseline of the highest tactile character. Where a tactile sign is provided at a door, the sign shall be located alongside the door at the latch side. Signs containing tactile characters shall be located so that a clear floor space of 18 inches (455 mm) minimum by 18 inches (455 mm) minimum, centered on the tactile characters, is provided beyond the arc of any door swing between the closed position and 45 degree open position. (ADAAG 4.1.3(16), 4.30 & New ADAAG 703)

Move signage so that it is located to comply with the new ADAAG. Mount signage so that it complies with the new ADAAG 703.4.1 and 703.4.2. Use the 60" maximum dimension to establish the mounting height.

Priority: H

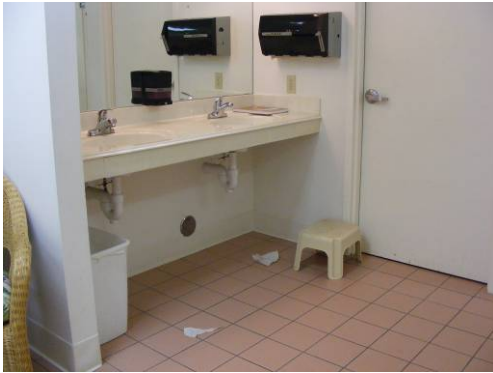
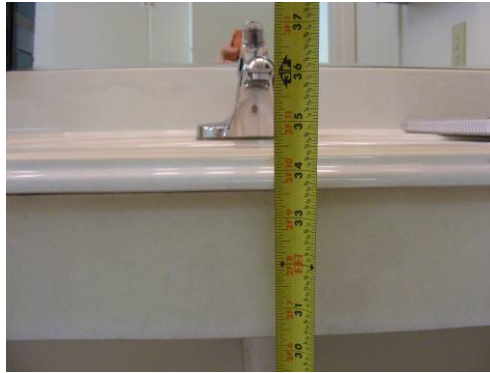
EXISTING CONDITION: Lavatory countertops at both the Men’s and Women’s Restrooms are slightly too high at 34-3/8” A.F.F. ADAAG requires lavatories to be mounted with the rim or counter surface no higher than 34 in (865 mm) above the finish floor.

(ADAAG 4.19.2)

Modify countertop height of at least one lavatory in each restroom to comply with ADAAG specifications.

Priority: L

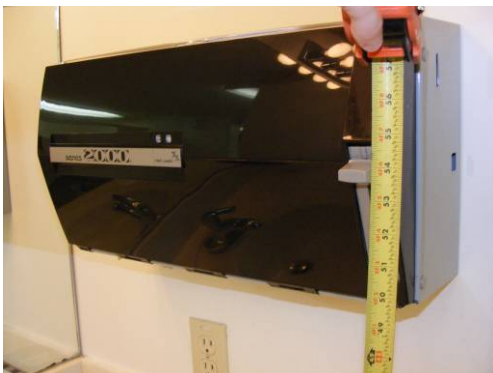
EXISTING CONDITION: Paper towel dispensers at the Men’s and Women’s Restrooms are located with the highest operable part at 54”. This complies with current ADAAG, but may be too high at 53” once the New ADAAG is adopted. The current ADAAG requires objects used by the public to be within a maximum reach range of 54-inches where a side reach is possible and a maximum of 48-inches where only a

forward reach is possible, to the highest operable part. However the new ADAAG changes this to a 48-inch maximum for either a forward or a side reach.

(ADAAG 4.2.5, 4.2.6 & New ADAAG 308)

Lower paper towel dispensers to comply with the new ADAAG at this time, or immediately upon adoption of the new ADAAG (Department of Justice is in its final review period, and imminent adoption is expected).

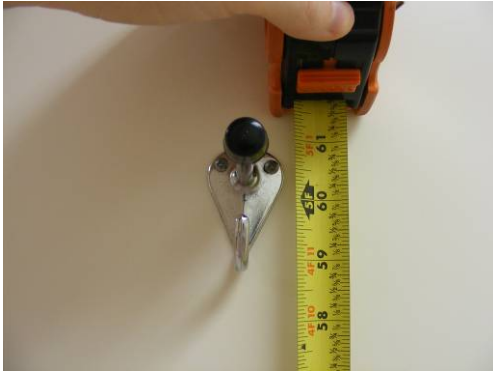
EXISTING CONDITION: Coat hooks in accessible restroom stalls (at Men’s and Women’s Restrooms) are located too high at 61”. Where coat hooks are provided, at least one must comply with reach ranges defined by ADAAG 4.2.5 or 4.2.6. The New ADAAG further limits this to a 48” maximum height. (ADAAG 4.25.3, 4.2.5, 4.2.6, & New ADAAG 308)

Install at least one lowered coat hook (48” A.F.F. maximum) in the accessible toilet stall, making sure not to make the hook a protruding object.

Priority: H

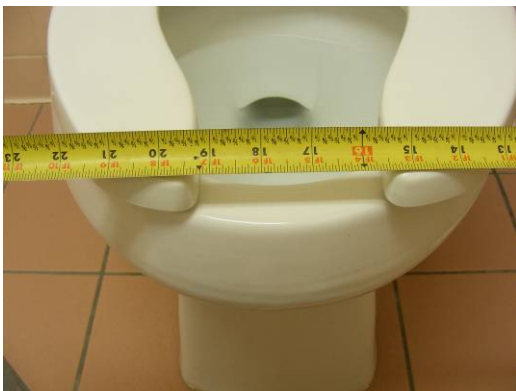
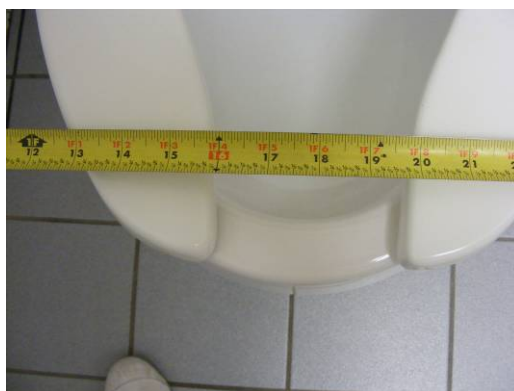
EXISTING CONDITION: The Men’s and Women’s Restroom water closets are not centered at exactly 18” from the wall.

The centerline of the existing water closet is located at 17-1/2” to 17-3/4” from the wall. ADAAG requires that water closets be located per Figure 28, with exactly 18” from the centerline of the water closet to the wall.

(ADAAG 4.16)

The new ADAAG guidelines allow for the water closet to be positioned where the centerline of the water closet is 16 inches minimum to 18 inches maximum from the side wall or partition (ADA-ABA 604.2). Because the toilet falls within this range, and these guidelines are expected to be adopted by the Department of Justice, this condition may be allowed to remain at this time.

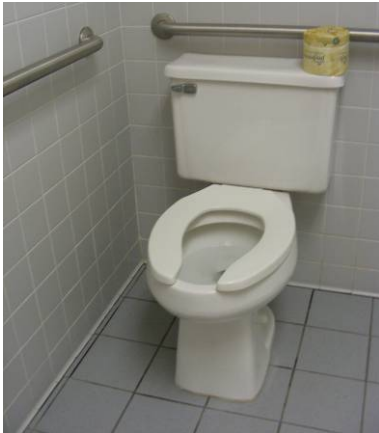
EXISTING CONDITION: The flush control for the Men's Restroom water closet is located on the wall side. ADAAG requires that controls for flush valves be mounted on the wide side of toilet areas no more than 44 in above the floor.

(ADAAG 4.16.5)

Modify the water closet so that the flush valve is on the wide side of the stall.

Priority: M

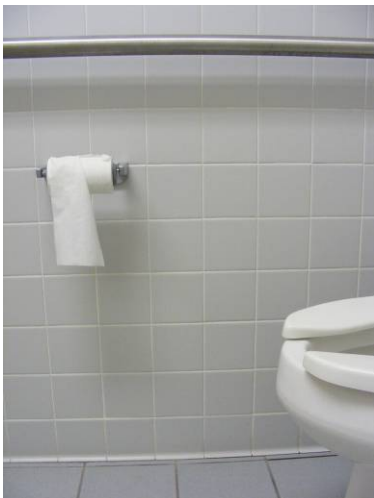
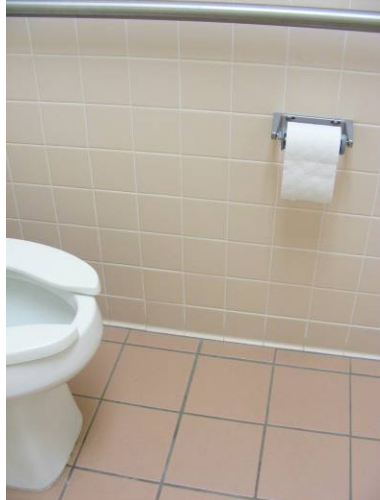
EXISTING CONDITION: The toilet paper dispenser is located too far from the front of the toilet bowls at the Men's and Women's Restrooms. The current ADAAG does not specify a horizontal distance from the toilet. The new ADAAG (604.7) will require the relocation of the dispenser horizontally to a location 7 to 9 inches forward of the toilet.

(ADAAG 4.16.6 & New ADAAG 604.7)

Relocate toilet paper dispenser at this time or immediately upon adoption of new ADAAG (Department of Justice is in its final review period, and imminent adoption is expected).

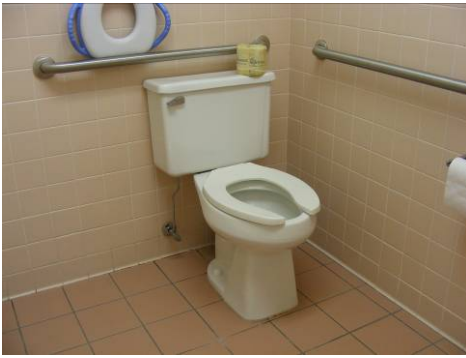
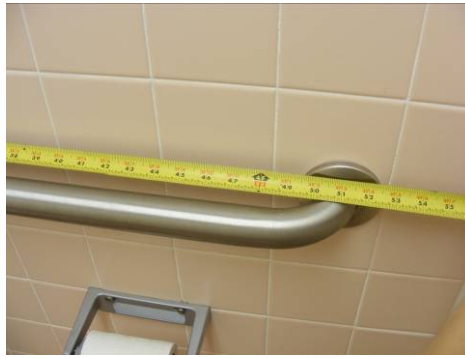
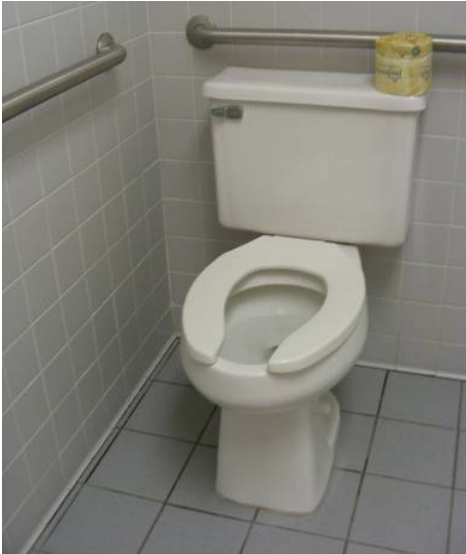
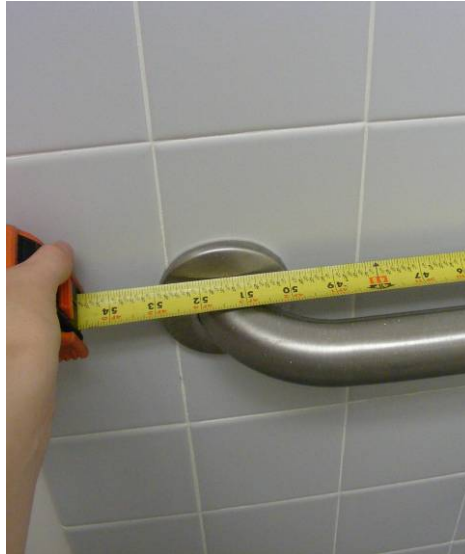
EXISTING CONDITION: The side grab bars at the Men’s and Women’s Restrooms comply with the current ADAAG (at 52”); however, the new ADAAG increases the side grab bar dimension from the back stall wall from 52” to 54” minimum. Per the new ADAAG, the side wall grab bar shall be 42 inches (1065 mm) long minimum, located 12 inches (305 mm) maximum from the rear wall and extending 54 inches (1370 mm) minimum from the rear wall.

(New ADAAG 604.5.1)

Relocate grab bars at this time or immediately upon adoption of new ADAAG (Department of Justice is in its final review period, and imminent adoption is expected).

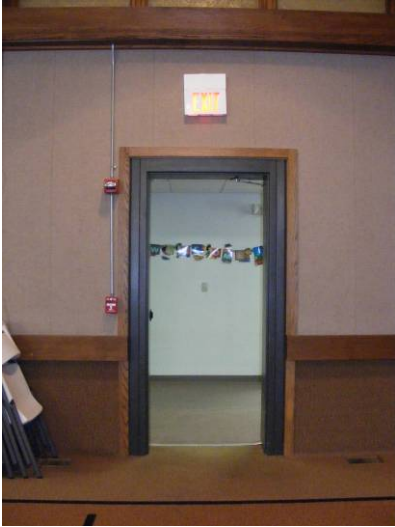
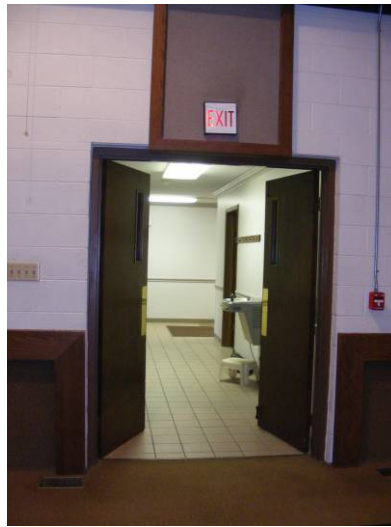
EXISTING CONDITION: Exit signs are not also provided in Braille. Signs that identify permanent rooms and spaces (room numbers, exit signs, and restrooms) are required to be provided in Braille, mounted at the latch side of doorway openings. The New ADAAG provides specific guidance on the location of signage. Tactile characters on signs are to be located 48 inches (1220 mm) minimum above the finish floor or ground surface, measured from the baseline of the lowest tactile character and 60 inches (1525 mm) maximum above the finish floor or ground surface, measured from the baseline of the highest tactile character. Where a tactile sign is provided at a door, the sign shall be located alongside the door at the latch side. Where a tactile sign is provided at double doors with one active leaf, the sign shall be located on the inactive leaf. Where a tactile sign is provided at double doors with two active leaves, the sign shall be located to the right of the right hand door. Where there is no wall space at the latch side of a single door or at the right side of double doors, signs shall be located on the nearest adjacent wall. Signs containing tactile characters shall be located so that a clear floor space of 18 inches (455 mm) minimum by 18 inches (455 mm) minimum, centered on the tactile characters, is provided beyond the arc of any door swing between the closed position and 45 degree open position. (ADAAG 4.1.3(16), 4.30 & New ADAAG 703)

Provide Braille signage at all locations where exit signs exist. Mount signage so that it complies with the new ADAAG 703.4.1 and 703.4.2. Use the 60" maximum dimension to establish the mounting height.

Priority: H

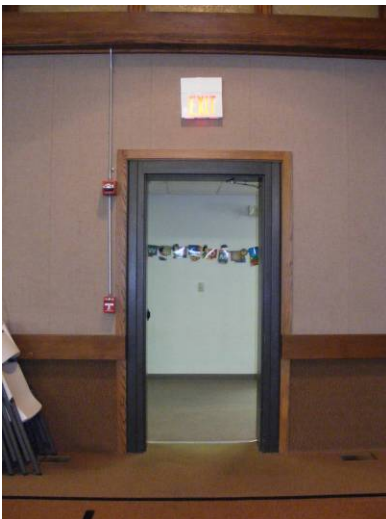
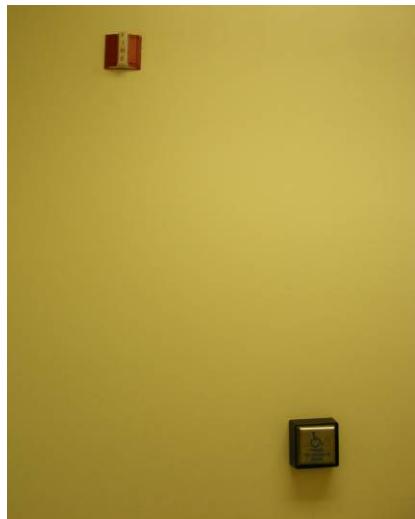
EXISTING CONDITION: Audible and visual alarms exist throughout the facility, but may not be located in every room. According to ADAAG, if emergency warning systems are provided, then they shall

include both audible alarms and visual alarms complying with 4.28. Generally, visual alarms are required to be seen in any space that audible alarms can be heard; this would generally include the installation of visual alarms in all rooms and spaces.

(ADAAG 4.1.3(14), 4.28)

Ensure that visual alarms are installed in all spaces occupied or used by the COMCARE program.

Priority: VH
