ADA ASSESMENT REPORT
COMCARE – NORTHRIDGE FRIENDS CHURCH
2655 N. BULLINGER, WICHITA, KS
Report Date: August 5, 2008

The following ADA site assessment was performed on July 16, 2008 upon request of April Powell, Project Manager for Sedgwick County Project Services.

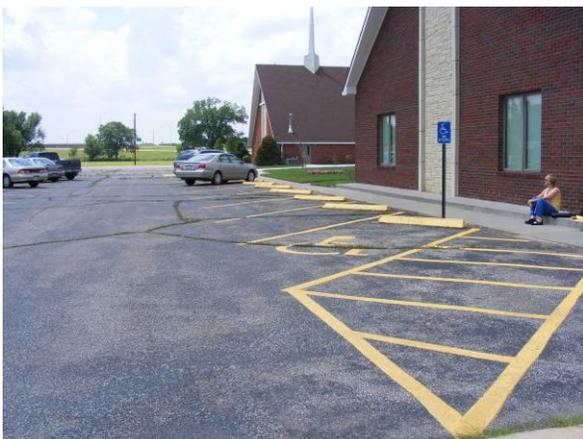
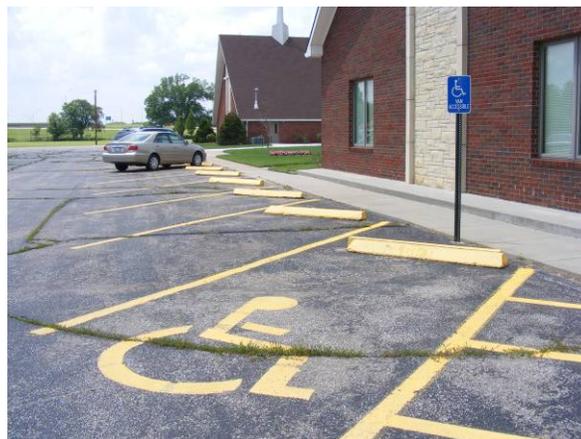
EXISTING CONDITION: One van accessible parking space exists to serve the COMCARE program (located near the COMCARE entrance). The slopes, dimensions, and signage comply with ADAAG

specifications. However, the parking space dimensions do not comply with new Wichita city code. Wichita city code requires all accessible parking spaces to be 11' wide with a 5' aisle for a total of 16'. ADAAG recognizes these dimensions as universal design.

EXISTING CONDITION: Parking space may not be accessible due to grass growing in a crack in the parking area and access aisle. ADAAG requires parking areas and access aisles to be level with surface slopes not exceeding 1:50 (2%) in all directions. The slopes of the paved area are compliant; however the grass growing from the crack may create abrupt changes in level.

(ADAAG 4.6.3)

RECOMMENDATION: No action necessary at this time; however, when the parking lot is altered or restriped, striping should be revised to meet Wichita city code.

RECOMMENDATION:

Remove grass, and repair crack so that abrupt changes in level do not occur.

Priority: H

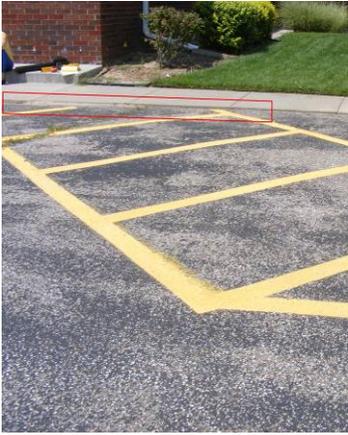
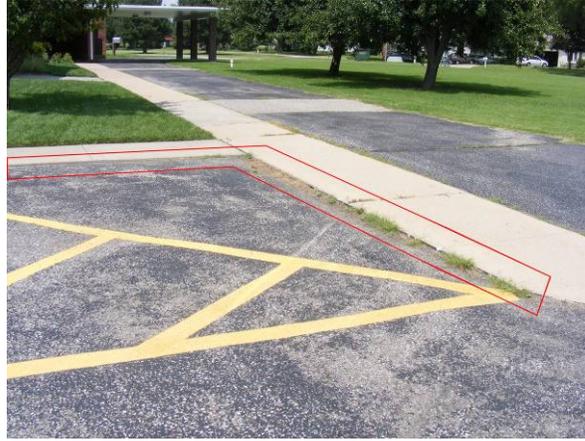
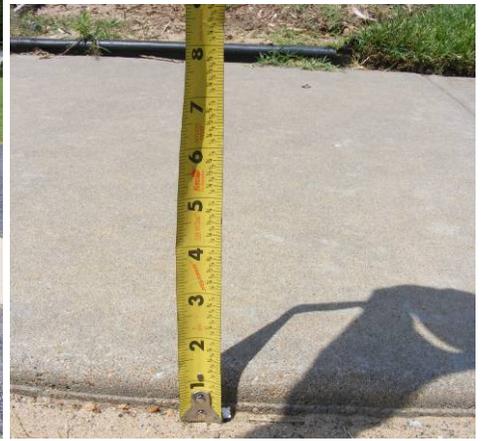
EXISTING CONDITION: An abrupt change in level of 1/2" - 3/4" exists on the path of travel from the access aisle to the sidewalk. This occurs where the sidewalk meets the asphalt paving. According to ADAAG, changes in level up to 1/4 in (6 mm) may be vertical and without edge treatment (see Fig. 7(c)). Changes in level between 1/4 in and 1/2 in (6 mm and 13 mm) shall be beveled with a slope no greater than 1:2 (see Fig. 7(d)).

(ADAAG 4.3, 4.3.7, 4.5.2)

RECOMMENDATION:

Modify transition so that an accessible route (at least 3'-0" wide) exists, and no abrupt changes in level occur. If the entire area is not made accessible, be sure to clearly mark the accessible route.

Priority: M

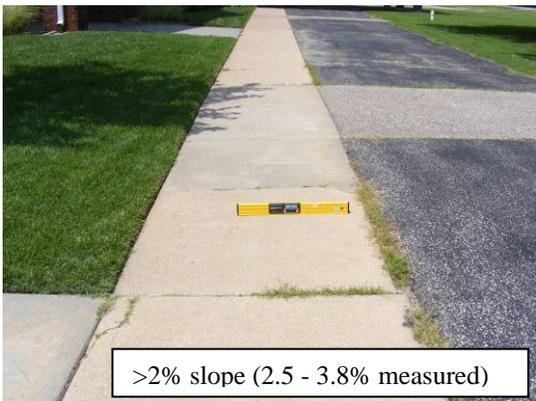
EXISTING CONDITION: A small portion of the sidewalk (on route from parking to building) is not accessible due to cross slopes over 2%. According to ADAAG, nowhere shall the cross slope of an accessible route exceed 1:50 (2%).

(ADAAG 4.3.7)

RECOMMENDATION:

Modify the sidewalk in front of accessible parking so the cross slope complies with ADAAG specifications and does not exceed 2%.

Priority: L

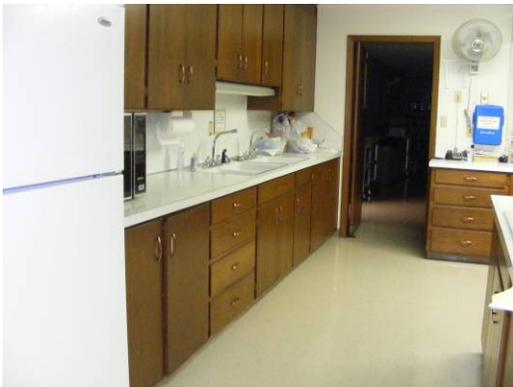
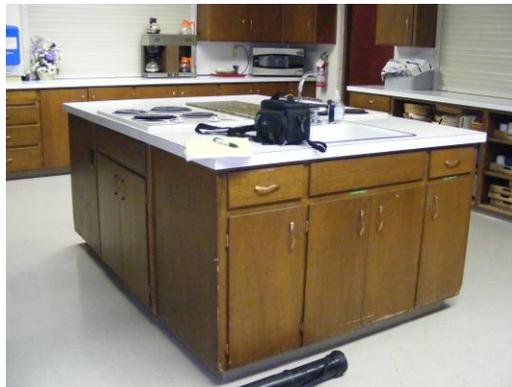
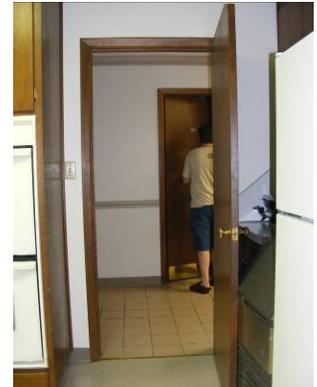
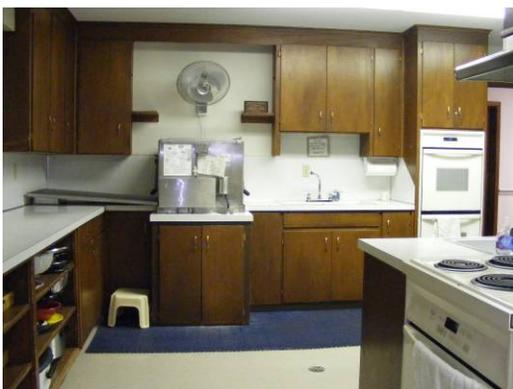
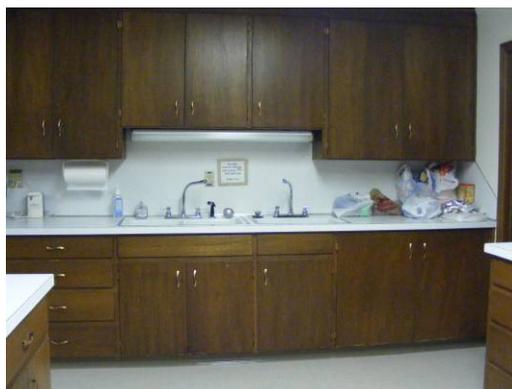
EXISTING CONDITION: Kitchen is inaccessible to people with disabilities due to the following structural inconsistencies:

- **The existing sinks (4 sinks) are too high at 36” and do not provide appropriate knee and toe clearance.** According to ADAAG, knee clearance that is at least 27 in (685 mm) high, 30 in (760 mm) wide, and 19 in (485 mm) deep shall be provided underneath sinks. In addition, each sink shall be a maximum of 6-1/2 in (165 mm) deep. Sinks shall be mounted with the counter or rim no higher than 34 in (865 mm) above the finish floor.
RECOMMENDATION: Ensure at least one sink is fully accessible. (ADAAG 4.24)
Priority: M

- **The top surface of the kitchen counter is 36 inches from the floor.**
RECOMMENDATION: Provide a portion of the countertop that is accessible with a surface that is between 28 and 34 inches from the floor or provide an accessible table in the kitchen for this purpose. (ADAAG 4.1.3(18), 4.32.4)
Priority: M

- **Some operating mechanisms, controls, and accessories may be located too high.** ADAAG requires the highest operable part of controls, dispensers, receptacles, and other operable equipment to be placed within at least one of the reach ranges specified in 4.2.5 and 4.2.6. The new ADAAG further restrict this to a maximum height of 48” A.F.F., and reach ranges are further limited when one must reach over an obstruction (ex. – countertop).
RECOMMENDATION: Ensure that all parts of equipment and accessories that are used by the public are located within an accessible reach range. (ADAAG 4.27.3 & New ADAAG 308)
Priority: M

- **The three doors to the kitchen are 2’-8” wide.** Doors, leading to accessible facilities, are required to have a minimum clear opening of at least 32-inches measured with the door open 90-degrees.
RECOMMENDATION: Provide at least one door with a clear opening of 32 inches with the door open 90 degrees, measured between the face of the door and the opposite stop. (ADAAG 4.13.5, Fig. 24)
Priority: H

- **Round door hardware exists on the main door to the kitchen (from the hall).** Accessible doors are required to have opening hardware, which does not require tight grasping or twisting of the wrist to operate.
RECOMMENDATION: Provide a door with hardware that is easy to grasp with one hand and that does not require tight grasping, pinching, or twisting of the wrist to operate. Lever-operated mechanisms, push-type mechanisms, and U-shaped handles are acceptable designs. (ADAAG 4.13.9)
Priority: H

- **The main door to the kitchen (from the hall), which is accessed through a front approach, lacks sufficient maneuvering clearance on the latch/pull side.**
RECOMMENDATION: On the pull side of the door, provide maneuvering clearance at least 60 inches deep and provide a minimum of 18 inches (24 inches is preferred) of maneuvering clearance on the latch side of the door. An alternate solution may be to provide an automatic opening mechanism or to provide signage which indicates, “This door to remain open during business hours to ensure accessibility,” and keep the door held open at all times during business hours. (ADAAG 4.13.6, Fig. 25)
Priority: M

RECOMMENDATION: Make modifications as necessary to provide program access to all part of the kitchen and equipment that is used by program participants. Note: Modifications are not required to those items or areas that are used by employees only.

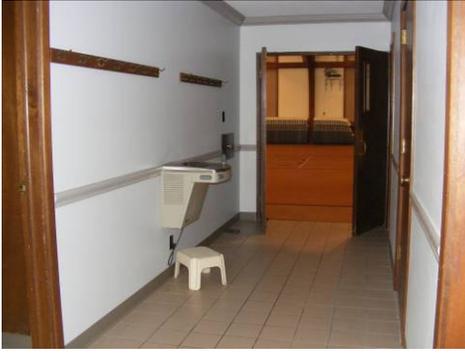
EXISTING CONDITION: Drinking fountain in hallway by kitchen is a protruding object that is not detectable by cane. Objects that project more than 4" from the wall, 27" above the floor and less than 80" above the floor are not cane detectable.

(ADAAG 4.4, 4.15)

RECOMMENDATION: Place a cane detectable object on each side of the drinking fountains. This may be achieved by wing walls or other methods such as those shown below.

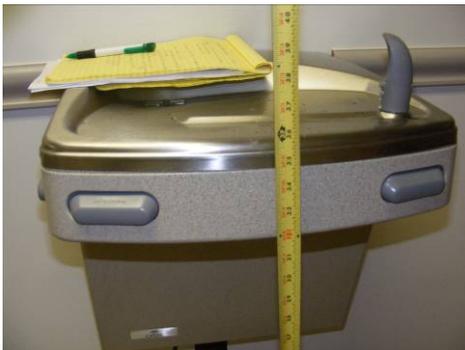
EXISTING CONDITION: Common use drinking fountain is inaccessible.

According to ADAAG if only one drinking fountain is provided on a floor there shall be a drinking fountain which is accessible to individuals who use wheelchairs and one accessible to those who have difficulty bending or stooping. Additionally, the spout of wheelchair accessible fountains shall be no higher than 36 in (915 mm), measured from the floor or ground surfaces to the spout outlet (see Fig. 27(a)). The existing spout is at 37" A.F.F. (ADAAG 4.15)

RECOMMENDATION:

It is recommended that at least one set of hi-lo drinking fountains exist on this floor, in the proximity of the COMCARE program. Note: Under certain conditions in existing buildings (areas built before 1/26/1992), cups at inaccessible drinking fountains are considered equivalent facilitation. Provide a cup holder at this fountain if a set of hi-lo drinking fountains cannot be provided. However, the hi-lo fountain is preferred. When not all drinking fountains are accessible, directional signage should be provided directing occupants to the nearest accessible location.

Priority: VH

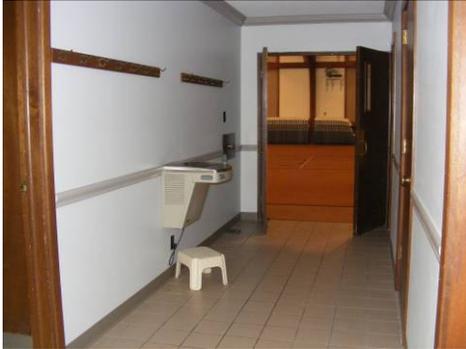
EXISTING CONDITION: Coat racks at hallway by kitchen are located too high at 64”.

Where coat racks or hooks are provided, at least one must comply with reach ranges defined by ADAAG 4.2.5 or 4.2.6. The New ADAAG further limits this to a 48” maximum height.

(ADAAG 4.25.3, 4.2.5, 4.2.6, & New ADAAG 308)

RECOMMENDATION:

Install at least one lowered coat hook (48” A.F.F. maximum) at an accessible location near the existing coat hooks, making sure not to make the hook a protruding object.

Priority: H

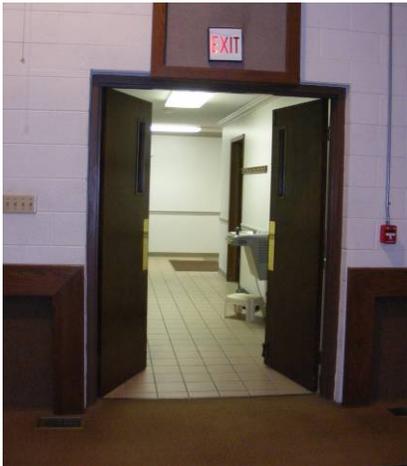
EXISTING CONDITION: Entrance doors (to multi-purpose room) provide less than 32” clear opening (each door is 2’-6”). ADAAG requires double leaf doorways to have at least one leaf that provides a clear 32” opening. Doors, leading to accessible facilities, are required to have a minimum clear opening of at least 32-inches measured with the door open 90-degrees.

(ADAAG 4.13)

RECOMMENDATION:

Modify doors to ensure that all doors used by the public comply with ADAAG specifications for clear opening width.

- Note: An alternate solution for these interior doors may be to provide signage which indicates, “These doors to remain open during business hours to ensure accessibility,” and keep the doors held open at all times during business hours.

Priority: H

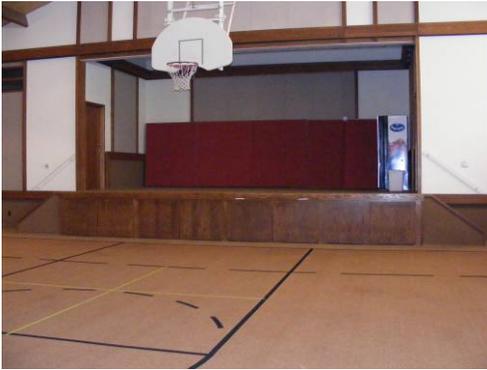
EXISTING CONDITION: A stage exists in the multi-purpose room. According to ADAAG, an accessible route shall connect stages, arena floors, dressing rooms, locker rooms, and other spaces used by performers. An accessible route cannot include steps.

(ADAAG 4.33.5)

RECOMMENDATION:

COMCARE staff and church staff stated that program participants were not allowed access to the stage, and that the stage was not part of their program. As such, no modifications are necessary at this time.

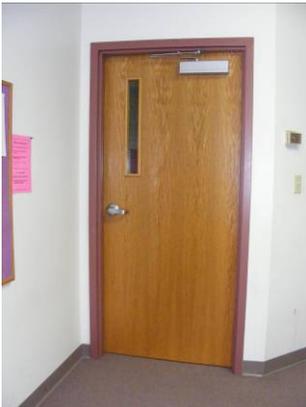
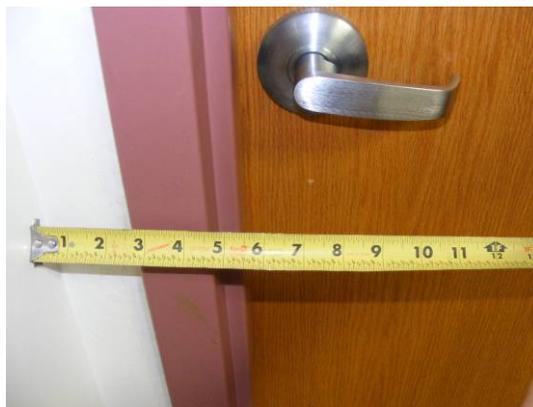
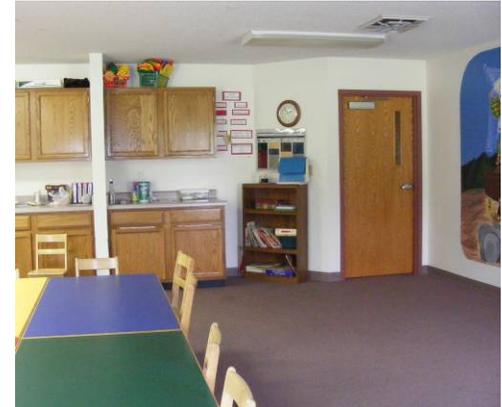
EXISTING CONDITION: Doorways to classrooms do not provide appropriate maneuvering space at door. ADAAG requires at least 12-inches to the latch push side of doors when doors have both a closer and a latch per ADAAG Figure 25.

(ADAAG 4.13.6)

RECOMMENDATION:

Modify interior doors to comply with ADAAG specifications or install an automatic opening mechanism. According to ADAAG, accessible entrances/exits must be provided, at a minimum, in the same number that local fire code requires entrances to exist. In other words, if local fire code requires two entrances at a facility, then both entrances are required to be accessible.

- Note: An alternate approach, if allowable by building and fire code, may be to either remove the closers, or add signage indicating, “These doors to remain open during business hours to ensure accessibility,” and keep the doors held open at all times during business hours. Note that this would not be acceptable if doors are required to be fire-rated.

Priority: M

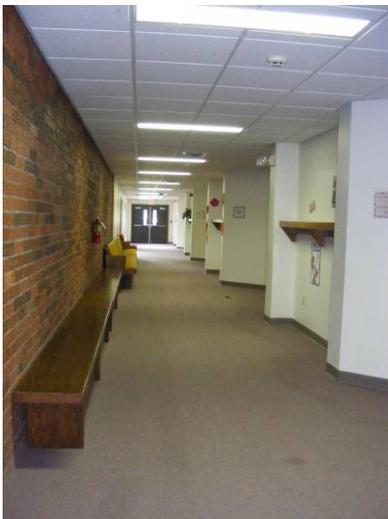
EXISTING CONDITION: Coat racks at hallway by classrooms are located at 48-1/2” to the lowest hook. This complies with current ADAAG, but may be too high at 53” once the New ADAAG is adopted.

Where coat racks or hooks are provided, at least one must comply with reach ranges defined by ADAAG 4.2.5 or 4.2.6. The New ADAAG further limits this to a 48” maximum height. (ADAAG 4.25.3, 4.2.5, 4.2.6, & New ADAAG 308)

RECOMMENDATION:

Install hook at this time (48” A.F.F. maximum), or immediately upon adoption of the new ADAAG (Department of Justice is in its final review period, and imminent adoption is expected).

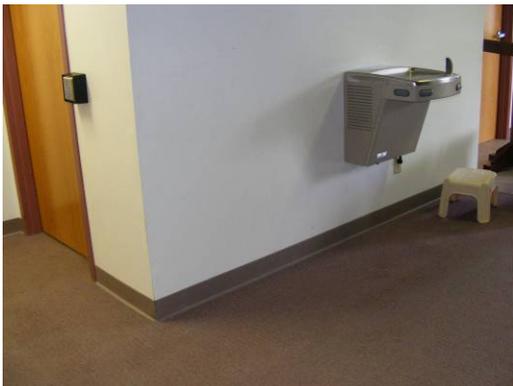
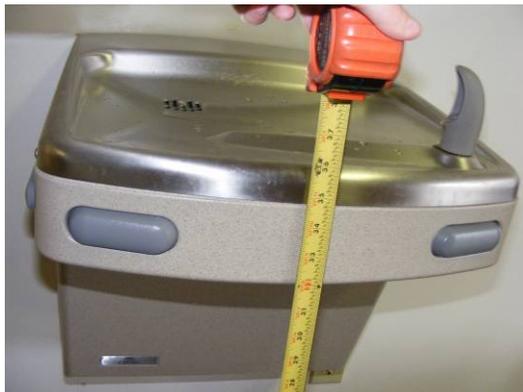
EXISTING CONDITION: Common use drinking fountain is inaccessible and is a protruding object.

RECOMMENDATION:

See comments about drinking fountain in hallway by kitchen. The same problems exist and require correction at this location.

Priority: VH

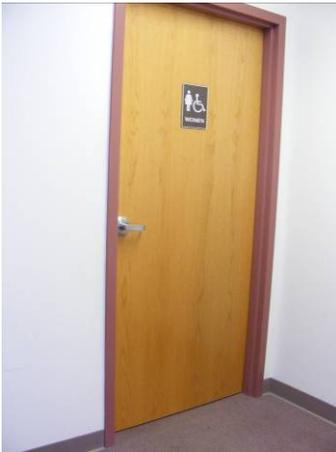
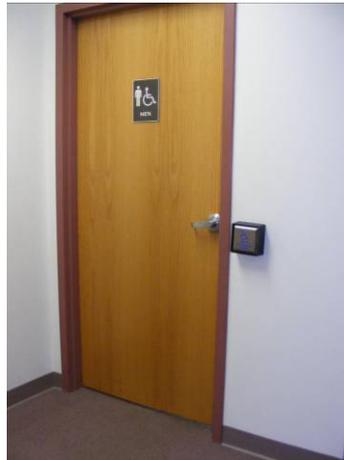
EXISTING CONDITION: Restroom signage is inappropriately located at both the Men's and Women's Restrooms. Signs that identify permanent rooms and spaces (room numbers, exit signs, and restrooms) are required to be provided in Braille, mounted at the latch side of doorway openings. The New ADAAG provides specific guidance on the location of signage. Tactile characters on signs are to be located 48 inches (1220 mm) minimum above the finish floor or ground surface, measured from the baseline of the lowest tactile character and 60 inches (1525 mm) maximum above the finish floor or ground surface, measured from the baseline of the highest tactile character. Where a tactile sign is provided at a door, the sign shall be located alongside the door at the latch side. Signs containing tactile characters shall be located so that a clear floor space of 18 inches (455 mm) minimum by 18 inches (455 mm) minimum, centered on the tactile characters, is provided beyond the arc of any door swing between the closed position and 45 degree open position. (ADAAG 4.1.3(16), 4.30 & New ADAAG 703)

RECOMMENDATION:

Move signage so that it is located to comply with the new ADAAG. Mount signage so that it complies with the new ADAAG 703.4.1 and 703.4.2. Use the 60" maximum dimension to establish the mounting height.

Priority: H

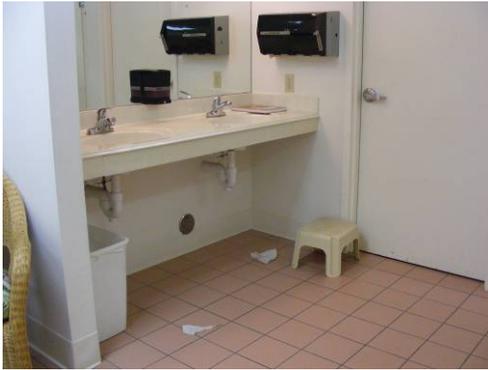
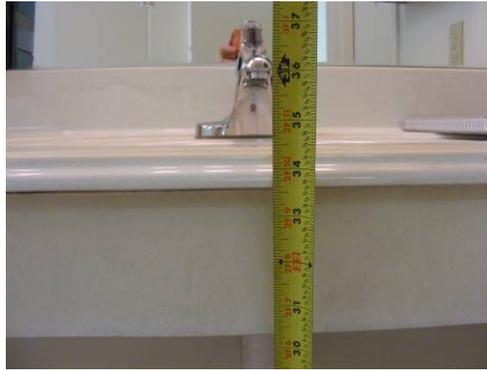
EXISTING CONDITION: Lavatory countertops at both the Men’s and Women’s Restrooms are slightly too high at 34-3/8” A.F.F. ADAAG requires lavatories to be mounted with the rim or counter surface no higher than 34 in (865 mm) above the finish floor.

(ADAAG 4.19.2)

RECOMMENDATION:

Modify countertop height of at least one lavatory in each restroom to comply with ADAAG specifications.

Priority: L

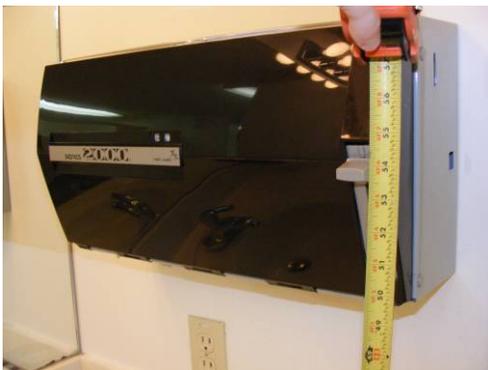
EXISTING CONDITION: Paper towel dispensers at the Men’s and Women’s Restrooms are located with the highest operable part at 54”. This complies with current ADAAG, but may be too high at 53” once the New ADAAG is adopted. The current ADAAG requires objects used by the public to be within a maximum reach range of 54-inches where a side reach is possible and a maximum of 48-inches where only a

forward reach is possible, to the highest operable part. However the new ADAAG changes this to a 48-inch maximum for either a forward or a side reach.

(ADAAG 4.2.5, 4.2.6 & New ADAAG 308)

RECOMMENDATION:

Lower paper towel dispensers to comply with the new ADAAG at this time, or immediately upon adoption of the new ADAAG (Department of Justice is in its final review period, and imminent adoption is expected).

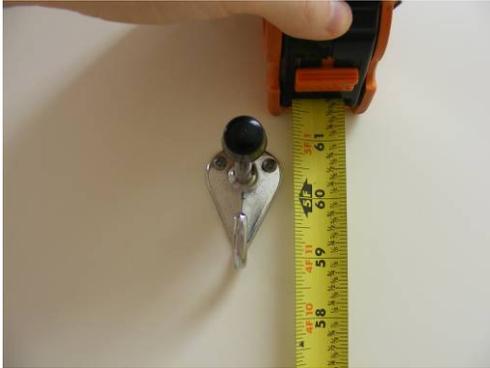
EXISTING CONDITION: Coat hooks in accessible restroom stalls (at Men’s and Women’s Restrooms) are located too high at 61”. Where coat hooks are provided, at least one must comply with reach ranges defined by ADAAG 4.2.5 or 4.2.6. The New ADAAG further limits this to a 48” maximum height. (ADAAG 4.25.3, 4.2.5, 4.2.6, & New ADAAG 308)

EXISTING CONDITION: Door pulls are not provided on both sides of the accessible stall door (at both the Men’s and Women’s Restrooms). The new ADAAG requires a door pull complying with 404.2.7 to be placed on both sides of the door near the latch.

RECOMMENDATION:

Install at least one lowered coat hook (48” A.F.F. maximum) in the accessible toilet stall, making sure not to make the hook a protruding object.

Priority: H

Add an accessible door pull on the outside of the accessible stall doors.

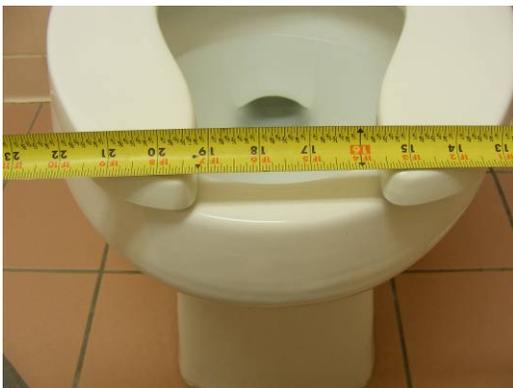
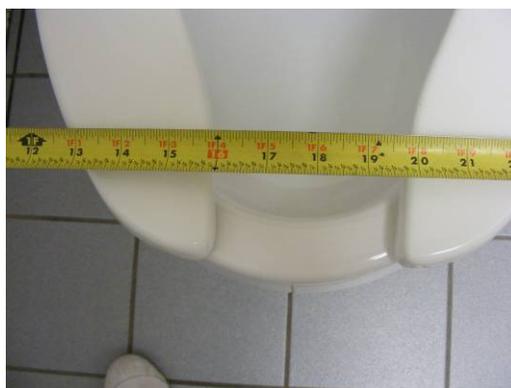
EXISTING CONDITION: The Men’s and Women’s Restroom water closets are not centered at exactly 18” from the wall.

The centerline of the existing water closet is located at 17-1/2” to 17-3/4” from the wall. ADAAG requires that water closets be located per Figure 28, with exactly 18” from the centerline of the water closet to the wall.

(ADAAG 4.16)

RECOMMENDATION:

The new ADAAG guidelines allow for the water closet to be positioned where the centerline of the water closet is 16 inches minimum to 18 inches maximum from the side wall or partition (ADA-ABA 604.2). Because the toilet falls within this range, and these guidelines are expected to be adopted by the Department of Justice, this condition may be allowed to remain at this time.

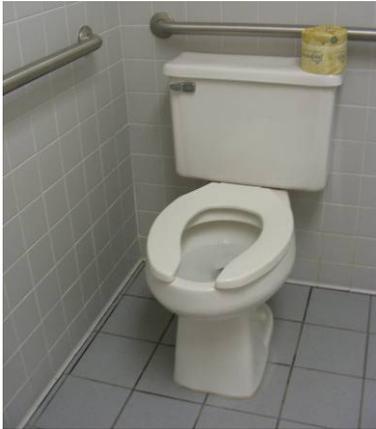
EXISTING CONDITION: The flush control for the Men's Restroom water closet is located on the wall side. ADAAG requires that controls for flush valves be mounted on the wide side of toilet areas no more than 44 in above the floor.

(ADAAG 4.16.5)

RECOMMENDATION:

Modify the water closet so that the flush valve is on the wide side of the stall.

Priority: M

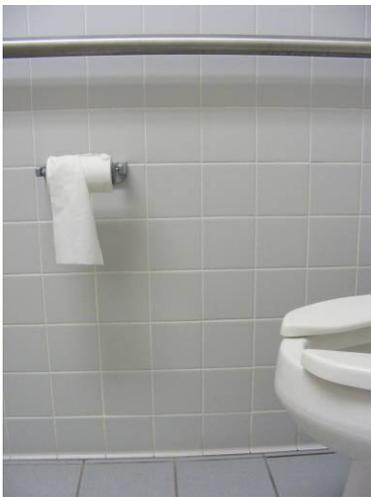
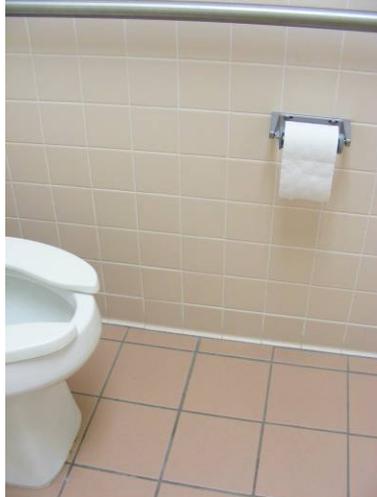
EXISTING CONDITION: The toilet paper dispenser is located too far from the front of the toilet bowls at the Men's and Women's Restrooms. The current ADAAG does not specify a horizontal distance from the toilet. The new ADAAG (604.7) will require the relocation of the dispenser horizontally to a location 7 to 9 inches forward of the toilet.

(ADAAG 4.16.6 & New ADAAG 604.7)

RECOMMENDATION:

Relocate toilet paper dispenser at this time or immediately upon adoption of new ADAAG (Department of Justice is in its final review period, and imminent adoption is expected).

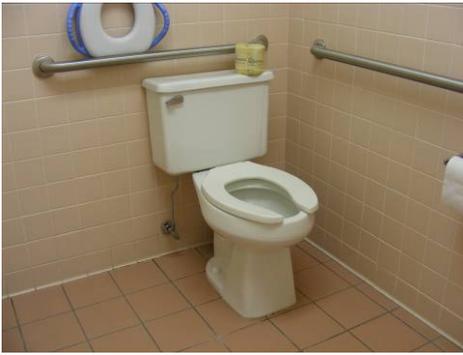
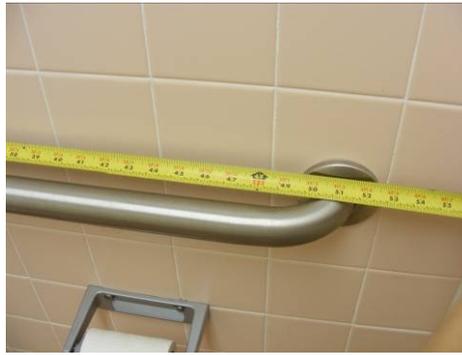
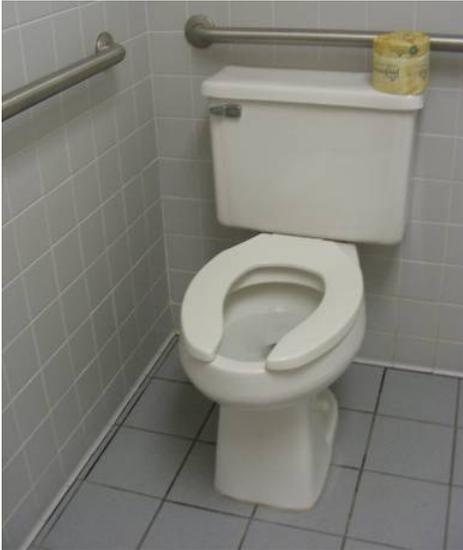
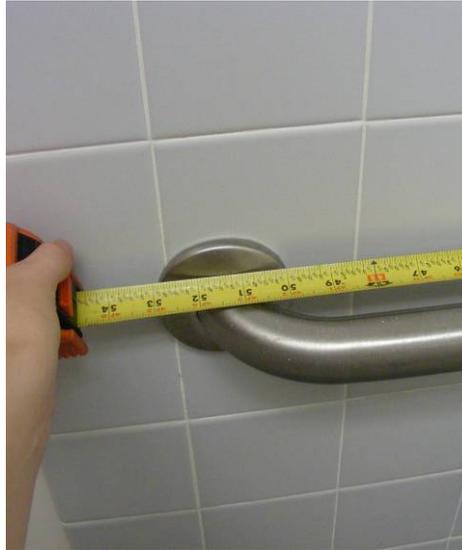
EXISTING CONDITION: The side grab bars at the Men’s and Women’s Restrooms comply with the current ADAAG (at 52”); however, the new ADAAG increases the side grab bar dimension from the back stall wall from 52" to 54" minimum. Per the new ADAAG, the side wall grab bar shall be 42 inches (1065 mm) long minimum, located 12 inches (305 mm) maximum from the rear wall and extending 54 inches (1370 mm) minimum from the rear wall.

(New ADAAG 604.5.1)

RECOMMENDATION:

Relocate grab bars at this time or immediately upon adoption of new ADAAG (Department of Justice is in its final review period, and imminent adoption is expected).

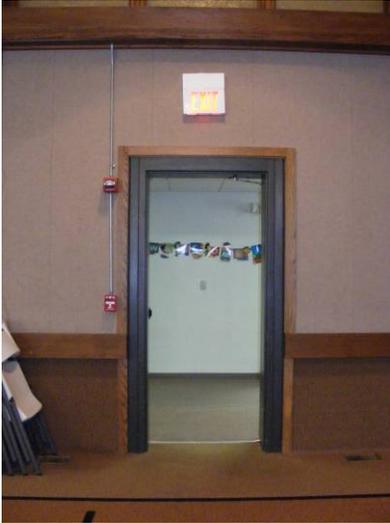
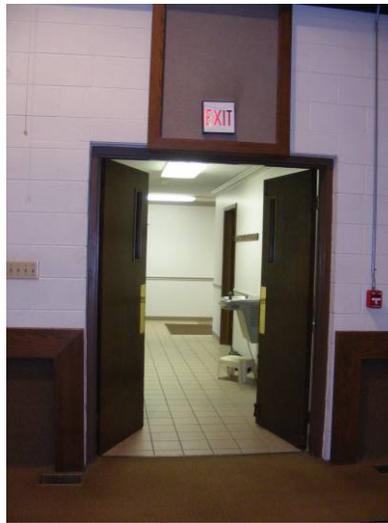
EXISTING CONDITION: Exit signs are not also provided in Braille. Signs that identify permanent rooms and spaces (room numbers, exit signs, and restrooms) are required to be provided in Braille, mounted at the latch side of doorway openings. The New ADAAG provides specific guidance on the location of signage. Tactile characters on signs are to be located 48 inches (1220 mm) minimum above the finish floor or ground surface, measured from the baseline of the lowest tactile character and 60 inches (1525 mm) maximum above the finish floor or ground surface, measured from the baseline of the highest tactile character. Where a tactile sign is provided at a door, the sign shall be located alongside the door at the latch side. Where a tactile sign is provided at double doors with one active leaf, the sign shall be located on the inactive leaf. Where a tactile sign is provided at double doors with two active leaves, the sign shall be located to the right of the right hand door. Where there is no wall space at the latch side of a single door or at the right side of double doors, signs shall be located on the nearest adjacent wall. Signs containing tactile characters shall be located so that a clear floor space of 18 inches (455 mm) minimum by 18 inches (455 mm) minimum, centered on the tactile characters, is provided beyond the arc of any door swing between the closed position and 45 degree open position. (ADAAG 4.1.3(16), 4.30 & New ADAAG 703)

RECOMMENDATION:

Provide Braille signage at all locations where exit signs exist. Mount signage so that it complies with the new ADAAG 703.4.1 and 703.4.2. Use the 60" maximum dimension to establish the mounting height.

Priority: H

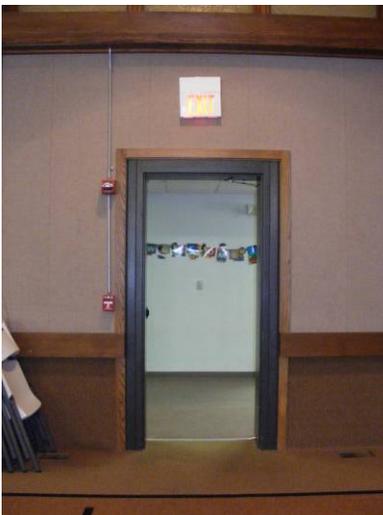
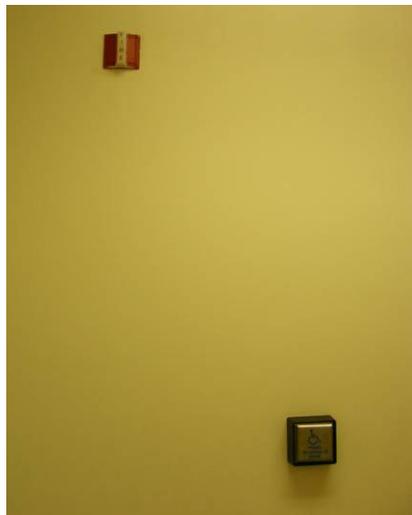
EXISTING CONDITION: Audible and visual alarms exist throughout the facility, but may not be located in every room. According to ADAAG, if emergency warning systems are provided, then they shall

include both audible alarms and visual alarms complying with 4.28. Generally, visual alarms are required to be seen in any space that audible alarms can be heard; this would generally include the installation of visual alarms in all rooms and spaces.

(ADAAG 4.1.3(14), 4.28)

RECOMMENDATION:

Ensure that visual alarms are installed in all spaces occupied or used by the COMCARE program.

Priority: VH
