**ADA ASSESMENT REPORT  
COMCARE TRANSITIONAL HOUSING  
731 HUNTER, WICHITA, KS  
Report Date: July 22, 2008**

The following ADA site assessment was performed on June 25, 2008 upon request of Paula Downs, Facilities Project Services Manager for Sedgwick County Project Services.

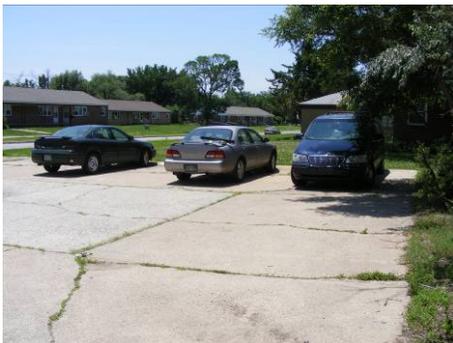
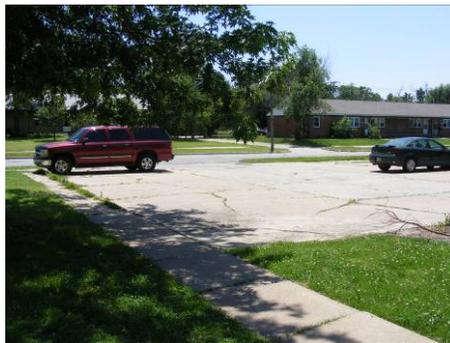
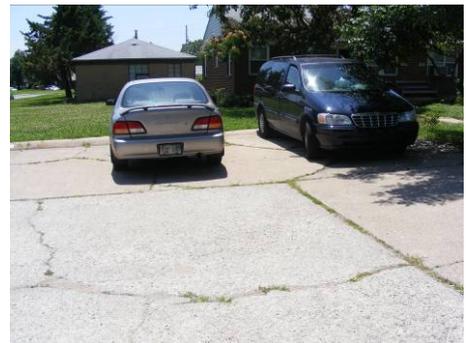
**EXISTING CONDITION: No accessible parking spaces are provided.**

If parking spaces are provided for self-parking by employees or visitors, or both, then accessible spaces complying with 4.6 shall be provided in each such parking area in conformance with the table shown in (5)(a). In addition, one in every eight accessible spaces, but not less than one, shall be "van accessible." According to UFAS - Parking spaces at accessible housing complying with 4.6 shall be provided in accordance with the following: (i) Where parking is provided for all residents, one accessible parking space shall be provided for each accessible dwelling unit; and (ii) Where parking is provided for only a portion of the residents, an accessible parking space shall be provided on request of the occupant of an accessible dwelling unit; (iii) Where parking is provided for visitors, 2 percent of the spaces, or at least one, shall be accessible. UFAS is applicable to federally funded housing complexes. Accessible parking spaces serving a particular building are required be located on the shortest accessible route of travel from adjacent parking to an accessible entrance.

(ADAAG 4.1.2(5)(a - b), 4.6, UFAS 4.1.1(5)(d))

**EXISTING CONDITION: Slopes of existing parking lot exceed 2% and abrupt changes in level exist.** The surface of the existing parking lot has slopes exceeding 4%. Additionally, abrupt changes in level exist due to cracked and settling pavement. ADAAG requires accessible parking spaces and access aisles to have surface slopes that do not exceed 2%.

**EXISTING CONDITION: No upright signs are provided to designate accessible parking.**

ADAAG requires accessible parking spaces to have upright signage that includes the symbol of accessibility and van accessible signage where required. Such signs are required to be located so they can be seen with a vehicle parked in the space. This requirement can generally be adhered to with the sign mounted at 5-feet high measured to the bottom of the lowest sign.

Provide at least one van accessible parking space for visitors to the office and at least one van accessible parking space for the designated accessible unit when necessary at the request of the tenant. Note: Wichita city code requires all accessible parking spaces to be 11' wide with a 5' aisle for a total of 16'. ADAAG recognizes these dimensions as universal design. Provide striping to meet Wichita city code, add the required access aisle, and provide ADAAG compliant signage.

Repave to correct slope & changes in level or provide other accessible parking at another location, which is still on the shortest path of travel to accessible entrance. Ensure that a fully accessible path of travel exists leading from accessible parking to the facility entrance.

Provide upright signage in front of each newly created accessible parking space, which complies with ADAAG specifications. Ensure that an additional "Van-Accessible" sign mounted below the symbol of accessibility occurs at each van accessible space.

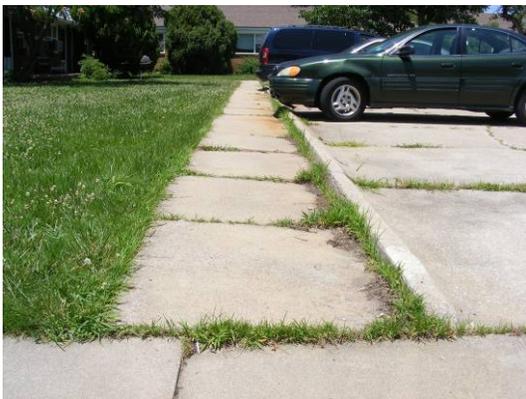
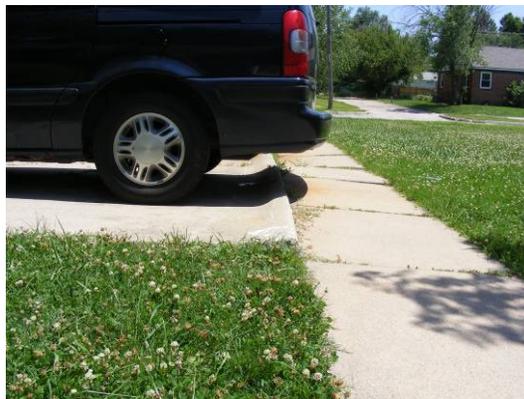
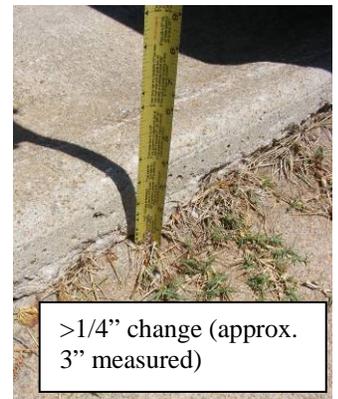
**EXISTING CONDITION: No accessible route exists connecting the parking lot with the route (sidewalk) to the office and apartments due to an abrupt change in level (curb) of approximately 3”.** According to ADAAG, changes in level up to 1/4 in (6 mm) may be vertical and without edge treatment (see Fig. 7(c)). Changes in level between 1/4 in and 1/2 in (6 mm and 13 mm) shall be beveled with a slope no greater than 1:2 (see Fig. 7(d)).

(ADAAG 4.3, 4.5.2, 4.7, 4.29)

Ensure that at least one accessible path of travel connects the parking area to the accessible route. Provide an ADAAG compliant curb ramp (with detectable warnings) if necessary or otherwise ensure that abrupt changes in level do not occur.

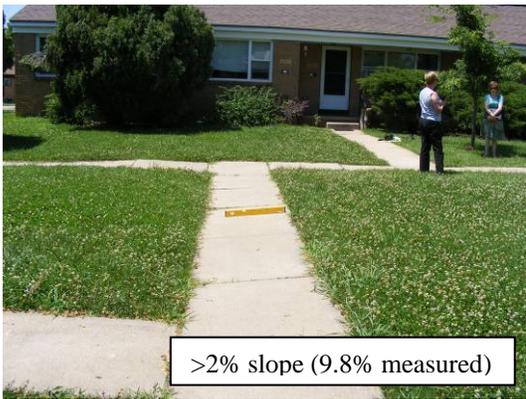
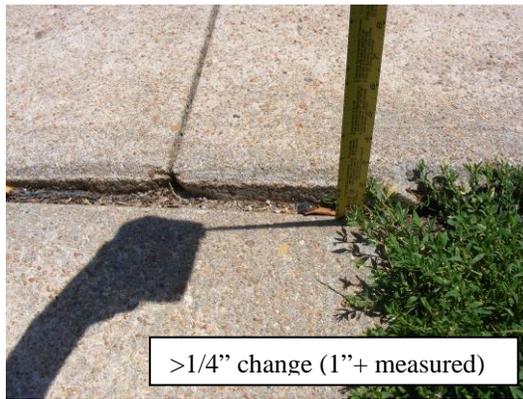
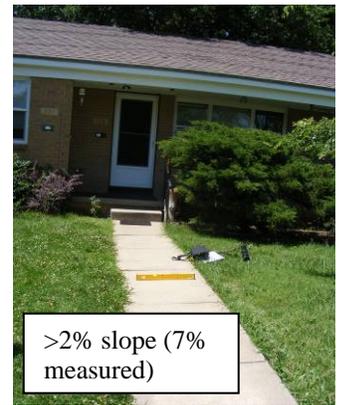
**EXISTING CONDITION:** Abrupt changes in level and steep cross slopes exists on the path of travel (sidewalk) leading to the apartments and the office. According to ADAAG, changes in level up to 1/4 in (6 mm) may be vertical and without edge treatment (see Fig. 7(c)). Changes in level between 1/4 in and 1/2 in (6 mm and 13 mm) shall be beveled with a slope no greater than 1:2 (see Fig. 7(d)). According to ADAAG, nowhere shall the cross slope of an accessible route exceed 1:50 (2%).

(ADAAG 4.3, 4.3.7, 4.5.2)

**EXISTING CONDITION:** Steps exist on the path of travel leading to the office and the apartments.

According to ADAAG, at least one accessible route shall connect accessible buildings, facilities, elements, and spaces that are on the same site. In addition, if an accessible route has changes in level greater than 1/2 in (13 mm), then a curb ramp, ramp, elevator, or platform lift (as permitted in 4.1.3 and 4.1.6) shall be provided that complies with 4.7, 4.8, 4.10, or 4.11, respectively. An accessible route does not include stairs, steps, or escalators. An accessible route shall connect at least one accessible entrance of each accessible dwelling unit with those exterior and interior spaces and facilities that serve the accessible dwelling unit.

Modify sidewalks so that cross slope complies with ADAAG specifications (does not exceed 2%) and so that abrupt changes in level do not occur. Ensure that at least one accessible path of travel leads to all accessible facilities and amenities (including parking, the office, accessible apartment, laundry facilities (if provided), mail boxes, trash services, and site amenities). Note: If not all public routes are made accessible, directional signage or other notifications (maps) should be provided to direct the public to accessible features and accessible routes.

Ensure that program access is provided for the apartments and all programs and services provided at the office and apartments. For new construction, ADAAG requires all public and common areas to be fully accessible. However, this facility is not considered new construction, and therefore falls under the program access provisions of Title II.

- It was understood from the department that programs and services (group counseling) offered at the office are also provided at other COMCARE locations. Ensure that all services can be provided at an alternate accessible location. A buzzer should be provided on an accessible route so that the public can contact a staff member at the office when necessary. Ensure that the buzzer is located such that its highest operable part is located within a maximum reach range of 48" above finished floor per ADAAG 4.2.5.

- It was explained that COMCARE operates this program through a HUD grant that is year-to-year, and that the future of this program is not guaranteed. It is recommended to remove the steps at the office and accessible apartment (and provide a ramp), but as a low priority, since programs and services can also be provided at an alternate accessible location. Ensure that an accessible path of travel is created leading to the office. (ADAAG 4.8)

- In the interim, COMCARE shall develop a policy/procedure and obtain information about other locations where an accessible apartment could be provided for a qualified individual with a disability. COMCARE shall enact such procedures to ensure that an applicant is not turned away due to an inaccessible facility. Services provided in the office can generally also be provided at another accessible location, so ensure that sufficient policies are in place, and staff is educated, to ensure that services are provided in an alternate accessible location when required.

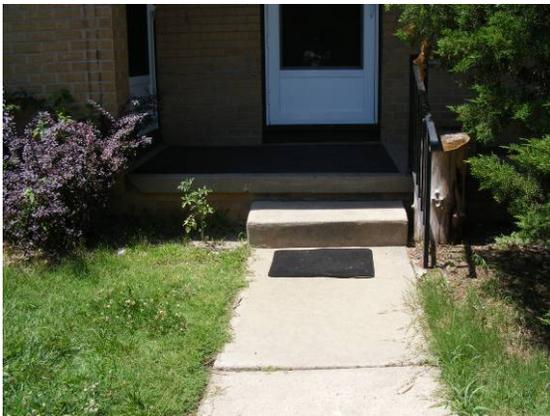
**EXISTING CONDITION:** The main public entrance consists of two doors in series with insufficient space between the two doors. According to ADAAG, the minimum space between two hinged or pivoted doors in series shall be 48 in (1220 mm) plus the width of any door swinging into the space. Doors in series shall swing either in the same direction or away from the space between the doors (see Fig. 26).

(ADAAG 4.13, 4.13.7)

Modify the entrance door to comply with ADAAG specifications for two doors in series or modify the entrance so that only one door exists. As previously mentioned, COMCARE services provided in the office can also be provided at another accessible location, so this is considered a low priority.

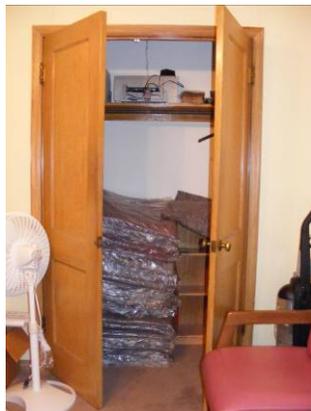
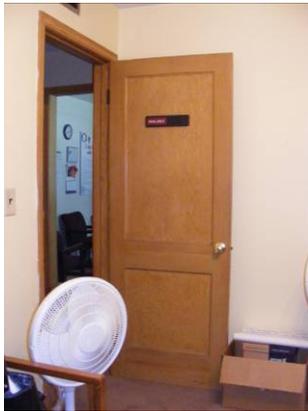
1. **Round door hardware exists on interior and exterior doors.** Doors are required to have opening hardware, which does not require tight grasping or twisting of the wrist to operate. Modify doors by replacing door knobs with lever-type hardware or installing add-on levers.

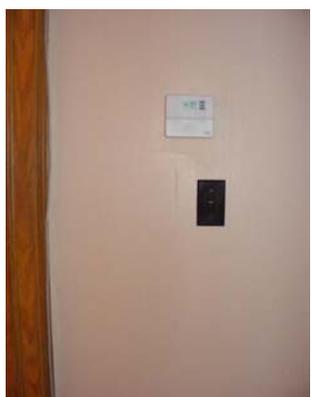
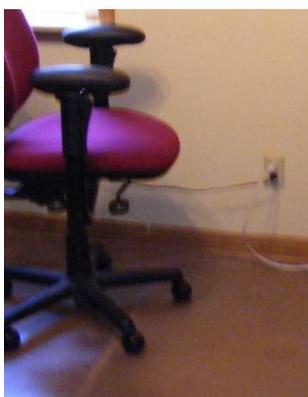
2. **Some controls are located too high and would not be accessible to a wheelchair user. Other items, including electrical receptacles, are located too low.** All controls in accessible spaces shall comply with 4.27. Those portions of heating, ventilating, and air conditioning equipment requiring regular, periodic maintenance and adjustment by the resident of a dwelling shall be accessible to people in wheelchairs. The highest operable part of all controls, dispensers, receptacles, and other operable equipment shall be placed within at least one of the reach ranges specified in 4.2.5 and 4.2.6 (the new ADAAG/ABAAG further restricts this to a 48" max. height). Except where the use of special equipment dictates otherwise, electrical and communications system receptacles on walls shall be mounted no less than 15 in (380 mm) above the floor.

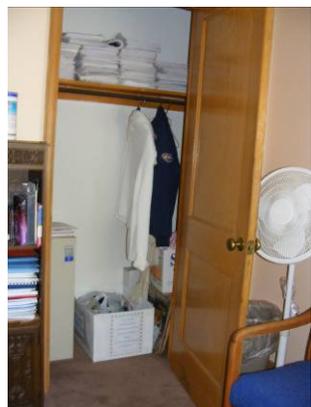
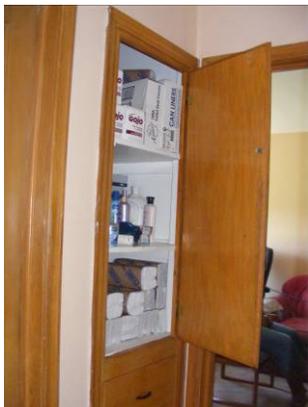
3. **Closet rods are located too high at 64-1/2". Closet door opening hardware is too high at 58".** Storage in accessible spaces in dwelling units, including cabinets, shelves, closets, and drawers, shall comply with 4.25. Accessible storage spaces shall be within at least one of the reach ranges specified in 4.2.5 and 4.2.6.

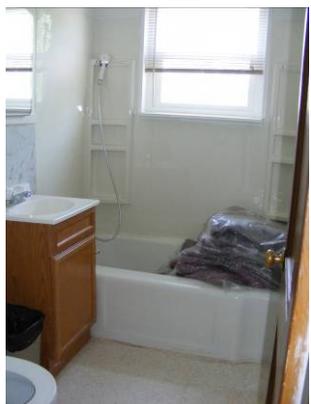
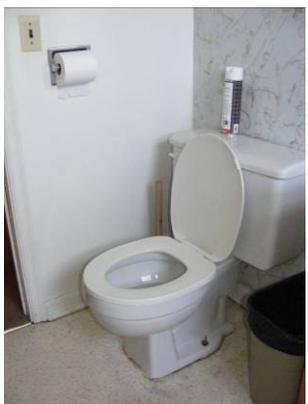
4. **Restroom is totally inaccessible due to numerous inconsistencies.** Inconsistencies include, but are not limited to, insufficient maneuvering and fixture clearances, inappropriate maneuvering space at entrance doors, no knee space at lavatory, inappropriate lavatory faucet controls, noncompliant shower, flush valve controls located on narrow side, no grab bars at water closets or

shower, etc. UFAS requires that at least one full bathroom shall comply with 4.34.5. A full bathroom shall include a water closet, a lavatory, and a bathtub or a shower.

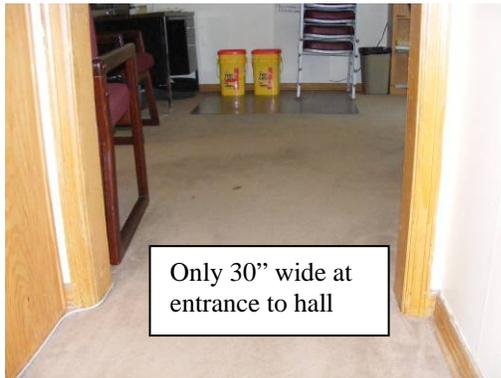
5. **Insufficient clearances due to narrow hall (36-1/2" wide) and narrow doors. Some doors are as small as 24" and 30". Door maneuvering clearances are not provided at many interior doors.** An accessible route is required to be 36 in (915 mm) minimum except at doors (see 4.13.5). If a person in a wheelchair must make a turn around an obstruction, the minimum clear width of the accessible route shall be as shown in Fig. 7. Doorways shall have a minimum clear opening of 32 in with the door open 90 degrees, measured between the face of the door and the stop (see Fig. 24(a), (b), (c), and (d)). Maneuvering clearances at doors are required per 4.13.6 (Fig. 25).

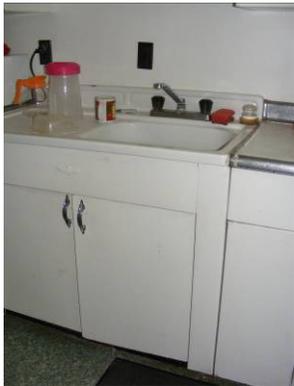
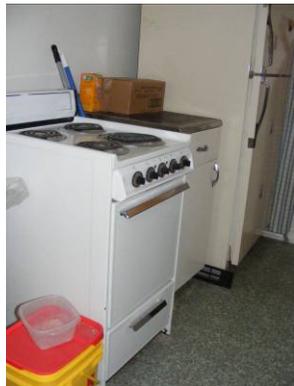
6. **Kitchen is inaccessible due to numerous inconsistencies.** UFAS requires kitchens to comply with 4.34.6. Inconsistencies include, but are not limited to, no knee space (or removable base cabinets) at sink, round controls at sink faucet, insufficient clearance at entry to kitchen (only 29"), countertops too high, no accessible work space, insufficient clearances at appliances, appliances don't meet all UFAS requirements.

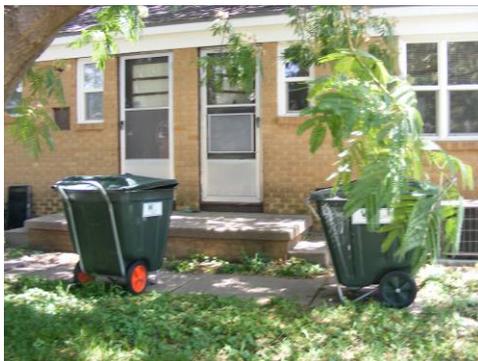
7. **Patio is not accessible due to a step at the door, a door too small (2'-8"), and two doors in a series without sufficient maneuvering space.** Patios are required to be accessible per 4.34.2(15)(d). Steps are not allowed on an accessible route. Doorways shall have a minimum clear opening of 32 in with the door open 90 degrees, measured between the face of the door and the stop (see Fig. 24(a), (b), (c), and (d)). The minimum space between two hinged doors in series shall be 48 in plus the width of any door swinging into the space. Doors in series shall swing either in the same direction or away from the space between the doors.
