ADA ASSESMENT REPORT
SEDGWICK COUNTY BRITTANY TAG OFFICE
BRITTANY CENTER, 21ST STREET AND WOODLAWN, WICHITA, KS
Report Date: July 15, 2008

The following ADA site assessment was performed on June 24, 2008 upon request of April Powell, Project Manager for Sedgwick County Project Services.

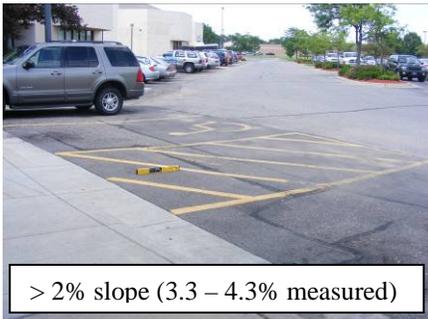
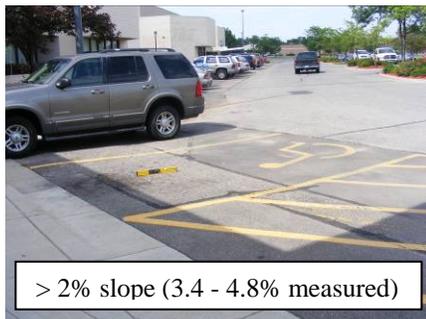
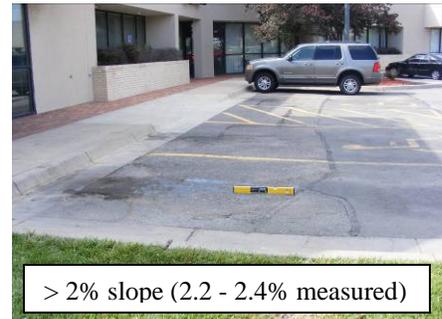
EXISTING CONDITION: All accessible spaces and the access aisle slope away from the building with slopes exceeding 2% for the portion of the parking space closest to the building. (ADAAG 4.6.3, 4.6.6)

RECOMMENDATION: Priority L
Repave to correct slope. Note: It appears that some paving work has occurred to improve slopes at the portion of the space furthest from the building. Since this part has been improved, this item is now a low priority.

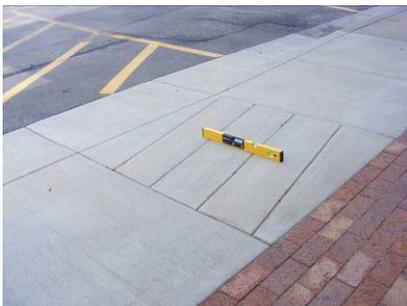
EXISTING CONDITION: The curb ramp, connecting the street (parking lot) level with the sidewalk level, does not provide an appropriate detectable warning surface. The existing curb cut has a detectable warning surface. However, this detectable warning does not comply with current ADAAG specifications regarding truncated domes.

RECOMMENDATION: Priority L
Modify the existing curb cut to comply with ADAAG specifications pertaining to a detectable warning surface with truncated domes. (ADAAG 4.29, 4.7.7)

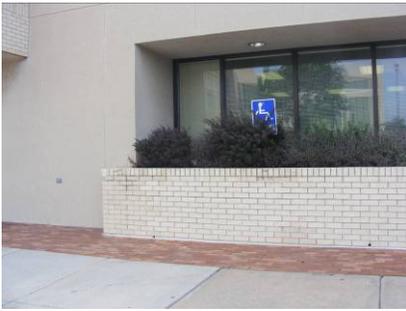
EXISTING CONDITION: Upright sign that designates accessible parking is not visible due to landscaping. ADAAG requires accessible parking spaces to have upright signage that is located so that it can be seen with a vehicle parked in the space.

RECOMMENDATION: Priority VH
Trim bushes or raise upright signage so that it is visible.
(ADAAG 4.6.4)

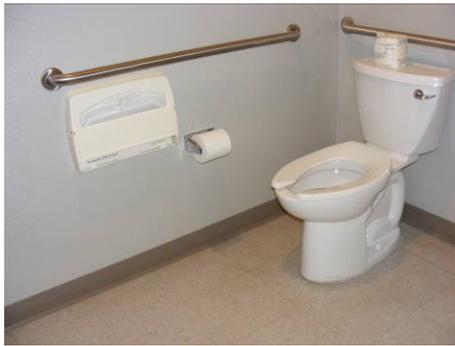
MENS RESTROOM

EXISTING CONDITION:
The toilet paper dispenser is located 3-1/2 inches forward of the toilet bowl. The current ADAAG does not specify a horizontal distance from the toilet. The new ADAAG (604.7) will require the relocation of the dispenser horizontally to a location 7 to 9 inches forward of the toilet.

EXISTING CONDITION:
Baby changing table is mounted too high. The table surface is 41 inches above the floor when open.

EXISTING CONDITION:
Door sign is located incorrectly per the current ADAAG. However, no wall space exists on either side of door, and sign is mounted on push side of door and no safety hazard exists.

EXISTING CONDITION: Door to Men's Restroom does not provide appropriate maneuvering space at door. ADAAG requires at least 12-inches to the latch push side of doors that have closers.

(ADAAG 4.13.6)

RECOMMENDATION:
Relocate toilet paper dispenser at this time or immediately upon adoption of new ADAAG (Department of Justice is in its final review period, and imminent adoption is expected).

RECOMMENDATION: Priority L
Reposition changing table so that surface is no more than 34 inches and no less than 28 inches above the floor.
(ADAAG 4.32.4)

RECOMMENDATION:
No action. The new ADAAG (703.4.2) will allow tactile signage to exist on the push side of doors with closers and without hold-open devices.

It does not appear that the 12” clearance can be easily achieved. Install automatic opener where sufficient maneuvering clearance does not exist and cannot otherwise be provided. Or, an alternate solution would be to remove the door closer (then the 12” clearance would not be required), but in this case restroom signage would need to be also located on an adjacent wall (one does not exist, but a wing wall could be created for this purpose).

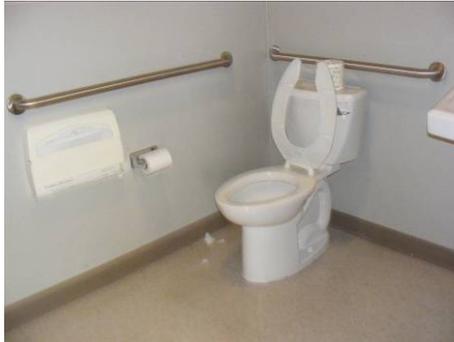
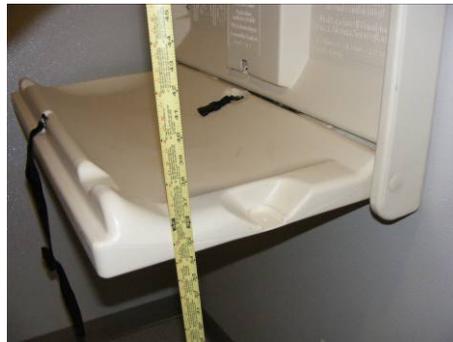
WOMENS RESTROOM

The toilet paper dispenser is located 3-1/2 inches forward of the toilet bowl. The current ADAAG does not specify a horizontal distance from the toilet. The new ADAAG (604.7) will require the relocation of the dispenser horizontally to a location 7 to 9 inches forward of the toilet.

Baby changing table is mounted too high. The table surface is 36 inches above the floor when open.

Door sign is located incorrectly per the current ADAAG. Currently, no wall space exists on either side of door, and sign is mounted on push side of door and no safety hazard exists.

EXISTING CONDITION: Door to Women’s Restroom does not provide appropriate maneuvering space at door. ADAAG requires at least 12-inches to the latch push side of doors that have closers.

(ADAAG 4.13.6)

Relocate toilet paper dispenser at this time or immediately upon adoption of new ADAAG (Department of Justice is in its final review period, and imminent adoption is expected).

Reposition changing table so that surface in no more than 34 inches and no less than 28 inches above the floor. (ADAAG 4.32.4)

Since renovation will move the location of the employee work area and service counter, ensure that wall space exists at the latch side and relocate signage per the new ADAAG 703.4.1 and 703.4.2.

Since renovation will move the location of the employee work area and service counter, ensure that sufficient maneuvering clearance is provided at the latch side of the door.

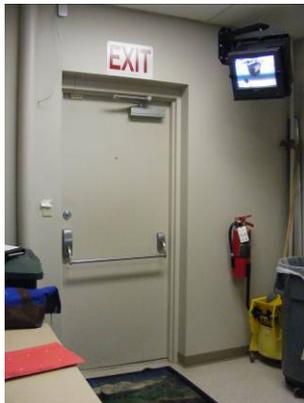
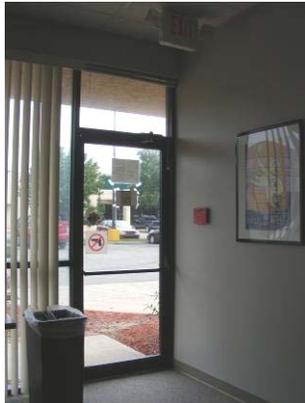
EXISTING CONDITION: Exit signs are not also provided in Braille.

Signs that identify permanent rooms and spaces (room numbers, exit signs, and restrooms) are required to be provided in Braille, mounted at the latch side of doorway openings. It is suggested to locate the signage per the new ADAAG 703.4.1 and 703.4.2.

(ADAAG 4.1.3(16), 4.30)

Provide Braille signage at all locations where exit signs exist.

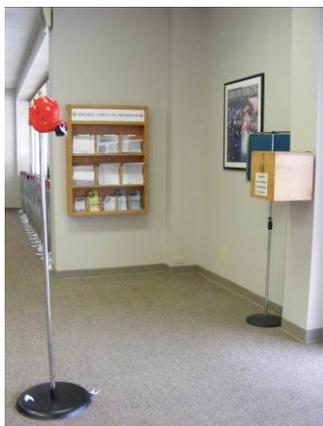
EXISTING CONDITION: Wall-mounted comment box and forms rack create protruding objects in the public area.

Where objects protrude from walls more than 4-inches and their leading edge is higher than 27-inches and lower than 80-inches, these objects are considered protruding objects, which may not be detectable by individuals who are blind and use a cane.

(ADAAG 4.4)

Provide cane detection underneath protruding objects or otherwise ensure protruding objects do not exist.

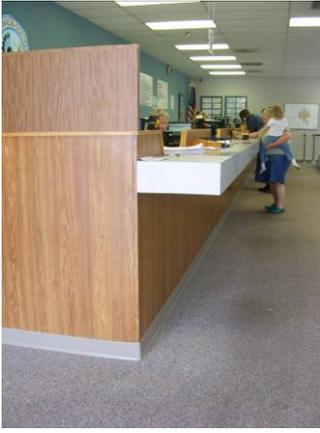
EXISTING CONDITION: Transaction counter creates a protruding object in the public area. Where objects protrude from walls more than 4-inches and their leading edge is higher than 27-inches and lower than 80-inches, these objects are considered protruding objects, which may not be detectable by individuals who are blind and use a cane.

(ADAAG 4.4)

It is understood that the transaction counter will be renovated, so the new design should ensure that countertop does not create a protruding object.

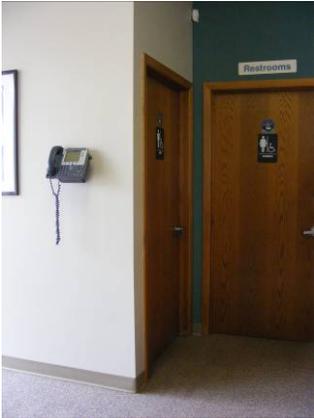
EXISTING CONDITION: Public telephone is located too high at 56”.

Where public telephones are provided, at least one must comply with reach ranges defined by ADAAG 4.2.5 or 4.2.6. The new ADAAG will further require that accessible objects be located within a maximum reach range of 48-inches, to the highest operable part. (ADAAG 4.2.5, 4.2.6)

Lower telephone so that it is within a maximum reach range of 48”.

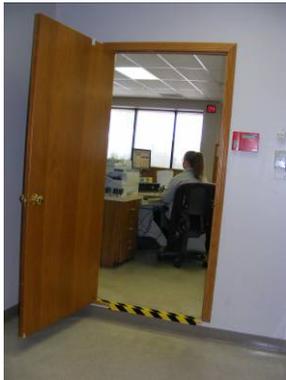
- Currently, there is no accessible route to the employee work room, break room, and storage areas at the west side of the facility (these areas can only be accessed through the employee work area, which is raised one step). **When the employee work area is modified, an accessible route should be provided to the employee areas at the back of the facility.**

It should also be mentioned that doors at the same location as a step (with no landing), create a safety hazard and generally are not allowed by the building code.

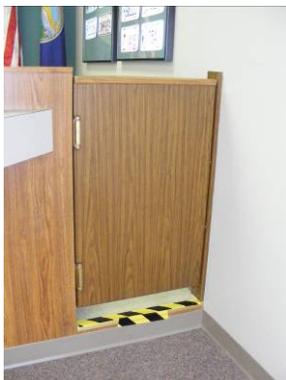
- Currently, the employee work area consists of a raised platform that is inaccessible to employees with disabilities, due to both a step and a door (gate) less than 36” (existing door is 24”). When the work area is renovated, each renovated area or element is required to meet the provisions for new construction. **This requires an accessible route (ramp) and ADA compliant door or gate to provide access to the raised employee work platform per ADAAG 4.1.1(3).**

It should also be mentioned that doors (or gates) at the same location as a step (with no landing), create a safety hazard and generally are not allowed by the building code.

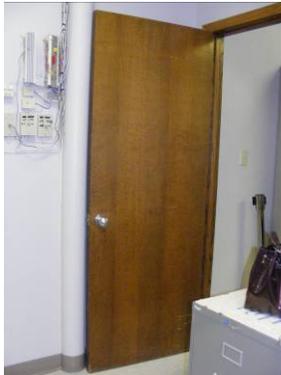
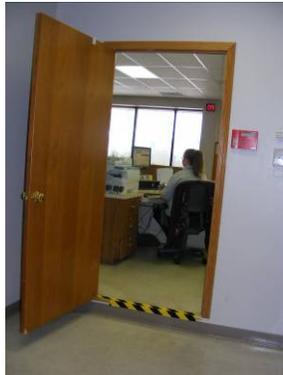
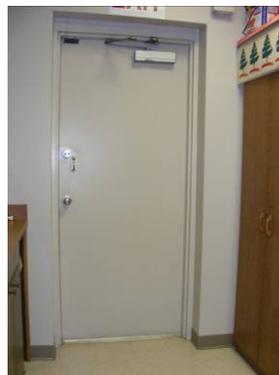
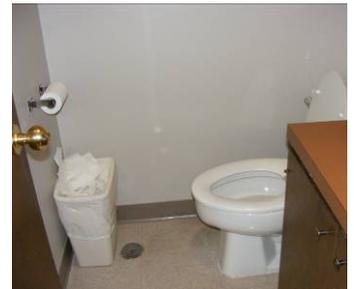
1. Doors:

EXISTING CONDITION: Round door opening hardware exists on many interior and exterior doors within the employee work area. According to ADAAG, accessible doors are required to have opening hardware, which does not require tight grasping or twisting of the wrist to operate.

(ADAAG 4.13)

EXISTING CONDITION: Some interior doorways (ranging from 2'-6" to 2'-0" doors) are too narrow. Doors, leading to accessible facilities, are required to have a minimum clear opening of at least 32-inches measured with the door open 90-degrees. (ADAAG 4.13.5)

Modify doors by replacing door knobs with lever-type hardware or installing add-on levers.

Modify interior doors to comply with ADAAG specifications.

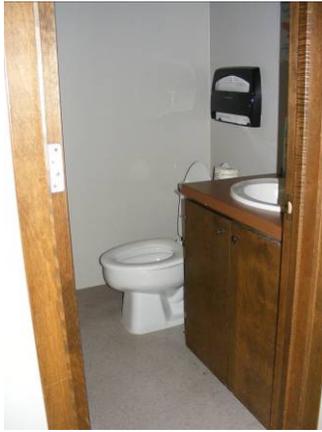
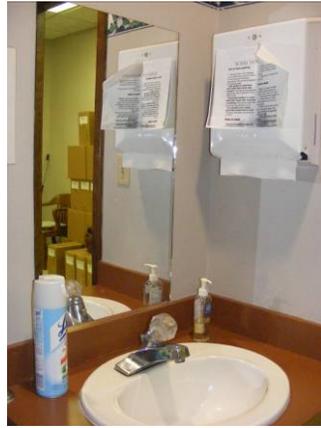
2. Employee Restroom:

EXISTING CONDITION: Existing employee restroom is totally inaccessible due to numerous inconsistencies.

In new construction, ADAAG requires all public and common use (which includes employee) restrooms to be fully accessible. However, this facility is not considered new construction. The scope of restroom improvements throughout the building should be proportional to the scope of alterations occurring in the remainder of the building. (ADAAG 4.23)

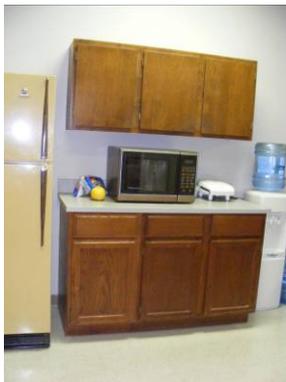
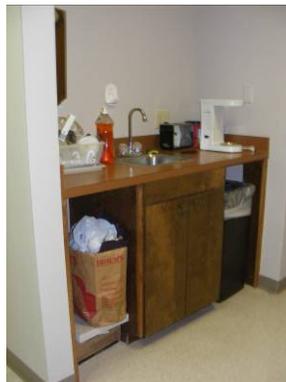
3. **Kitchenette:**

EXISTING CONDITION: Sink is too high, does not provide appropriate knee clearance due to cabinets underneath, and has round knob for faucet controls.

The existing sink does not provide knee and toe clearance. According to ADAAG, knee clearance that is at least 27 in (685 mm) high, 30 in (760 mm) wide, and 19 in (485 mm) deep shall be provided underneath sinks. In addition, each sink shall be a maximum of 6-1/2 in (165 mm) deep and no higher than 34”.

(ADAAG 4.24)

Make sink accessible, complying with ADAAG specifications as described above.

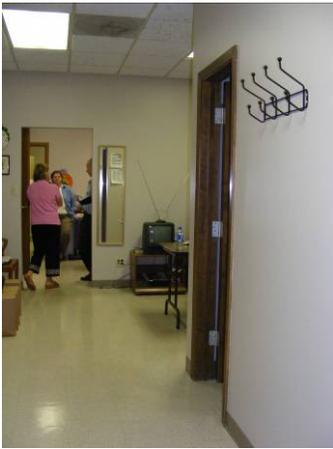
4. **Coat Hooks:**

EXISTING CONDITION: Coat rack is located too high at 5'-7" and creates a protruding object by projecting 4-3/4" from the wall.

Where accessible coat racks or hooks are provided, at least one must comply with reach ranges defined by ADAAG 4.2.5 or 4.2.6. The new ADAAG will further require that accessible objects be located within a maximum reach range of 48-inches, to the highest operable part. Additionally, where objects protrude from walls more than 4-inches and their leading edge is higher than 27-inches and lower than 80-inches, these objects are considered protruding objects, which may not be detectable by individuals who are blind and use a cane.

(ADAAG 4.4, 4.2.5, 4.2.6)

Replace coat rack with a one that does not protrude from the wall more than 4" or provide cane detection. Install such that at least one hook is within a maximum reach range of 48".
