ADDENDUM #8 RFB #25-0052 COMCARE COMMUNITY CRISIS RELOCATION AND EXPANSION

Phase I Environmental Site Assessment

235 S. Topeka Ave. Wichita, Kansas

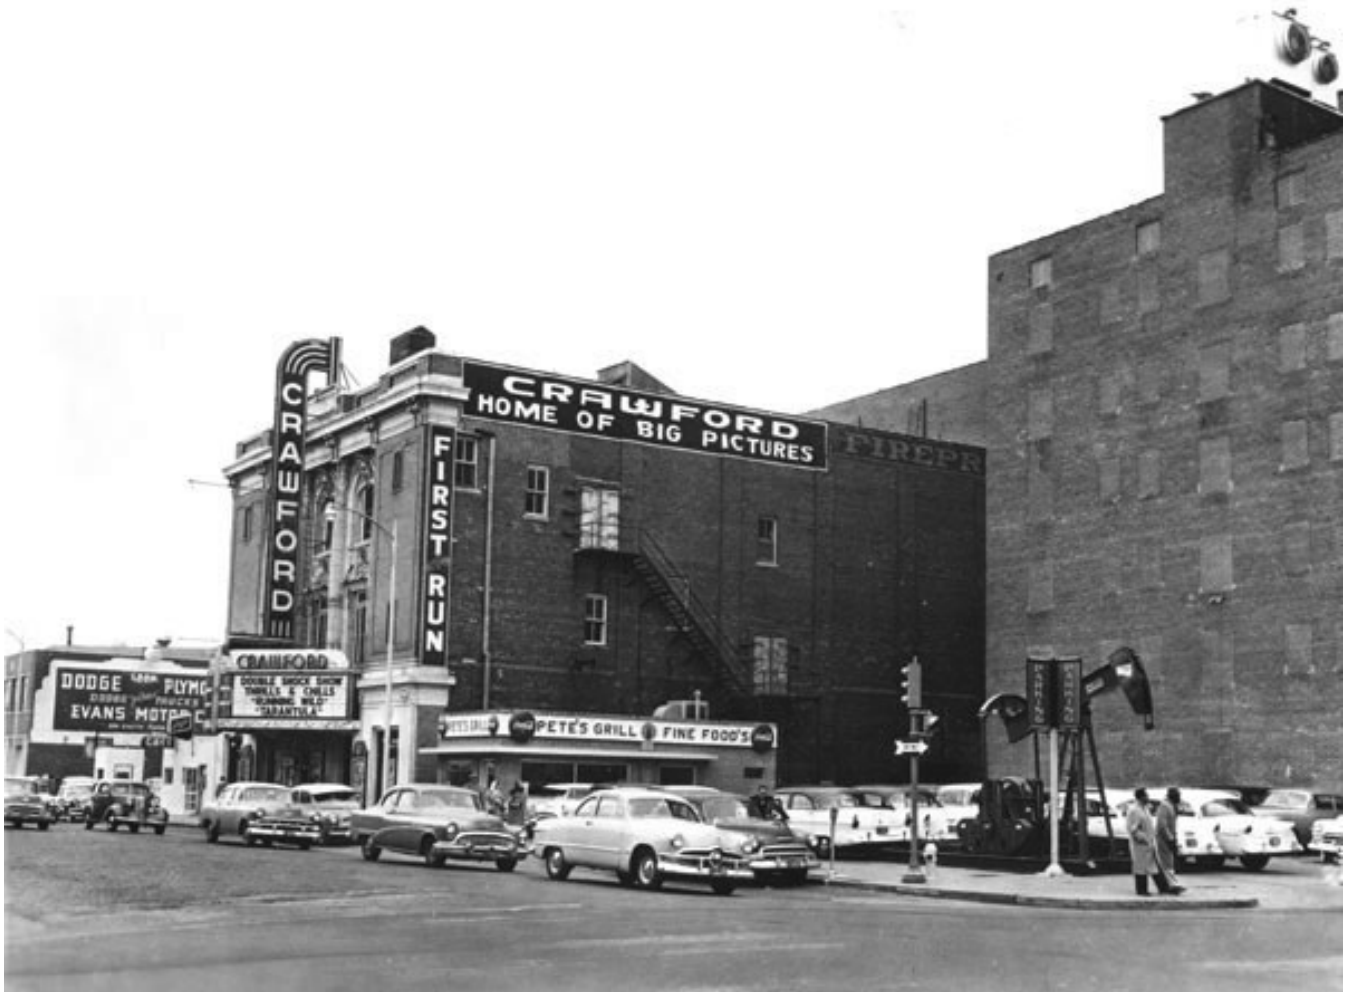
Figure 3. Corner of William and Topeka

An archived photo from 1952 shows the corner of William and Topeka, just immediately north of 235 S. Topeka Ave. The image is looking south and on said corner is an oil pumper, presumably pumping oil from the ground below in Figure 3. No records were found of any underground storage tank (UST), or its removal, from the area.
