**ADA ASSESMENT REPORT**  
**COMCARE – RAINBOWS UNITED**  
**603 S. ERIE, WICHITA, KS**  
**Report Date: July 31, 2008**

The following ADA site assessment was performed on July 16, 2008 upon request of April Powell, Project Manager for Sedgwick County Project Services.

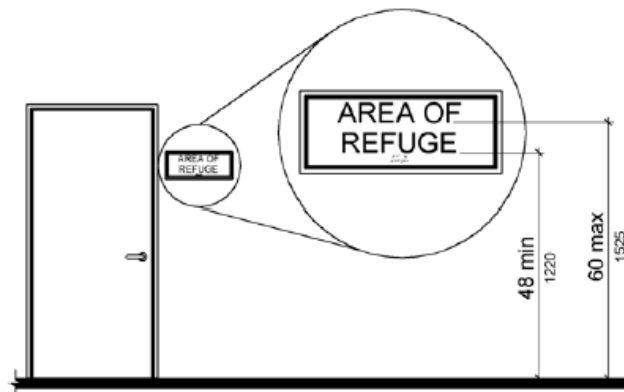
Figure 703.4.1 Height of Tactile Characters

**EXISTING CONDITION:** Exit signs are not also provided in Braille. Signs that identify permanent rooms and spaces (room numbers, exit signs, and restrooms) are required to be provided in Braille, mounted at the latch side of doorway openings. The New ADAAG provides specific guidance on the location of signage. Tactile characters on signs are to be located 48 inches (1220 mm) minimum above the finish floor or ground surface, measured from the baseline of the lowest tactile character and 60 inches (1525 mm) maximum above the finish floor or ground surface, measured from the baseline of the highest tactile character. Where a tactile sign is provided at a door, the sign shall be located alongside the door at the latch side. Where a tactile sign is provided at double doors with one active leaf, the sign shall be located on the inactive leaf. Where a tactile sign is provided at double doors with two active leaves, the sign shall be located to the right of the right hand door. Where there is no wall space at the latch side of a single door or at the right side of double doors, signs shall be located on the nearest adjacent wall. Signs containing tactile characters shall be located so that a clear floor space of 18 inches (455 mm) minimum by 18 inches (455 mm) minimum, centered on the tactile characters, is provided beyond the arc of any door swing between the closed position and 45 degree open position. (ADAAG 4.1.3(16), 4.30 & New ADAAG 703)
