ADA ASSESMENT REPORT
COMCARE – NORTHRIDGE FRIENDS CHURCH
2655 N. BULLINGER, WICHITA, KS
Report Date: August 5, 2008

The following ADA site assessment was performed on July 16, 2008 upon request of April Powell, Project Manager for Sedgwick County Project Services.

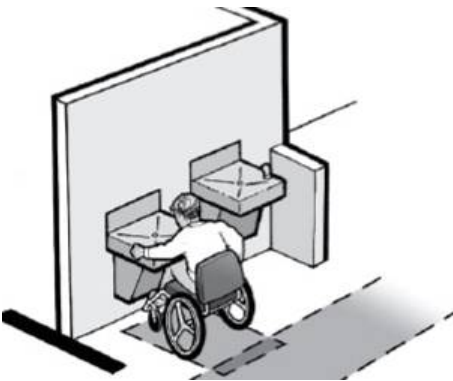
Wing walls.

RECOMMENDATION: Place a cane detectable object on each side of the drinking fountains. This may be achieved by wing walls or other methods such as those shown below.

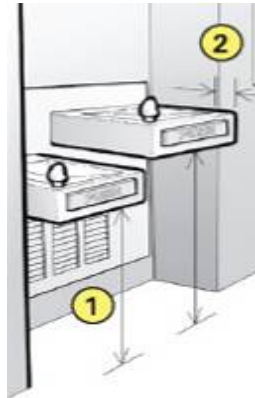
Recessing the drinking fountains such that dimension #2 does not exceed 4".

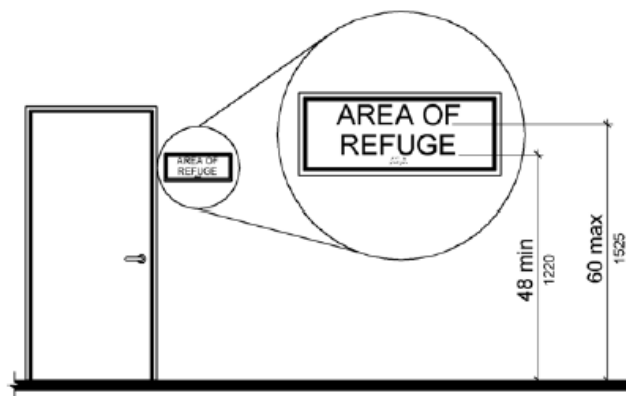
Figure 703.4.1 Height of Tactile Characters Above Finish Floor or Ground

EXISTING CONDITION: Restroom signage is inappropriately located at both the Men's and Women's Restrooms. Signs that identify permanent rooms and spaces (room numbers, exit signs, and restrooms) are required to be provided in Braille, mounted at the latch side of doorway openings. The New ADAAG provides specific guidance on the location of signage. Tactile characters on signs are to be located 48 inches (1220 mm) minimum above the finish floor or ground surface, measured from the baseline of the lowest tactile character and 60 inches (1525 mm) maximum above the finish floor or ground surface, measured from the baseline of the highest tactile character. Where a tactile sign is provided at a door, the sign shall be located alongside the door at the latch side. Signs containing tactile characters shall be located so that a clear floor space of 18 inches (455 mm) minimum by 18 inches (455 mm) minimum, centered on the tactile characters, is provided beyond the arc of any door swing between the closed position and 45 degree open position. (ADAAG 4.1.3(16), 4.30 & New ADAAG 703)

Move signage so that it is located to comply with the new ADAAG. Mount signage so that it complies with the new ADAAG 703.4.1 and 703.4.2. Use the 60" maximum dimension to establish the mounting height.
