**ADA ASSESMENT REPORT  
COMCARE TRANSITIONAL HOUSING  
731 HUNTER, WICHITA, KS  
Report Date: July 22, 2008**

The following ADA site assessment was performed on June 25, 2008 upon request of Paula Downs, Facilities Project Services Manager for Sedgwick County Project Services.

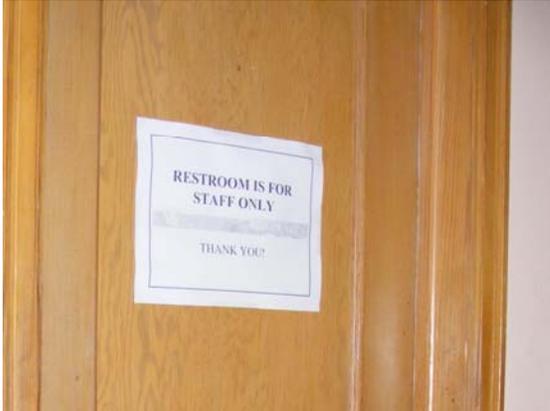
**OFFICE**

**It was explained that the public is only allowed access to the group counseling room (living room). The kitchen, offices (bedrooms), and restroom are not open to the public. Signage is posted at the restroom identifying it for use by employees only.** Improvements are not necessary to employee-only areas unless necessary to accommodate an employee with a disability.
