POST-INCIDENT ANALYSIS

Independent Review of the Brookhollow Apartment Fire

Project #: 1JHM24002 Date: December 16, 2024

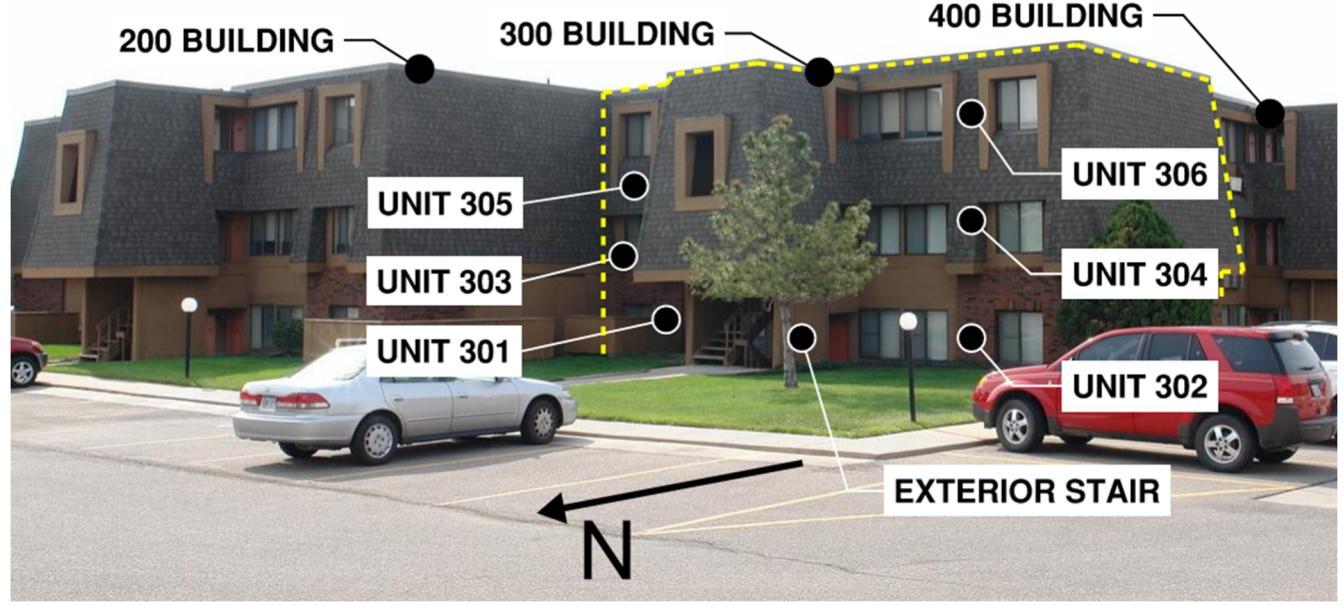
Figure 3: Undated Photo of Brookhollow Apartment Building 300.

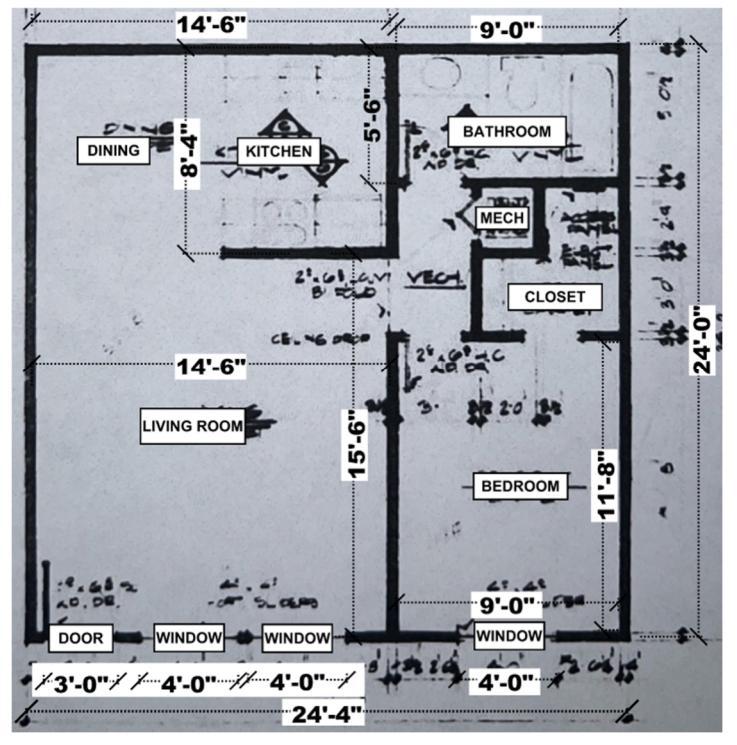
Figure 5: Architectural floor plan of even numbered Building 300 units (302, 304, 306); odd numbered units are mirrored along the living room wall.

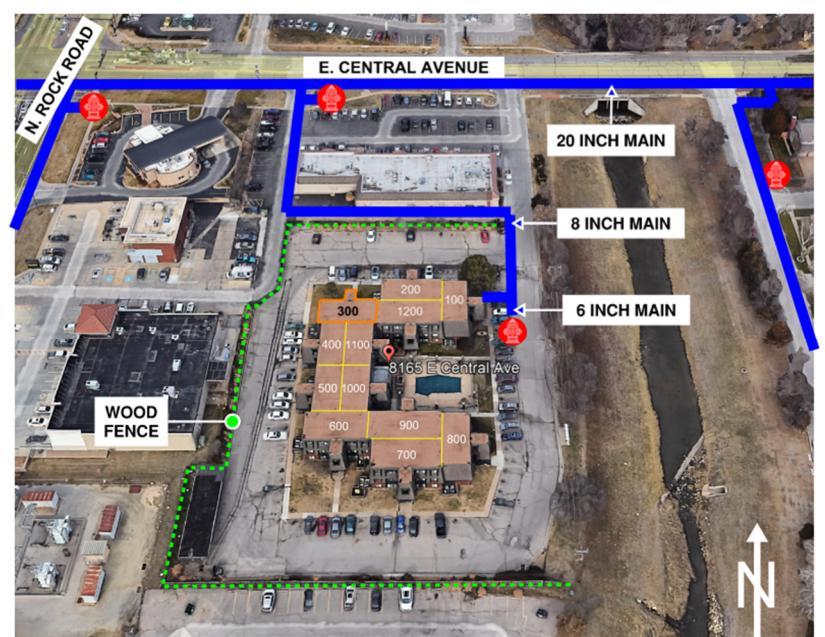
Based on the 1977 permit drawings, a single city-supplied fire hydrant is located on the northeast side of the building along the eastern driveway, near the entrance to the 100 Building. Notes on the original drawings indicate that the fire hydrant is fed from the north by an 8-inch water main. The next closest fire hydrant to the complex is over 300 feet away, located at the west driveway of the Brookhollow Center retail building on E. Central Avenue. Additional fire hydrants are located on the southeast corner of N. Rock and E. Central and across the water retention area east of N. Tara.

Figure 6: Brookhollow Complex water mains and hydrants. (Credit: Google Maps 2024)

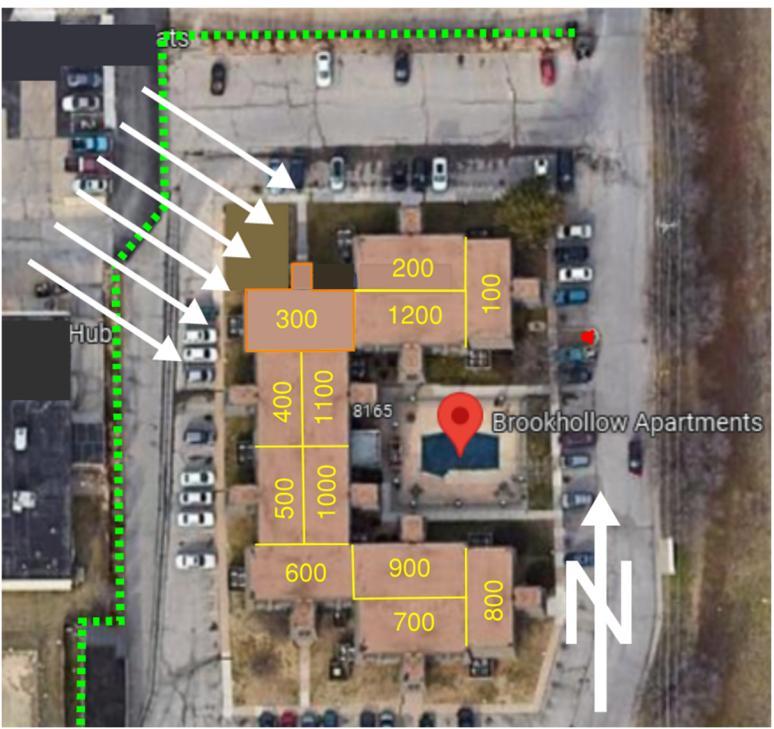
On the morning of the fire, October 13, 2023, between 3 a.m. and 5 a.m., the weather at the airport was reported to have average temperatures of 54°F, an average dew point of 52°F, and an average humidity of 60%. Sustained winds ranged between 17 and 25 mph out of the west-northwest, with gusts up to 38mph, and the skies were mostly cloudy. There was no reported lightning in the area.

Figure 7: Wind direction the morning of the fire. (Credit: Google Maps 2024)

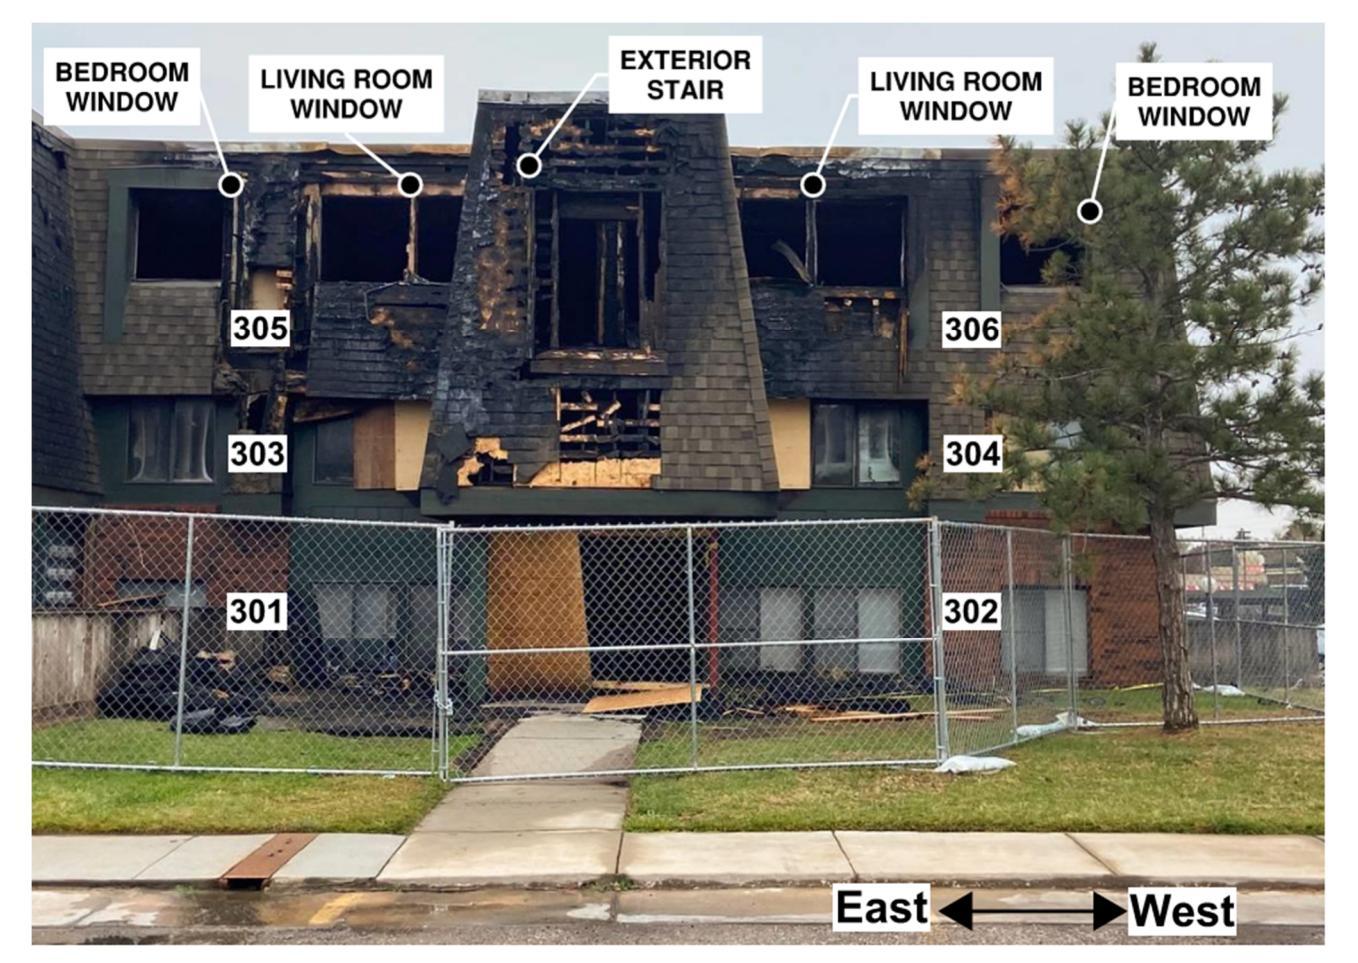
Figure 8: Post-fire photo of Building 300. (Credit: Jaime Green/The Wichita Eagle; annotations by Jensen Hughes)

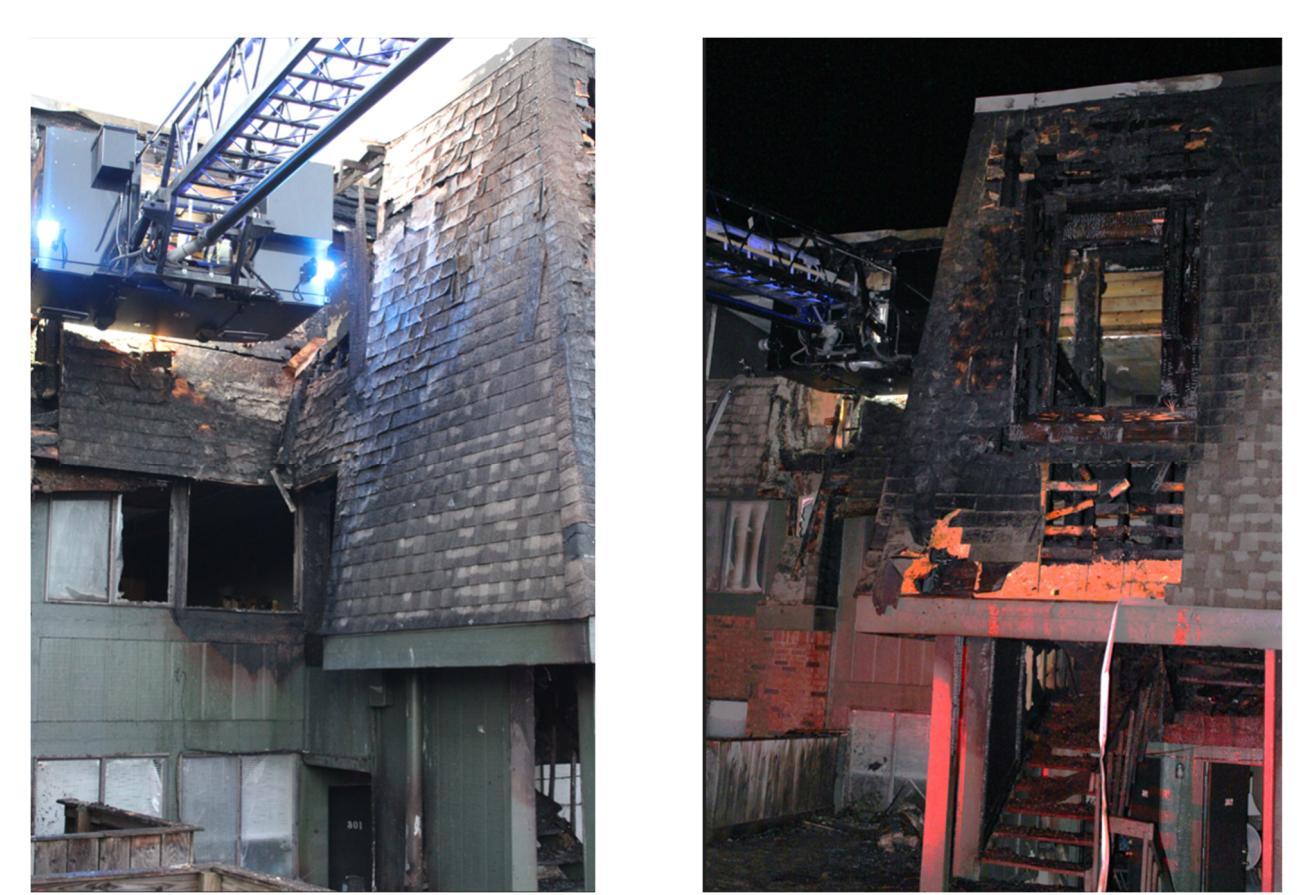
Figure 9: Post-fire damage to the exterior of Building 300. Left: Units 305 (top) 303 (middle) 301 (bottom) and east facing side of exit stairway enclosure. Right: North-facing side of exit stairway enclosure. (Credit: WFD FIU)

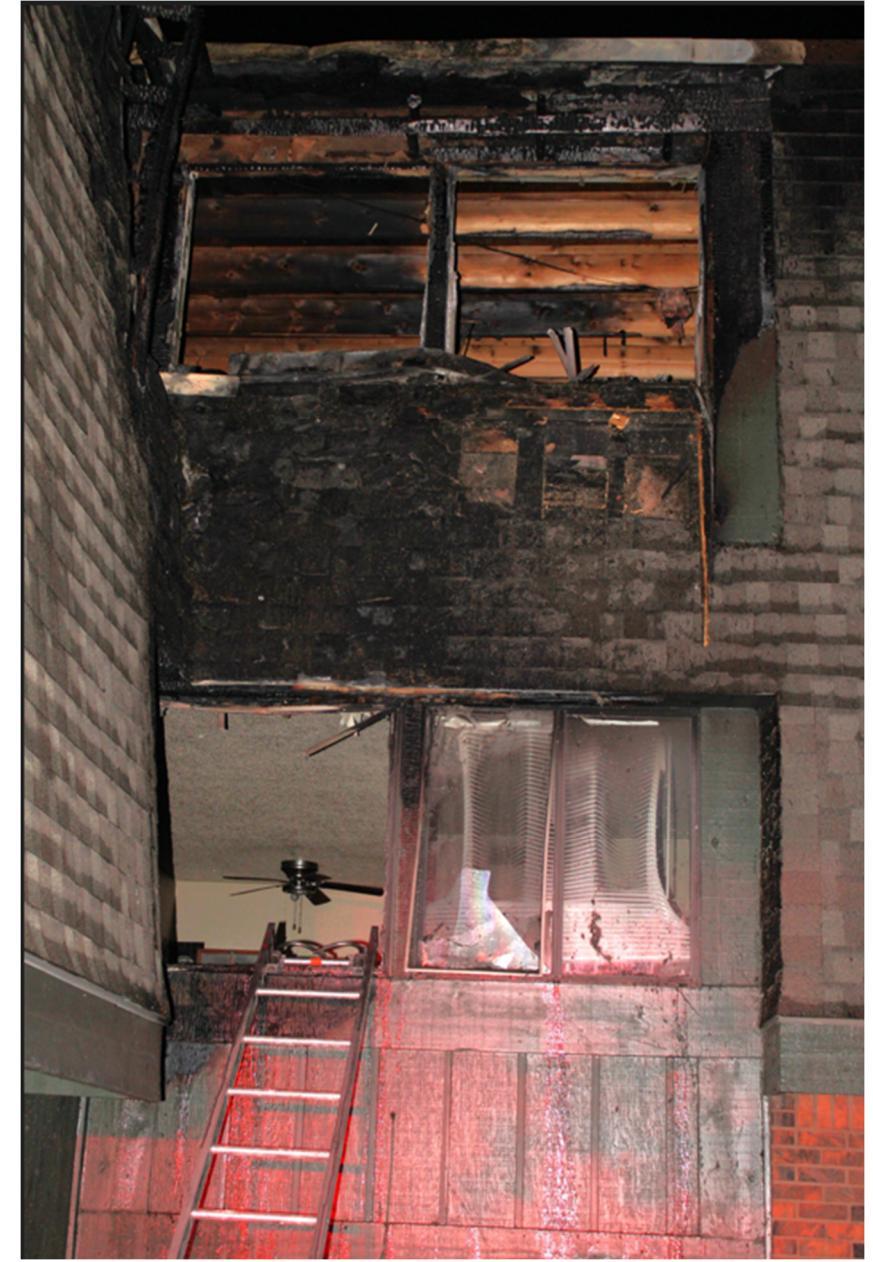
- In reviewing the available fire scene photographs provided by the Wichita Fire Department, patterns of fire impingement on the exterior doors and subsequent heat/smoke damage to the interior walls suggest the exterior door of Unit 306 may have been open during a portion of the incident while other apartment unit doors remained closed.

Figure 10: Post-fire damage to the exterior of Building 300. Living room windows seen for Units 306 (top) 304 (bottom). (Credit: WFD FIU)

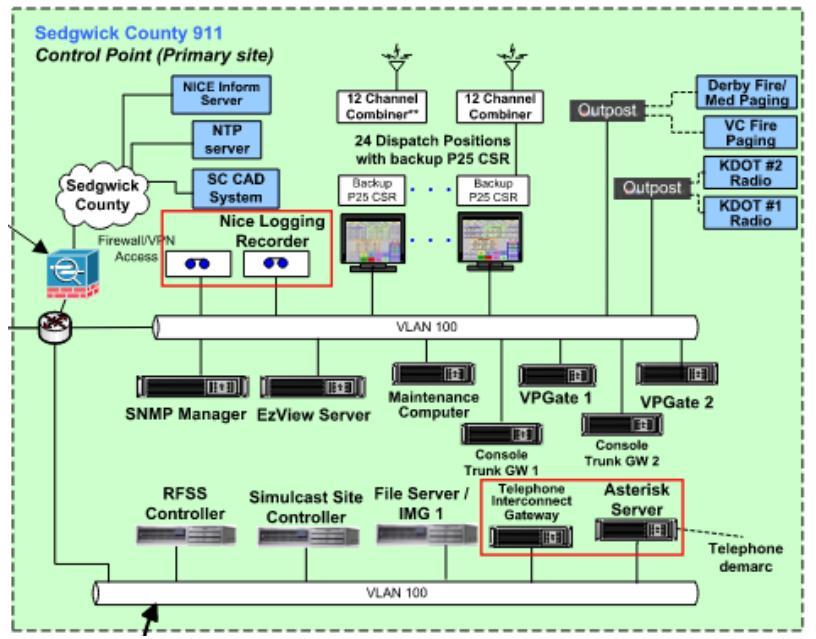
The figure below shows the IP connectivity of the recorder in relation to the phone system. The Telephone Interconnect Gateway is connected to VLAN100 (same as recorder), indicating that these two systems are on the same IP address.

Figure 12: IP connectivity of recorder in relation to the phone system. (Credit: SCEM)

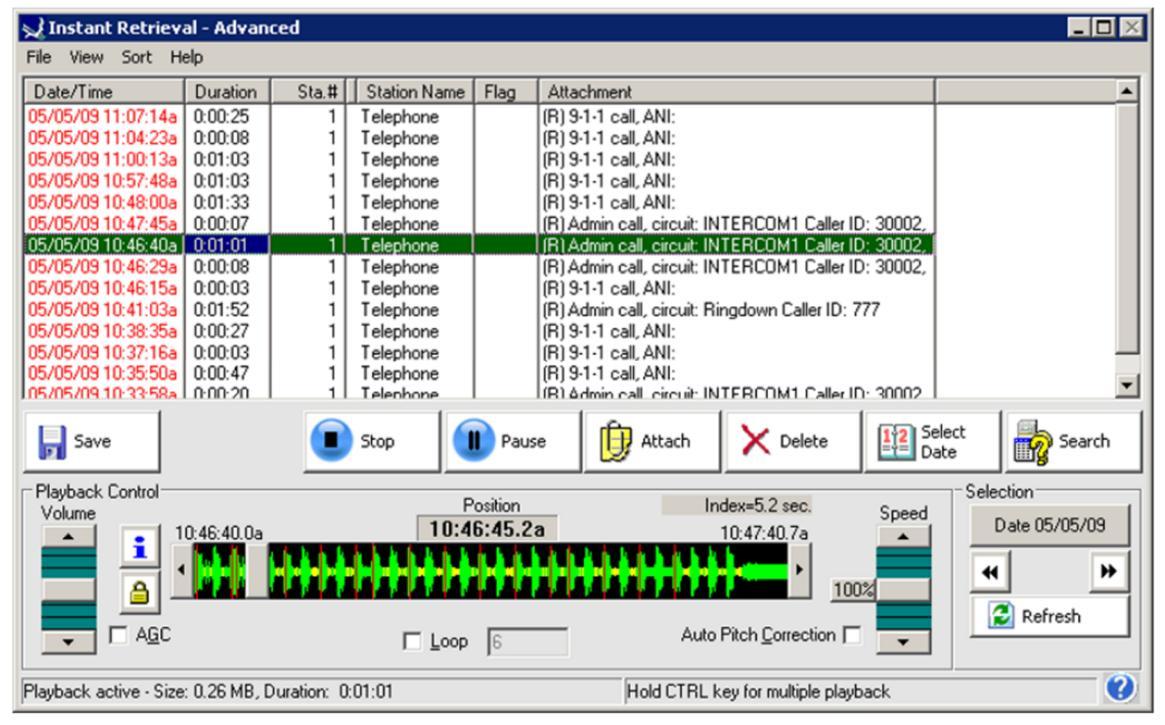
911 phone instant recall from VESTA-Instant Recall Recorder (IRR) is a telephony, radio, and microphonebased message recording and recorded message handling device (see figure). The IRR button allows call takers to open the IRR from their 911 phone console and listen to playback through headsets and/or external speakers.

Figure 13: Vesta 4.0/Sentinel 4.0 Instant Recall feature on 911 phone system. (Credit: VESTA 4.0 Sentinel 4.0 Product Guide)

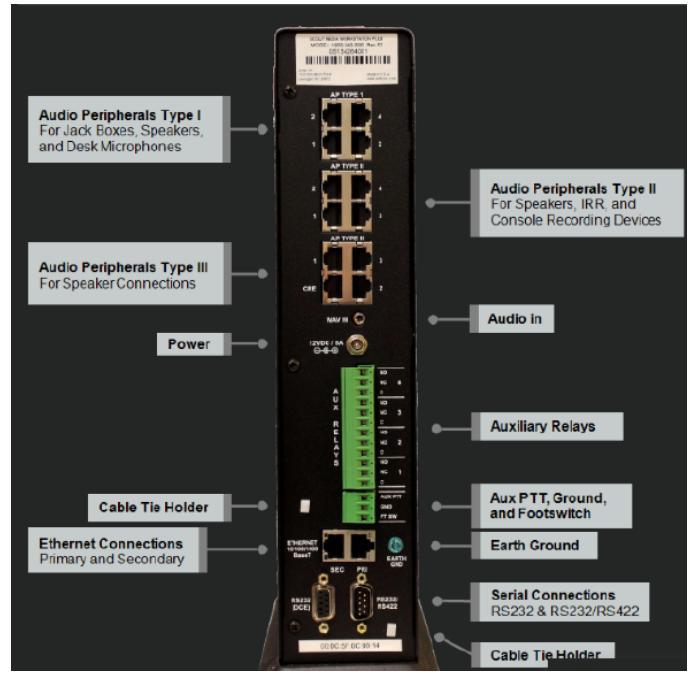
The Radio communications system includes a business-grade computer (PC), an Avtech Media Workstation Plus that is connected to inbound and outbound audio sources including speakers, headsets, recording, and footswitches, and an Avtech USB NENA Jackbox to connect the headset.

Figure 14: Avtech Media Workstation Plus. (Credit: Avtech USB NENA Jackbox Configuration Guide)

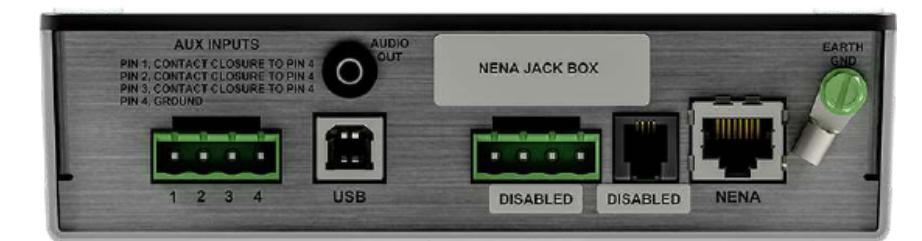
Figure 15: Avtech USB NENA Jack Box. (Credit: Avtech USB NENA Jackbox Configuration Guide)

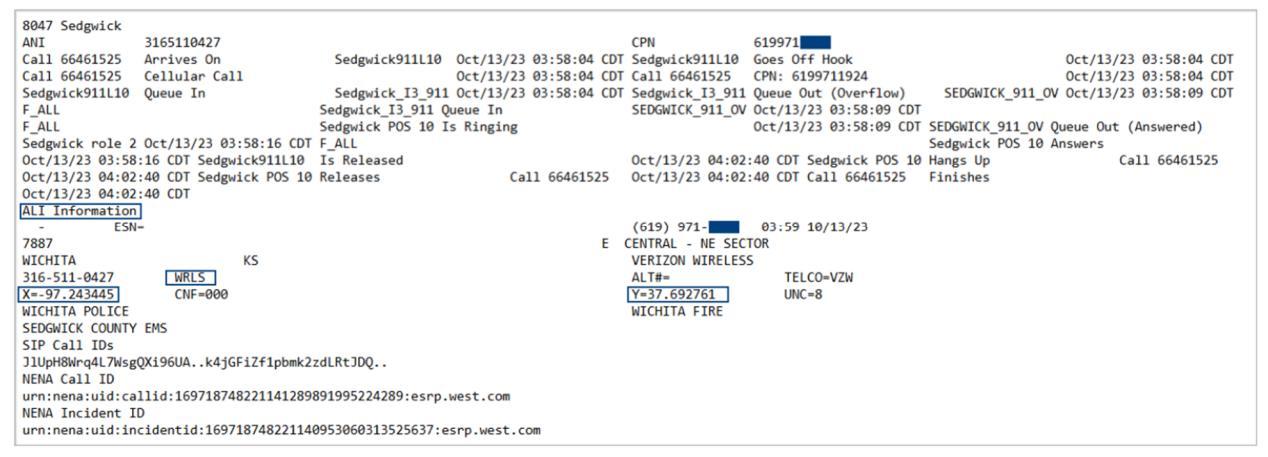
Automatic Number Identification (ANI) and Automatic Location Identification (ALI) data have been essential in 911 systems for caller identification and location tracking. By all accounts, the caller location technologies from the 911 phone system at SCEC were utilized as trained and configured. Wireless Phase I (WRLS) data was provided on Ms. Bedeski's and all other 911 calls for this incident. There was no WPH2 call data identified during our analysis.

Figure 18: Raw data for Ms. Bedeski's cellular call to SCEC with location information.

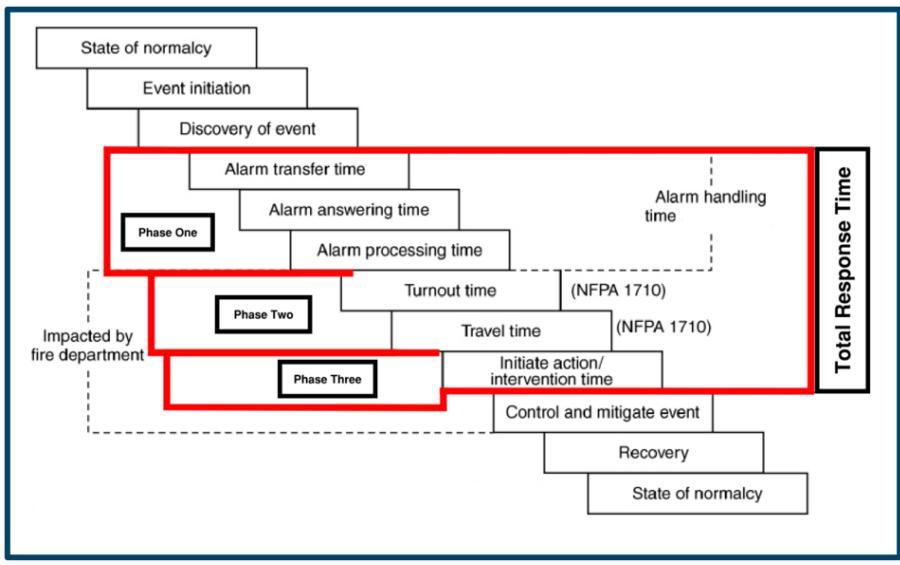
- + Total Response Time (TRT) time interval from the Receipt of the alarm at the primary PSAP to when the first emergency response unit is initiating action or intervening to control the incident.
- + Total Effective Response Force (ERF) total minimum number of personnel considered to be effective in response to a fire based on the hazard type (i.e. garden-style apartment).

Figure 20: Total Response Time (TRT) diagram from NFPA 1710 (2020 Ed).

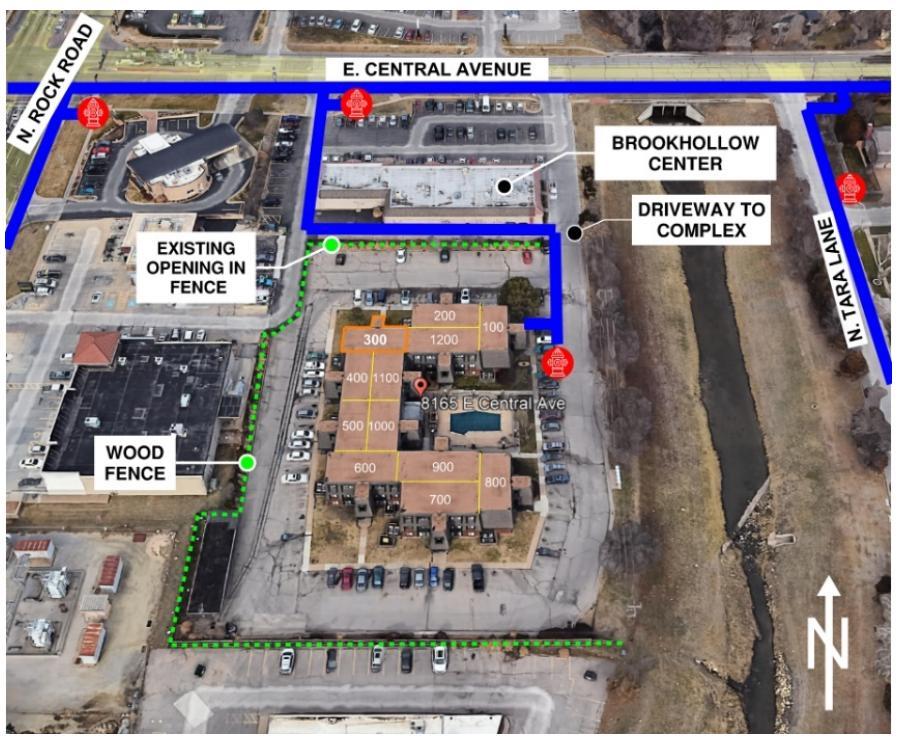
E9 arrived in the area moments later, and according to their Incident Report, they staged at a hydrant (Central Avenue). Approximately one (1) minute after E9 reported on scene, E14 arrived in the area and selfassigned by indicating that they were "laying in" a supply line. Approximately one (1) minute later, E18 arrived and was directed by Command to deploy a third attack line from E15. E18 chose to stretch a second 2 1/2inch attack line. In approximately three (3) minutes following E15's arrival, three (3) attack lines were deployed, charged, and operated

Figure 21: Locations of closest fire hydrants. (Credit: Google Maps 2024)

from a single engine using only booster tank water. As a result, E15 ran out of tank water before a continuous water supply was secured.

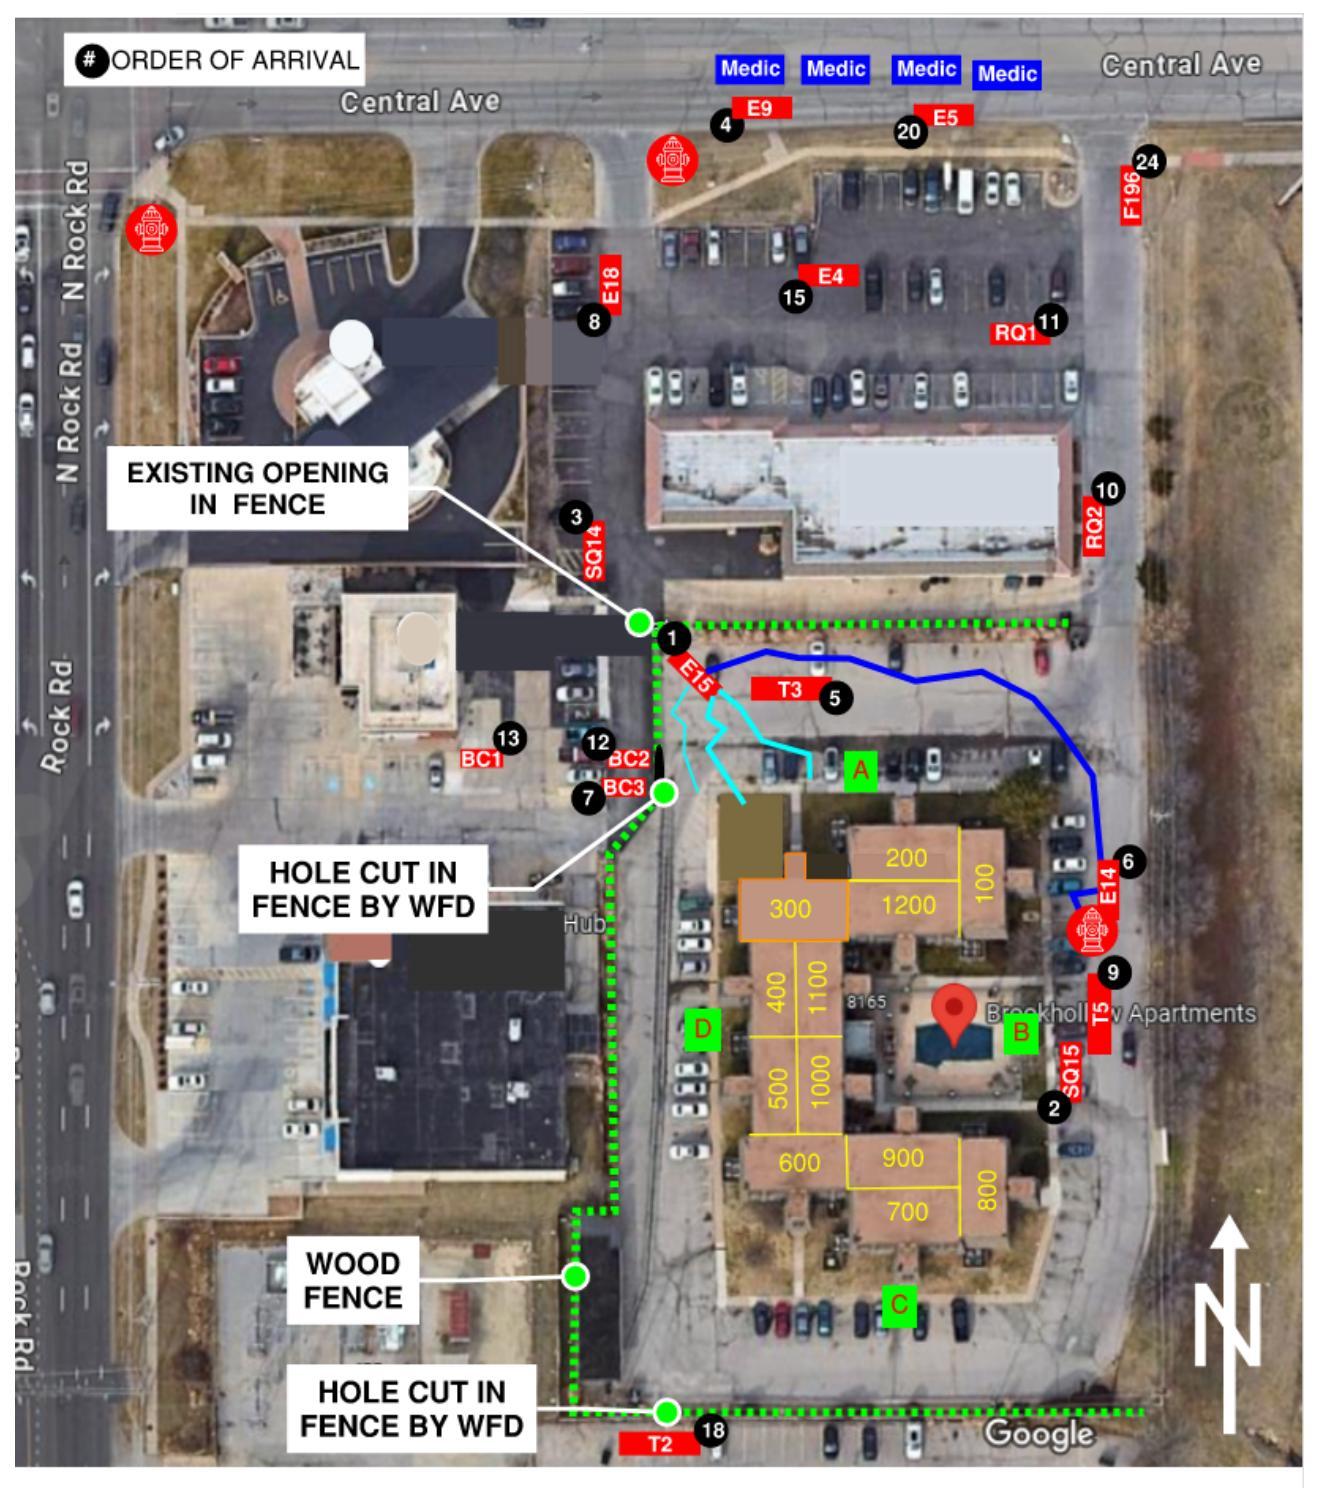
Fire Units Unknown Location: E10 (14), MA1 (16), F160 (17), SQ5 (19), E20 (21), F132 (22), F171/F172 (23) Medic Units Unknown Location on Central: M34 (2), M22 (3), M32 (4), M27 (6) Medic District Chief Unknown Location: M2 (1), M1 (5)

Figure 22: Approximate locations of WFD and SCEMS equipment. (Credit: Google Maps 2024)

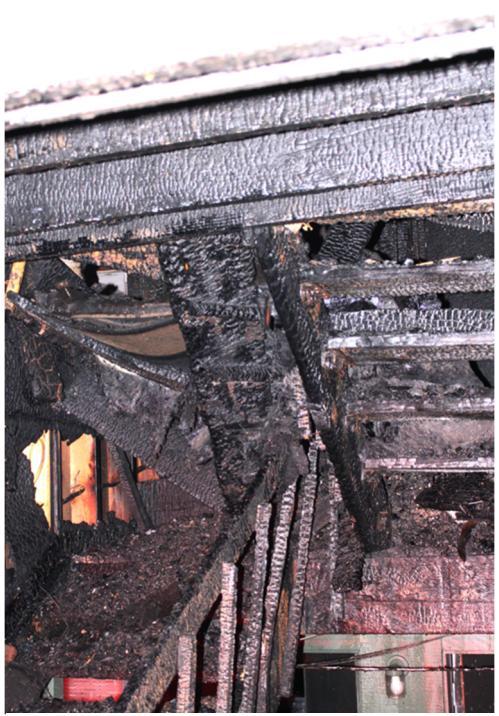
Figure 23: Collapse debris inside exit stairway. Stair (left) up to second floor landing. (Credit: WFD FIU).

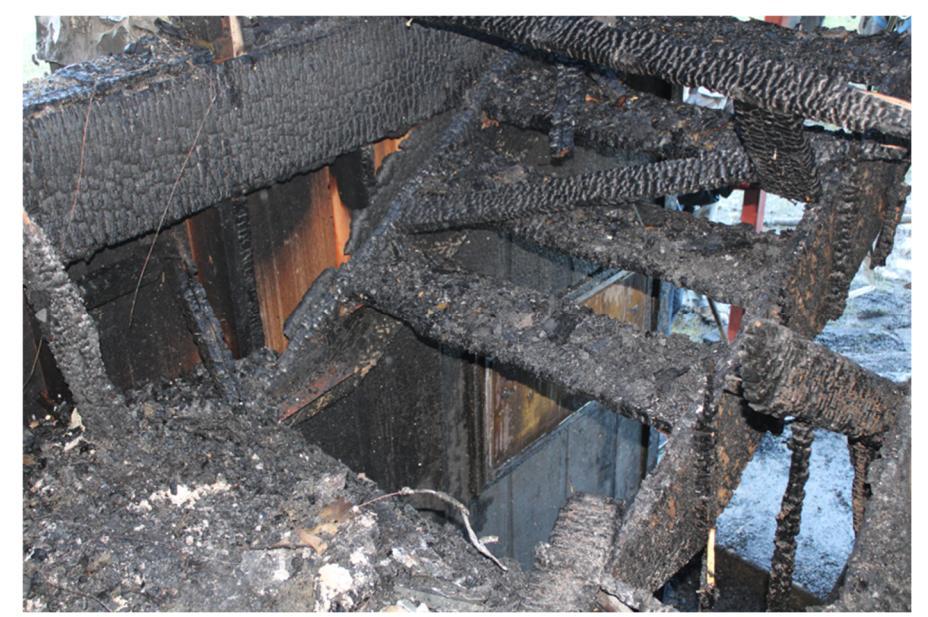
Figure 24: Second floor exit stairway landing with fire debris outside Units 303 and 304 (Credit: WFD FIU).

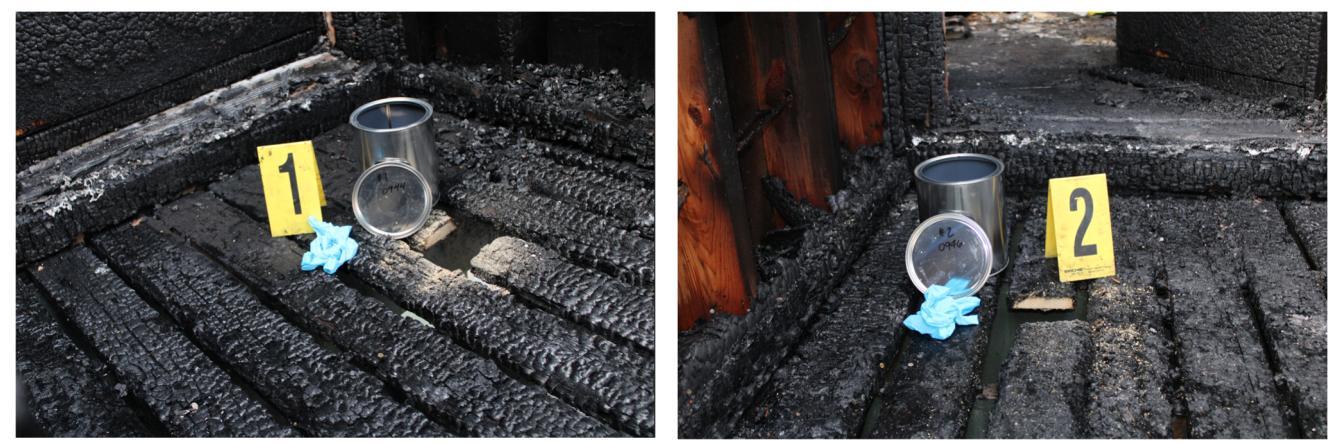
+ Two samples of wood decking evidence were collected from the stairway for testing. Although photographs of the sample locations were taken, the photographs were not taken in context and there was no diagram of the location where evidence was collected. Per NFPA 921, Section 17.5.2, physical evidence should be thoroughly documented before it is moved.

Figure 25: Wood decking taken as evidence. (Credit: WFD FIU).

- No control sample (sample from another area not suspected to be involved) collected / tested. Per NFPA 921, Section 17.5.4.6, this is an important step if the evidence items are to be tested for ignitable liquids.
- + The fire investigation report and/or supplements do not include the reasoning or rational for identification of where to collect samples and why.
- + The Request for Laboratory Services (for the debris samples) indicates the Offense as "Arson" and collection date of October 13, 2023.
